January 31, 2023.

Board of Directors
The Marina at the Bluffs Condominium Association, Inc.
1550 Marina Isle Way
Jupiter, FL 33477

**Re: Milestone Inspection Report – Phase One.
Building 10.
1001 Seafarer Circle, Jupiter, FL 33477**

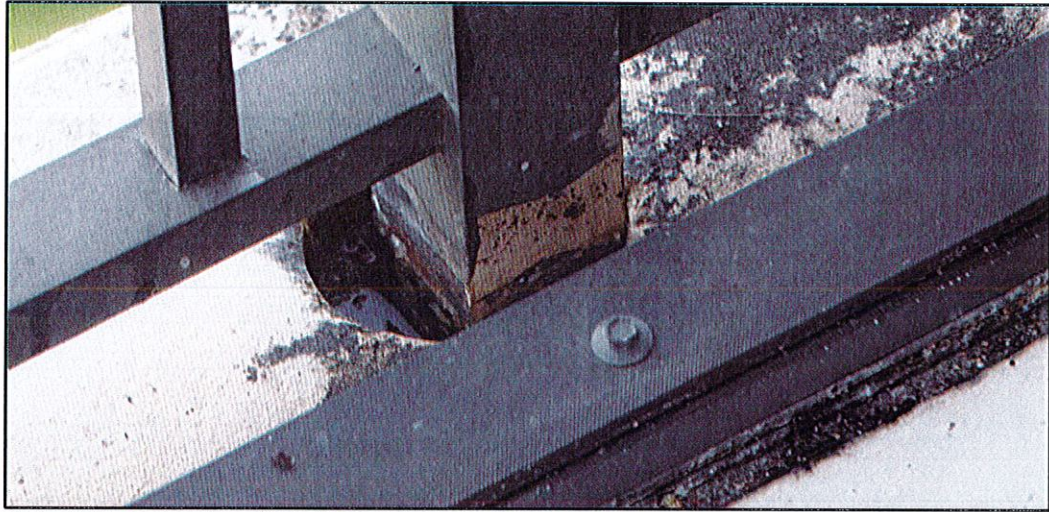
- Balcony guardrail vertical posts with visible separation and/or large gaps between the concrete wall of the concrete pocket and the post. Moisture was observed inside the cavity or gaps (see **Photo #1**). Also, moisture was observed ponding in low spots around the post base. This condition indicates moisture has penetrated the base of the post and could cause damage to the concrete and corrosion of the reinforcement in the slab. Further evidence of moisture within the railing post base can be observed at locations with vegetation and/or organic growth (See **Photos #2 through #4**). Also, at several locations, the degree of deterioration of the post base grout allows unwanted lateral movement of the guardrail system top member or top rail.

Photo #1. View of post base filled with water and with missing grout or sealant (unit 506 balcony).

- At locations where concrete/grout cracks, delamination, and/or spalling is identified, remove all grout to expose the embedded portion of railing post and remove adjoining cracked, delaminated and/or spalled concrete.
- Remove all grout, corrosion, scale, slurry, and other bond-inhibiting material from exposed railing post by thorough wire-brushing or high-pressure water blasting.

- Install weep hole at post base above finishes.
- Replace removed concrete non-shrink non-metallic grout around the post.
- Prime railing posts to a minimum of 1-inch above the finish concrete surface to provide adequate grout-to-aluminum isolation.
- Seal around post base with sealant.
- Plaster finish and paint the repair area to match the surroundings.

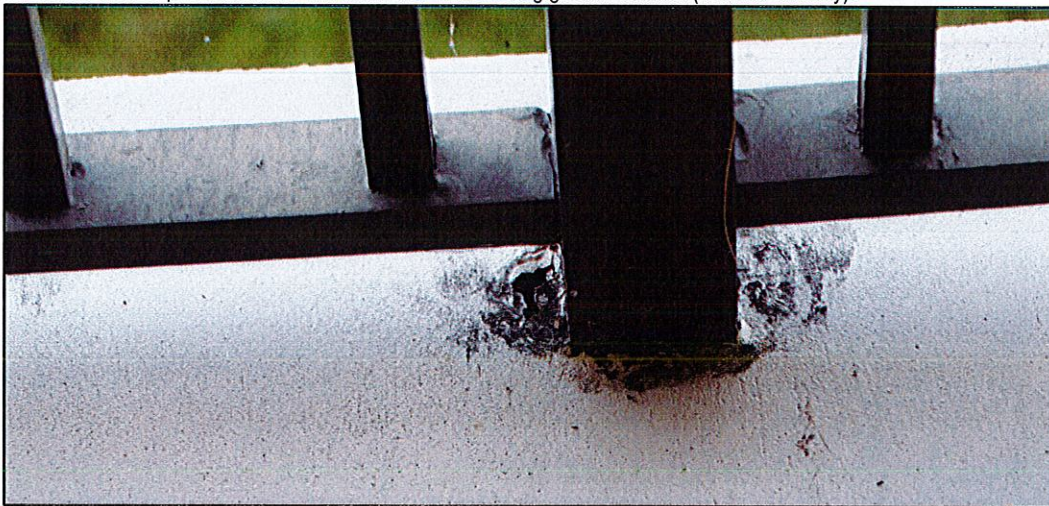
Photo #2. View of post base deteriorated grout and organic growth (unit 206 front corridor).

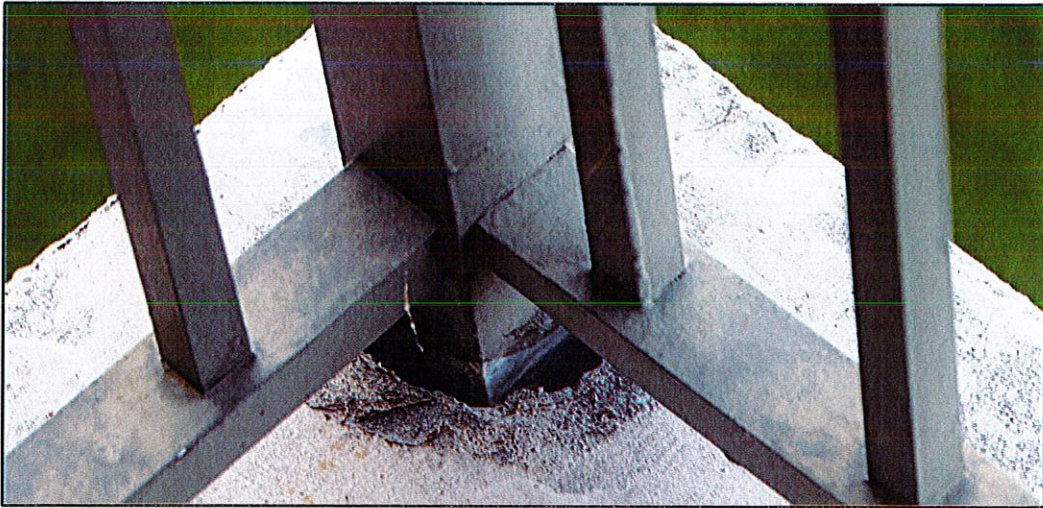
Photo #3. View of post base deteriorated grout and signs of organic growth (unit 405 balcony).

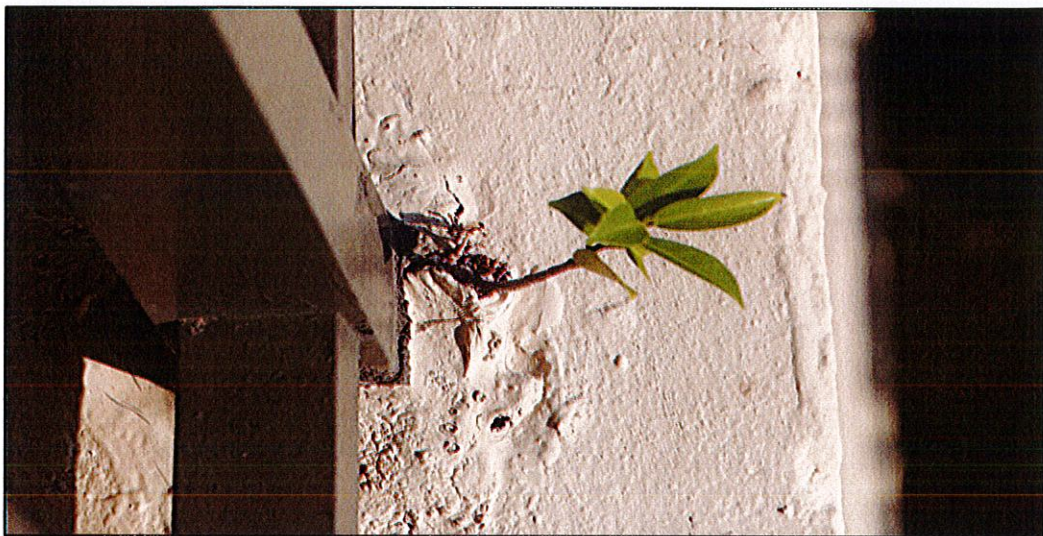
Photo #4. View of post base deteriorated grout and vegetation growth (unit 506 front corridor).

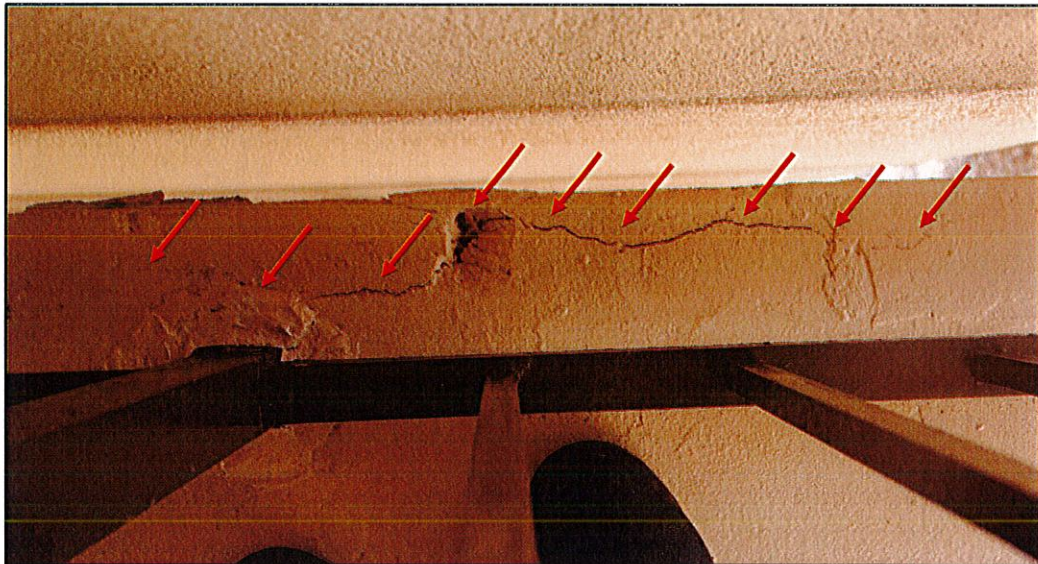
- Balcony floors and exterior edges with imminent concrete spalls. This condition can also be caused by insufficient rebar concrete coverage and by superficial cracks that allow moisture intrusion. Corrosion present at reinforcing steel produces expansion of the diameter of the bar which leads to displacement of surface materials, in this case, concrete (See **Photos #5 & #6**). Due to the uncertainty of this condition, it is not possible to predict if or when the finishes will fall. We recommend removing the deficient portions of the finishes or concrete elements from the slab edges or ceilings to prevent pieces of debris from falling down and hurting residents.

Photo #5. View of imminent spalling of concrete slab edge observed at corridor near wall in front of stairs between units 501 & 502.

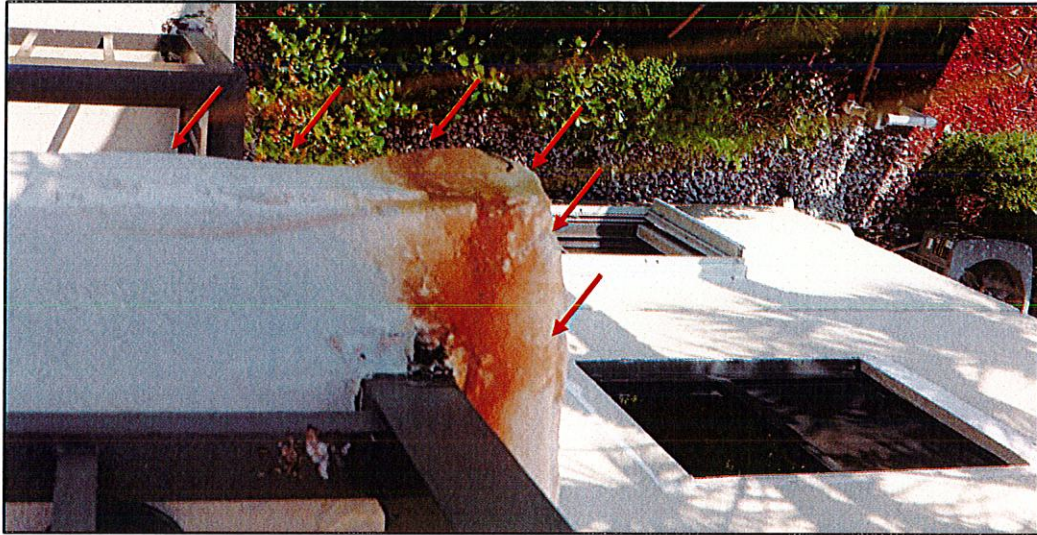
Photo #6. View of imminent spalling of concrete slab edge and/or stucco finishes observed at corner of front corridor at unit 401.

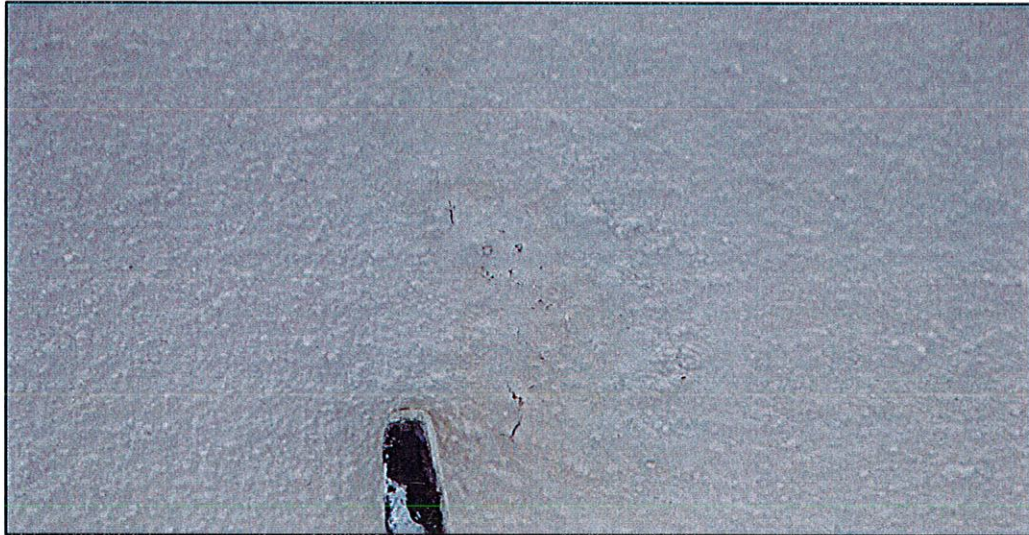
- Balcony ceiling and exterior edges with exposed and corroded reinforcement bars. This condition can be caused by insufficient rebar concrete coverage and by superficial cracks that allow moisture intrusion. Corrosion present at reinforcing steel produces expansion of the diameter of the bar (exfoliation) which leads to displacement (jacking) of surface finishes, such as stucco. This condition can be observed prior to stucco/concrete finishes failure, in the form of bulging of the exterior finishes (see **Photos #7, #8 & #9**).

Photo #7. View of deteriorated ceiling stucco finishes, visible efflorescence stains and cracks in finishes, condition observed at ceiling of unit 405 balcony.

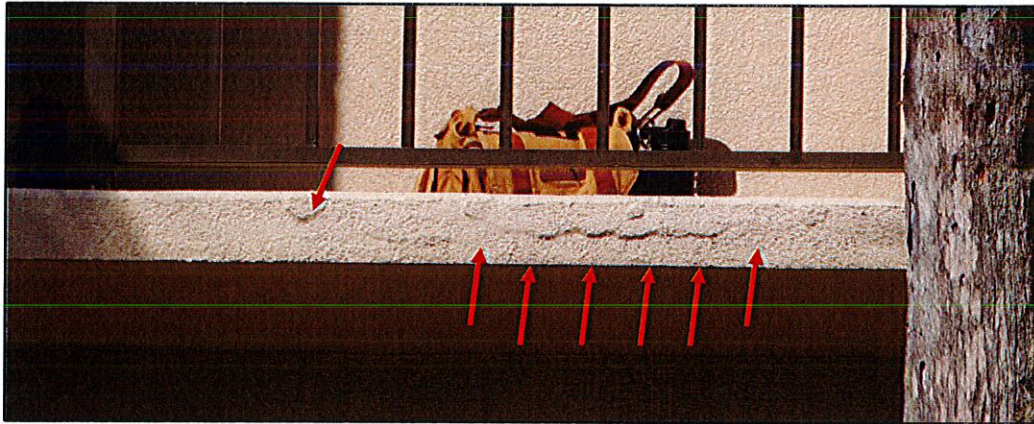
Photo #8. View of exterior stucco finishes with localized bulging (unit 206 front corridor).

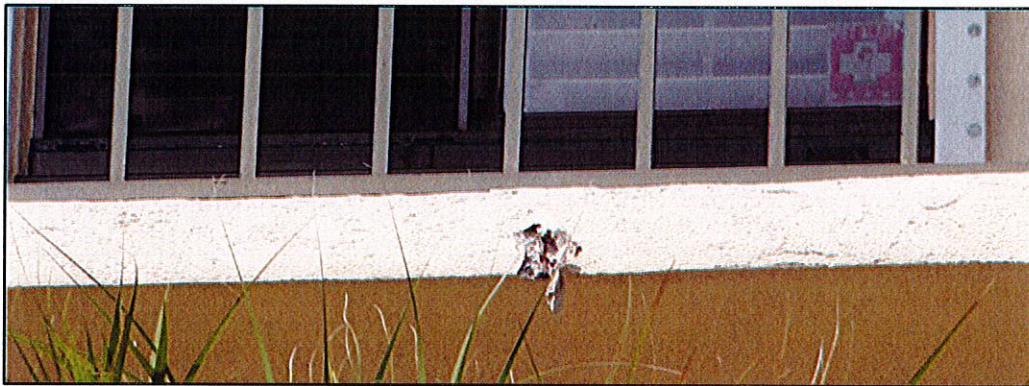
Photo #9. View of exterior stucco finishes with spalled finishes and exposed reinforcing bars (unit 406 front corridor).

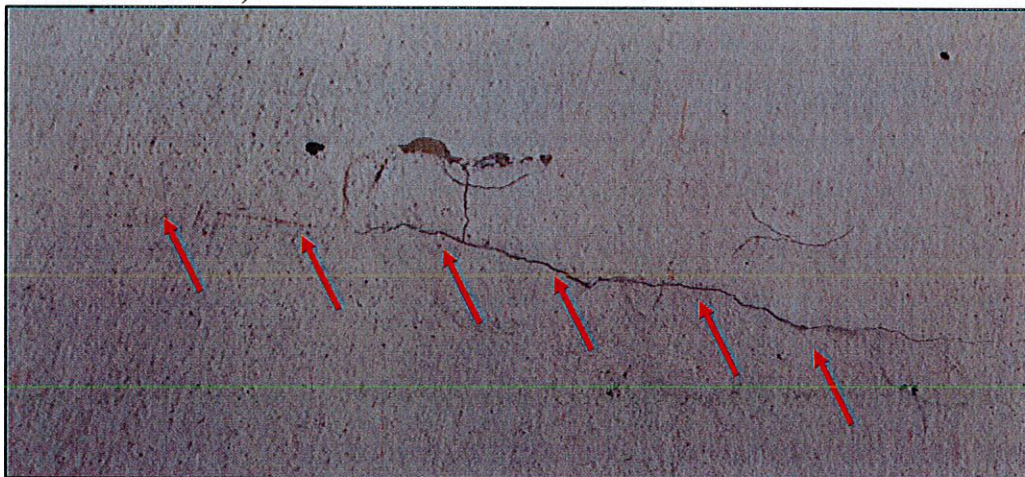
- In certain instances, this condition can be concealed by finishes that have not yet failed or have been covered by previous repairs. This condition requires additional invasive evaluations to clearly define the limits of the deficiency (see **Photos #10 & #11**).

Photo #10. View of deteriorated floor finishes, signs of concrete slab spalling due to corroded reinforcing, condition observed at floor (Top of slab) of unit 204 balcony.

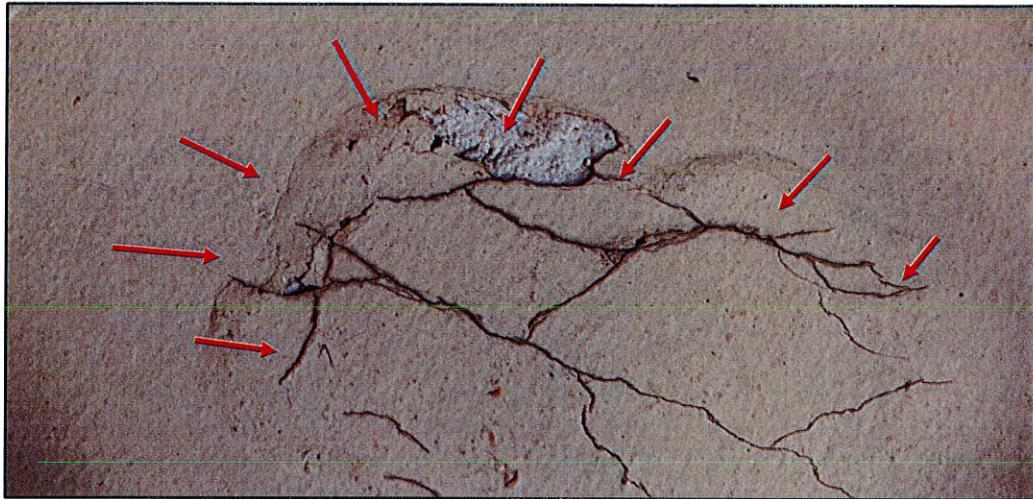
Photo #11. View of deteriorated floor finishes, signs of concrete slab spalling due to corroded reinforcing, condition observed at floor of unit 203 front corridor.

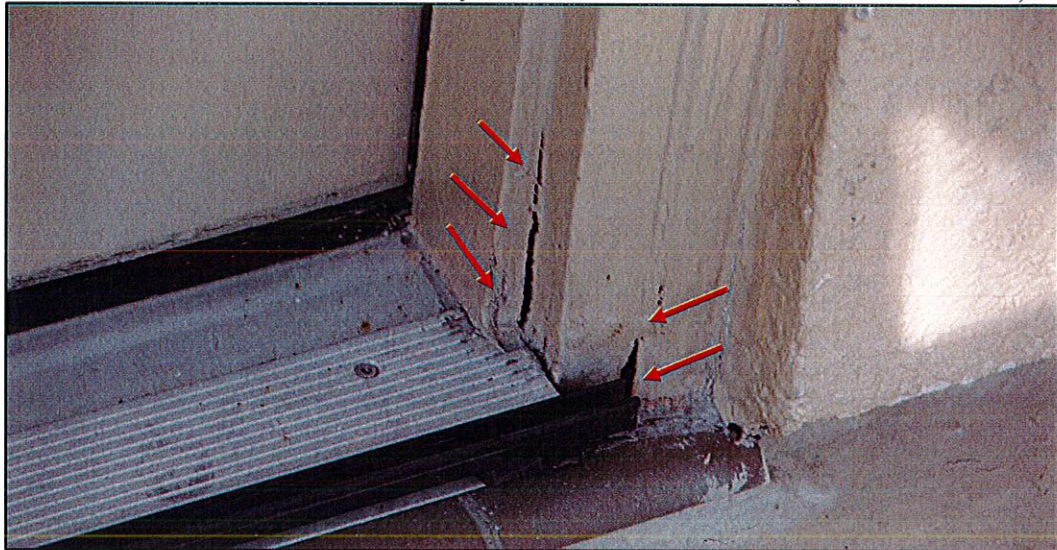
- Exterior sealants around door and window observed with signs of deterioration (cohesion failure). This condition can allow wind driven rain to enter the building envelope and cause damage to the concrete elements as well as damage to interior finishes, personal property and create environmental contamination such as mold and mildew. Sealant shall be removed and replaced preferably with a paintable and UV resistant silicone or hybrid sealant material (See **Photo #12**).

Photo #12. View of deteriorated sealant around the front door of unit 301.

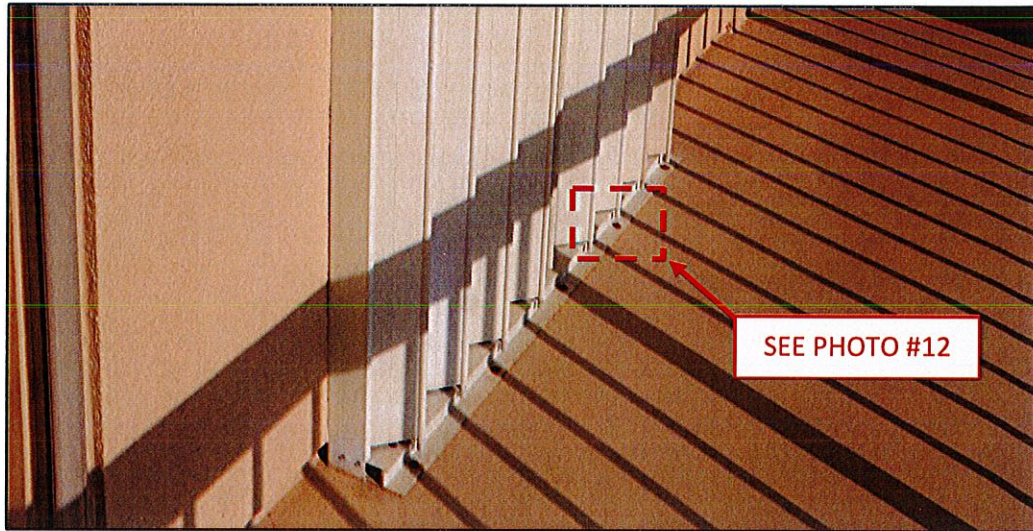
- Anchors for hurricane shutters observed with severe deterioration in the form of corrosion. This condition will compromise the structural integrity of the shutters under severe wind events. Expansion of the anchor due to severe corrosion will damage the concrete and can allow moisture to enter and damage reinforcing bars within the slab (see **Photos #13 & #14**). Corroded anchors shall be replaced with corrosion resistant anchors.

Photo #13. View of deteriorated metal anchors for the hurricane shutters. Observed at several units (Unit 503 shown).

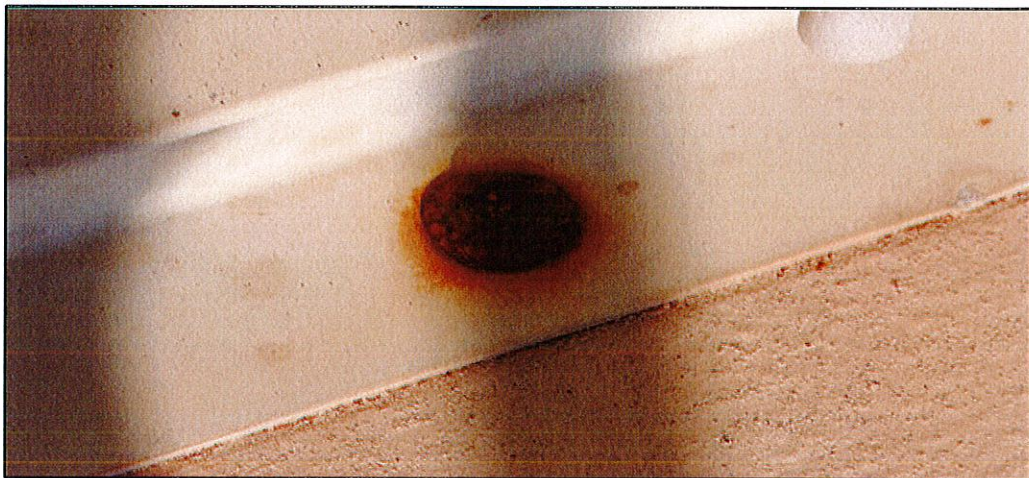
Photo #14. Close up view of deteriorated metal anchors for the hurricane shutters. (Unit 503 shown).

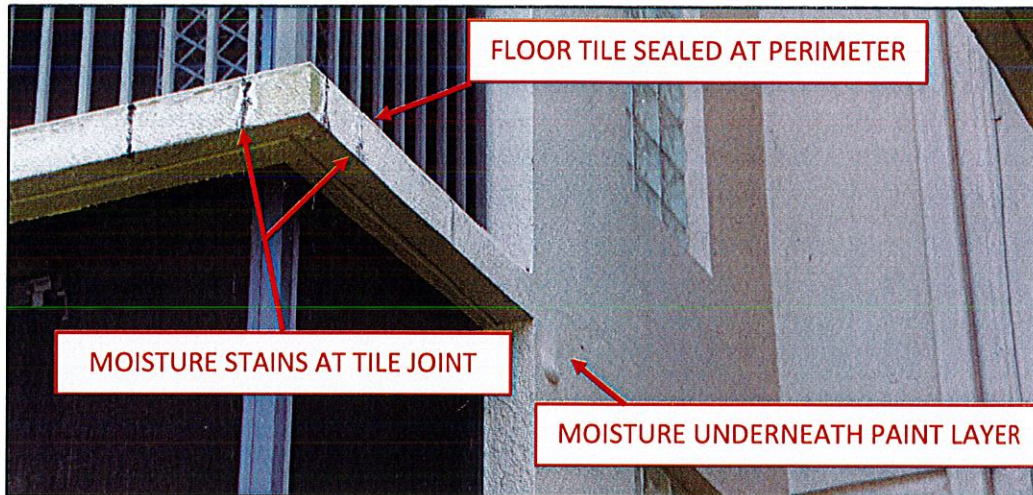
- Balcony ceiling and exterior edges with exposed and corroded metals and corroded steel elements observed at numerous units. This condition refers to metals used in the slab during construction, and also metals installed after construction. Exposed corroded metals shall be removed by grinding metals to a depth of at least 1 inch, coating remains of metal elements in cavity, patching hole and finish or paint to match existing adjacent areas.
- Also, it was observed, at private balcony units with floor finishes (i.e. tile) installed up to the edge of the slab and the edge of the tile perimeter completely sealed preventing water that enters through grout lines or cracks to escape. In many cases water accumulates with no way to drain out damaging the finishes and potentially the concrete and reinforcement within the slabs (See **Photo #15**).

Photo #15. View of floor finishes (tile) with edges sealed (Unit 303 balcony shown).

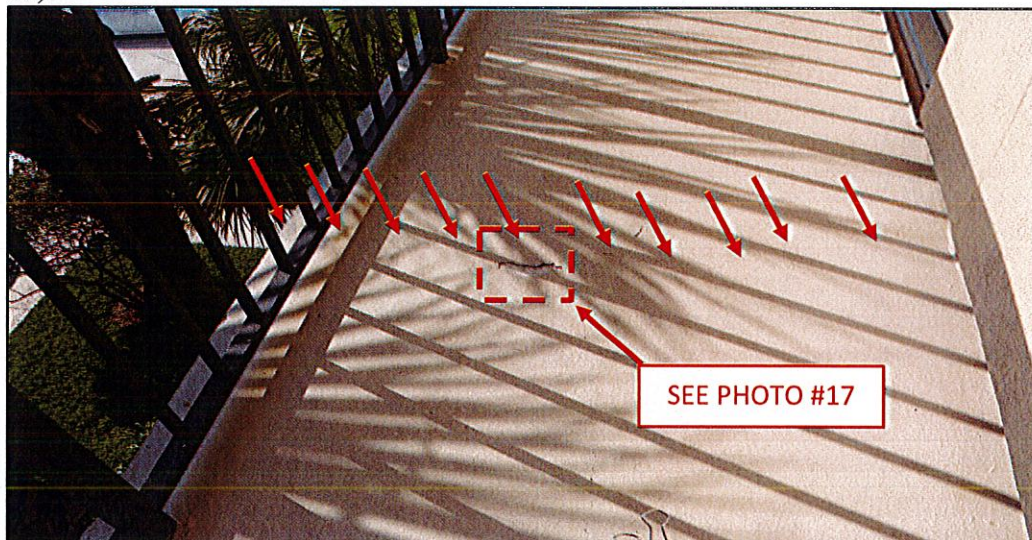
- View of floor slab with unsealed penetrations and floor cracks. Unsealed penetrations allow rainwater to penetrate and usually leads to corrosion of member reinforcement and spalling of concrete (Long term). Unsealed penetrations shall be filled with epoxy materials. The majority of the cracks observed are hairline cracks and do not represent a structural concern, however if not repaired they can cause future damage to the structure. Cracks shall be routed, sealed and surfaces finished with waterproofing membrane. (See **Photos #16 and 17**).

Photo #16. View of slab with visible cracks and spalled concrete (Unit 402 front corridor shown).

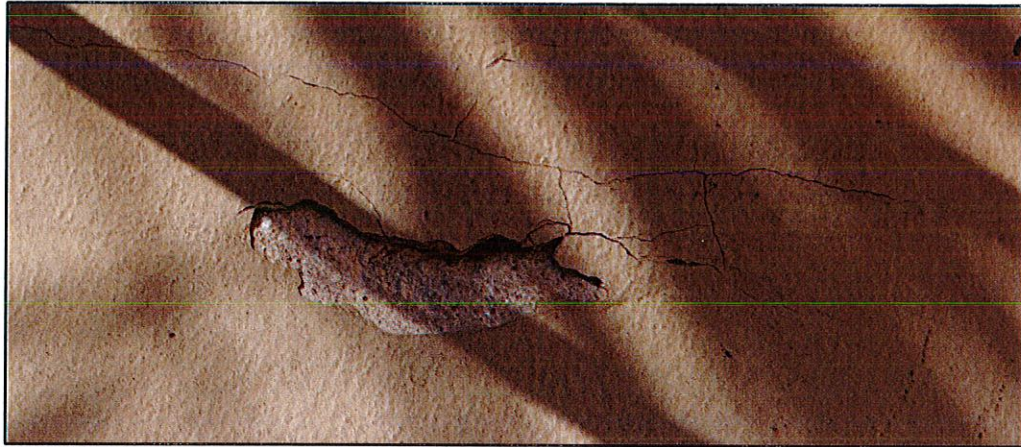
Photo #17. Close up view of slab crack and spalled concrete (Unit 402 front corridor shown).
