January 31, 2023

Board of Directors  
The Marina at the Bluffs Condominium Association, Inc.  
1550 Marina Isle Way  
Jupiter, FL 33477

**Re: Milestone Inspection Report – Phase One.  
Building 11.  
1101 Seafarer Circle, Jupiter, FL 33477**

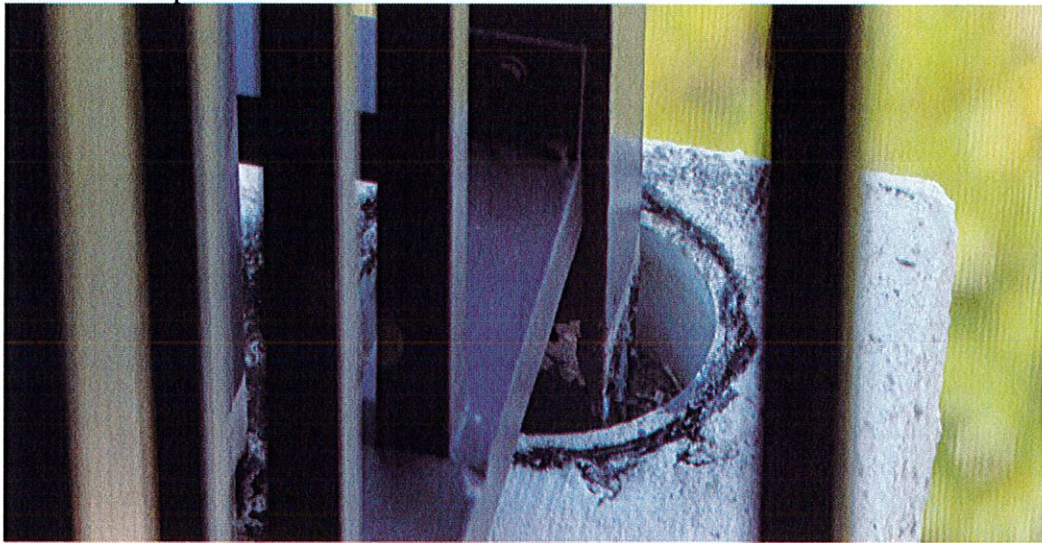
- Balcony guardrail vertical posts with visible separation and/or gaps between the concrete wall of the concrete pocket and the post (see **Photos #1 and #2**). Also, moisture was observed ponding in low spots around the post base. This condition indicates moisture has penetrated the base of the post and could cause damage to the concrete and corrosion of the reinforcement in the slab. Further evidence of moisture within the railing post base can be observed at locations with vegetation and/or organic growth. Also, at several locations, the degree of deterioration of the post base grout allows unwanted lateral movement of the guardrail system top member or top rail.

**Photo #1.** View of post base deteriorated grout with large gaps and metal post with signs of corrosion damage (unit 501 balcony).

Since the existing guardrail system is not “current” code compliant, the guardrail system cannot be removed or un-installed from the current location. If the guardrail is removed, a new current code compliant system shall be installed in its place. For that reason, we recommend the following remedial actions:

- At locations where concrete/grout cracks, delamination, and/or spalling is identified, remove all grout to expose the embedded portion of railing post and remove adjoining cracked, delaminated and/or spalled concrete.
- Remove all grout, corrosion, scale, slurry, and other bond-inhibiting material from exposed railing post by thorough wire-brushing or high-pressure water blasting.
- Install weep hole at post base above finishes.
- Replace removed concrete non-shrink non-metallic grout around the post.
- Prime railing posts to a minimum of 1-inch above the finish concrete surface to provide adequate grout-to-aluminum isolation.
- Seal around post base with sealant.
- Plaster finish and paint the repair area to match the surroundings.

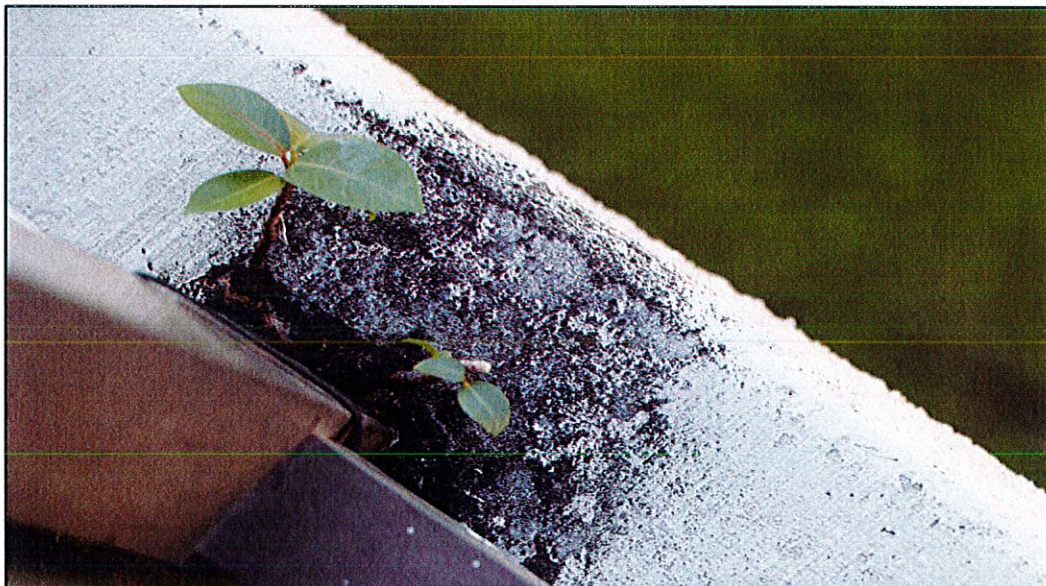
**Photo #2.** View of post base deteriorated grout and visible vegetation growth (unit 306 balcony).

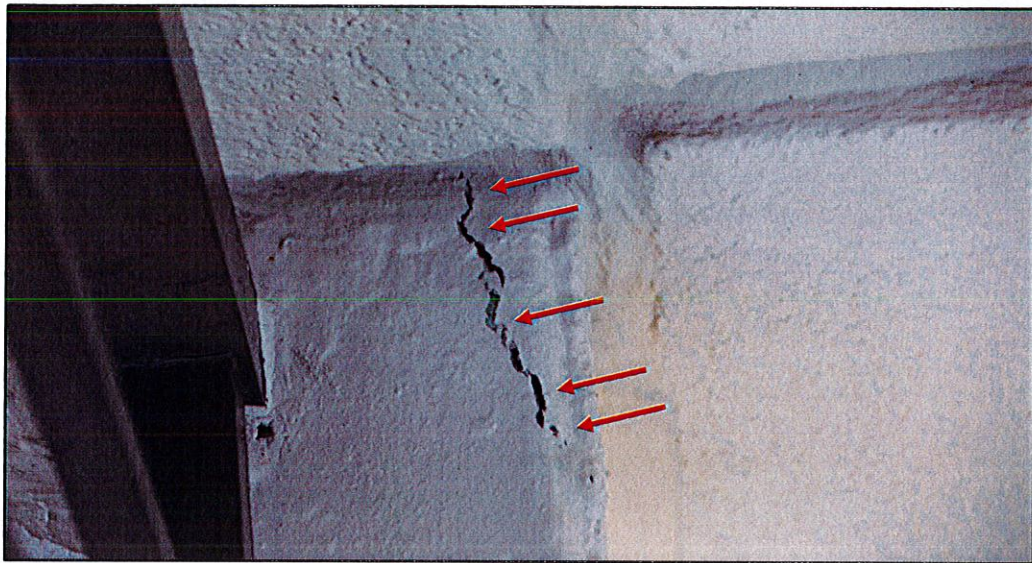
- Balcony floors and exterior edges with imminent concrete spalls. This condition can also be caused by insufficient rebar concrete coverage and by superficial cracks that allow moisture intrusion. Corrosion present at reinforcing steel produces expansion of the diameter of the bar which leads to displacement of surface materials, in this case, concrete (See **Photo #3**). Due to the uncertainty of this condition, it is not possible to predict if or when the finishes will fall. We recommend removing the deficient portions of the finishes or concrete elements from the slab edges or ceilings to prevent pieces of debris from falling down and hurting residents.

**Photo #3.** View of imminent spalling of concrete corner observed at edge of floor slab (unit 206 corridor).

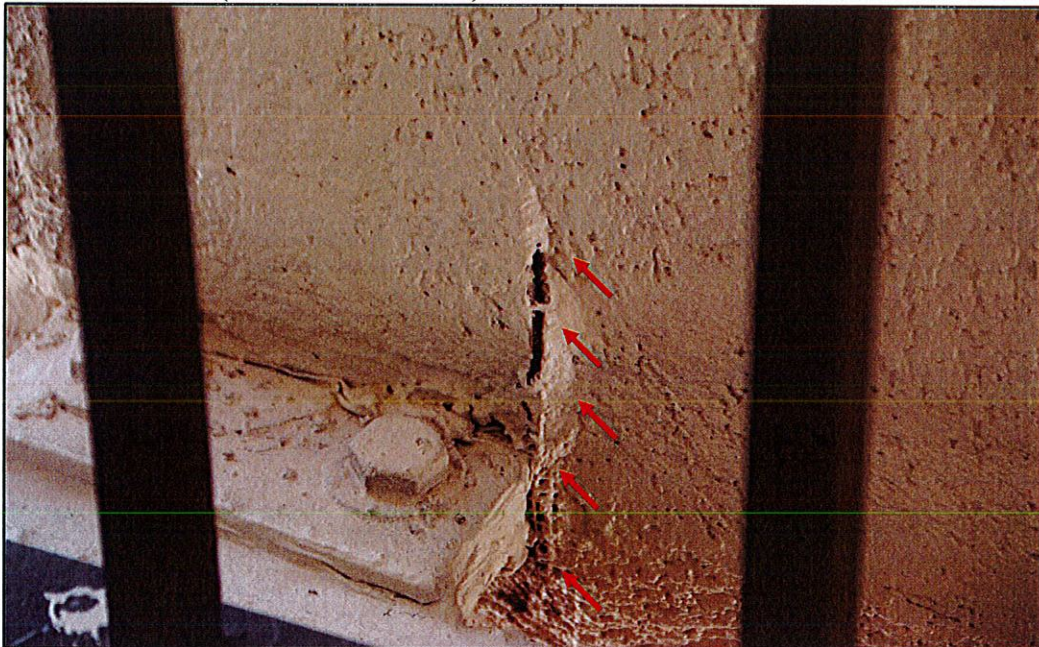
- Balcony ceiling and exterior edges with exposed and corroded reinforcement bars. This condition can be caused by insufficient rebar concrete coverage and by superficial cracks that allow moisture intrusion. Corrosion present at reinforcing steel produces expansion of the diameter of the bar (exfoliation) which leads to displacement (jacking) of surface finishes, such as stucco. This condition can be observed prior to stucco/concrete finishes failure, in the form of bulging of the exterior finishes (see **Photo #4 & #5**).

**Photo #4.** View of deteriorated stucco finishes at wall in front of stairs, signs of concrete spalling due to corroded reinforcing, condition observed at wall in front of stairs next to unit 202 front corridor.

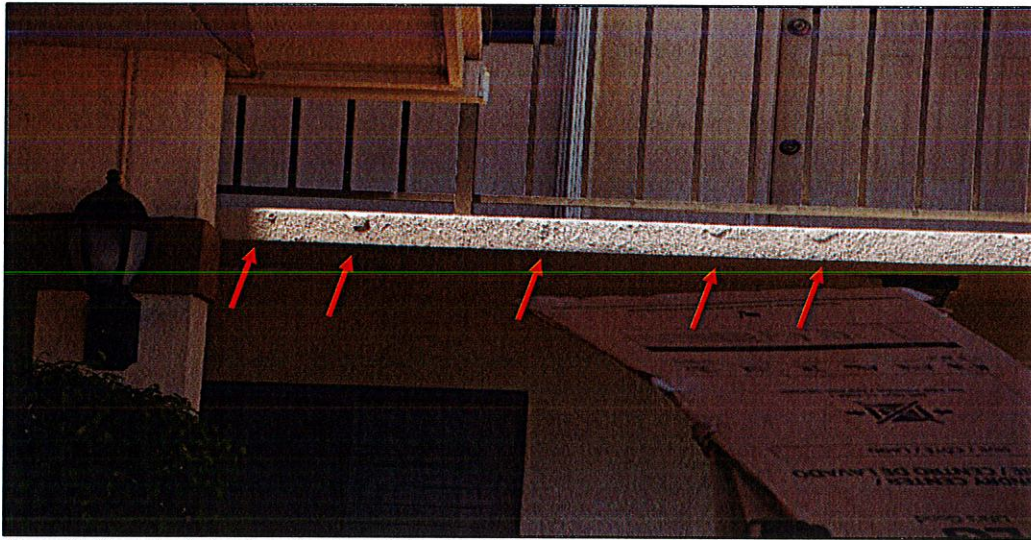
Photo #5. View of exterior stucco finishes with localized bulging (ceiling of unit 104 front corridor).

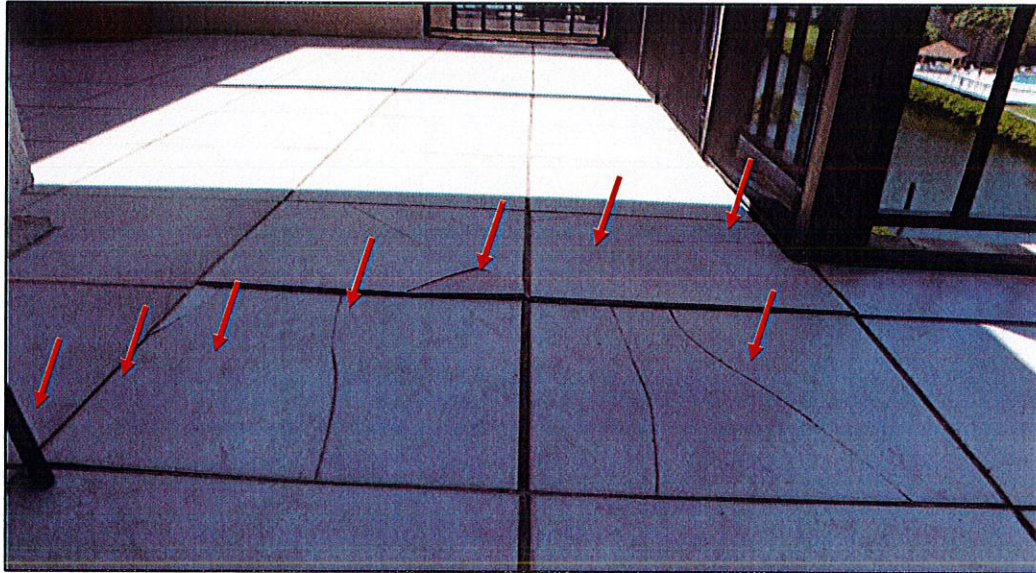
- In certain instances, this condition can be concealed by finishes that have not yet failed or have been covered by previous repairs. This condition requires additional invasive evaluations to clearly define the limits of the deficiency (see Photo #6 and 7).

Photo #6. View of cracks and deteriorated floor finishes, signs of concrete slab spalling due to corroded reinforcing, condition observed at floor (top of slab) of unit 505 balcony.

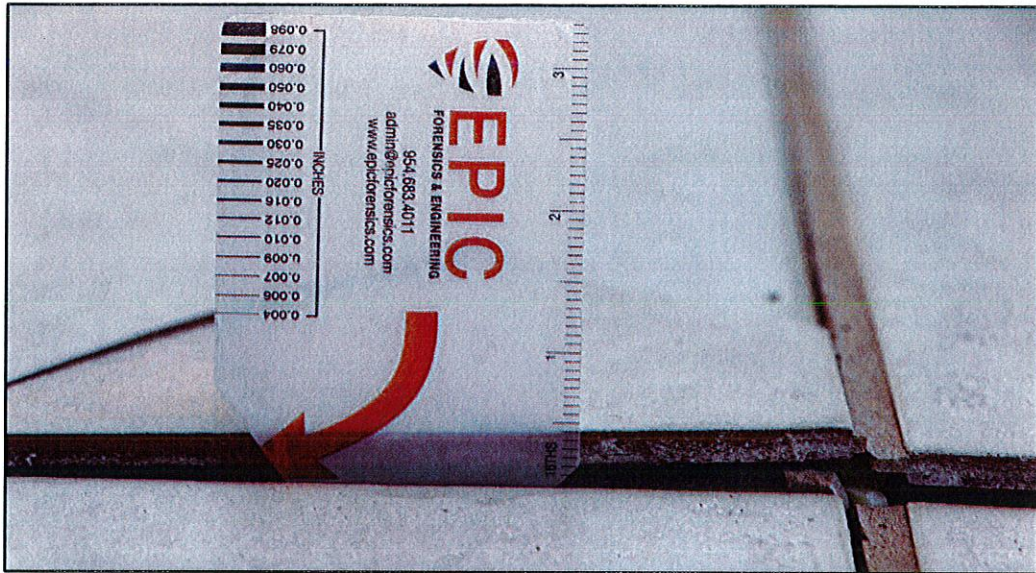
**Photo #7.** Close up view of cracks and deteriorated floor finishes, signs of concrete slab spalling due to corroded reinforcing, condition observed at floor (top of slab) of unit 505 balcony.

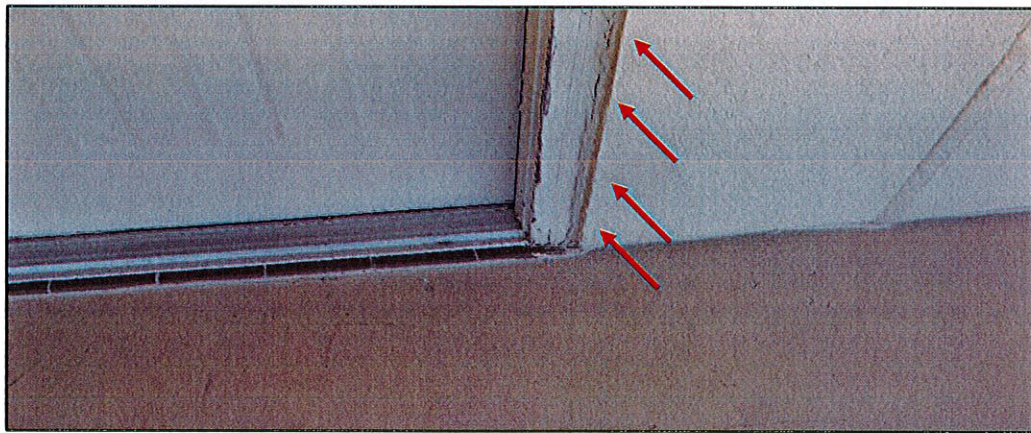
- Exterior sealants around door and window observed with signs of deterioration (cohesion failure). This condition can allow wind driven rain to enter the building envelope and cause damage to the concrete elements as well as damage to interior finishes, personal property and create environmental contamination such as mold and mildew. Sealant shall be removed and replaced preferably with a paintable and UV resistant silicone or hybrid sealant material (See **Photo #8**).

**Photo #8.** View of deteriorated sealant around the front door of unit 503.

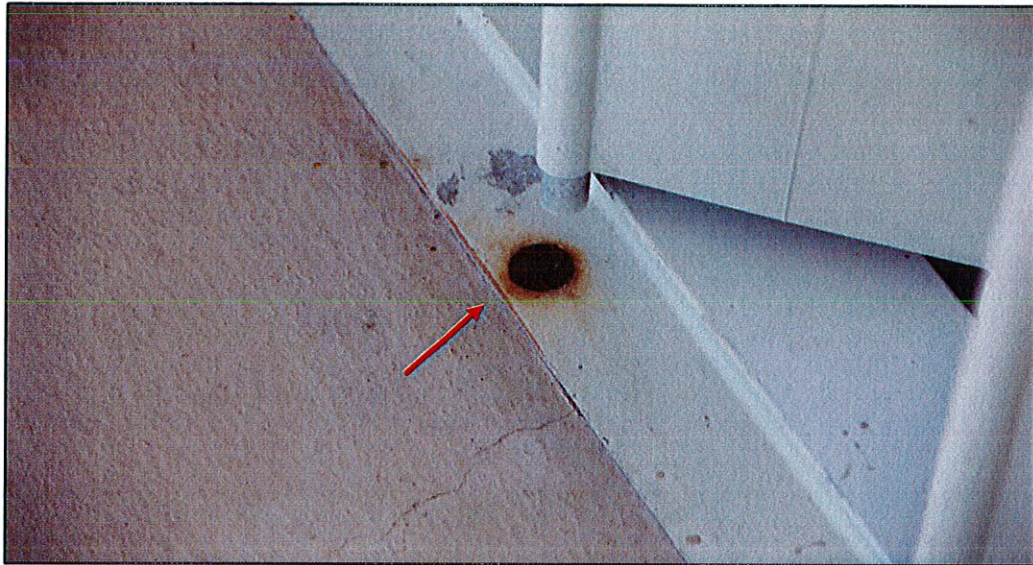
- Anchors for hurricane shutters observed with severe deterioration in the form of corrosion. This condition will compromise the structural integrity of the shutters under severe wind events. Expansion of the anchor due to severe corrosion will damage the concrete and can allow moisture to enter and damage reinforcing bars within the slab (see **Photo #9**). Corroded anchors shall be replaced with corrosion resistant anchors.

**Photo #9.** View of deteriorated metal anchors for the hurricane shutters. Observed at several units (unit 406 shown).

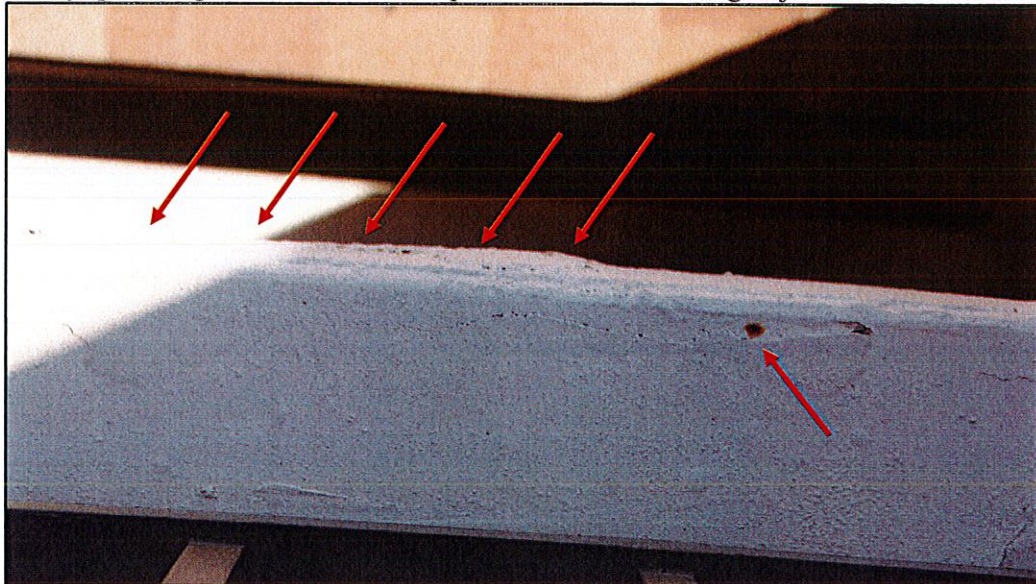
- Balcony ceiling and exterior edges with exposed and corroded metals and corroded steel elements observed at numerous units. This condition refers to metals used in the slab during construction, and also metals installed after construction (see **Photo #10**. Exposed corroded metals shall be removed by grinding metals to a depth of at least 1 inch, coating remains of metal elements in cavity, patching hole and finish or paint to match existing adjacent areas.

**Photo #10.** Close up view of embedded metals within concrete slabs with visible corrosion stains (unit 304 front corridor).

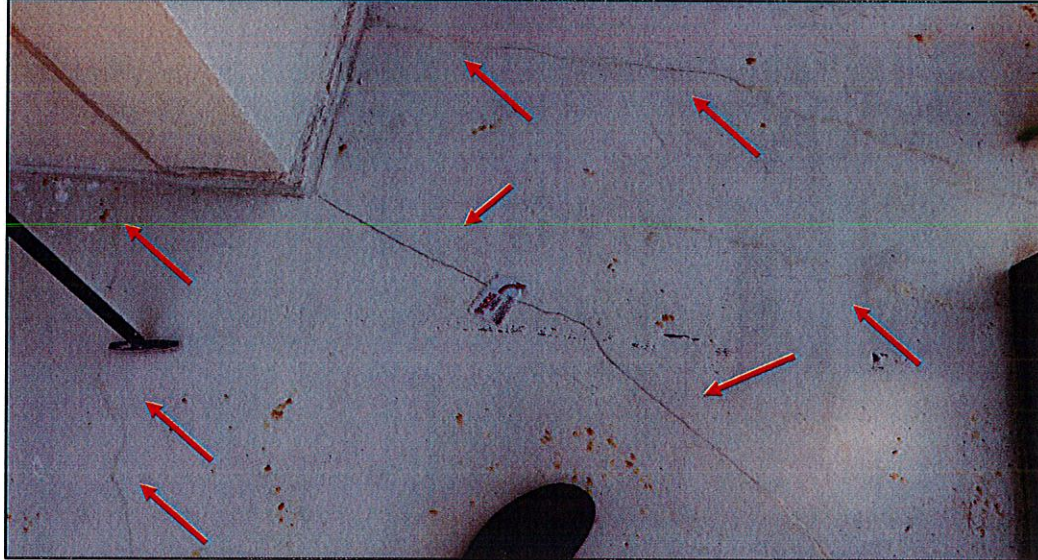
- Floor slabs with unsealed penetrations and cracks. Unsealed penetrations allow rainwater to penetrate and usually leads to corrosion of member reinforcement and spalling of concrete (Long term). The majority of the cracks observed are hairline cracks and do not represent a structural concern, however if not repaired

they can cause future damage to the structure. Cracks shall be routed, sealed and surfaces finished with waterproofing membrane. (See **Photo #11**).

**Photo #11.** View of unsealed cracks at top of the slab (unit 506 balcony shown).

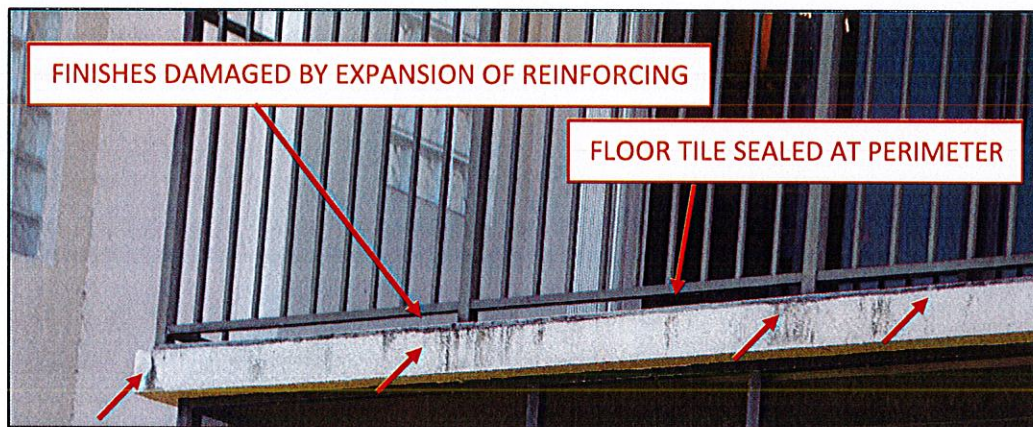
- Balcony units with floor finishes (i.e. tile), it was observed, at private balcony units with floor finishes (i.e. tile) installed up to the edge of the slab and the edge of the tile perimeter completely sealed preventing water that enters through grout lines or cracks to escape. In many cases water accumulates with no way to drain out damaging the finishes and potentially the concrete and reinforcement within the slabs (See **Photo #12**).

**Photo #12.** View of floor finishes (tile) with edges sealed (Unit 204 balcony shown).

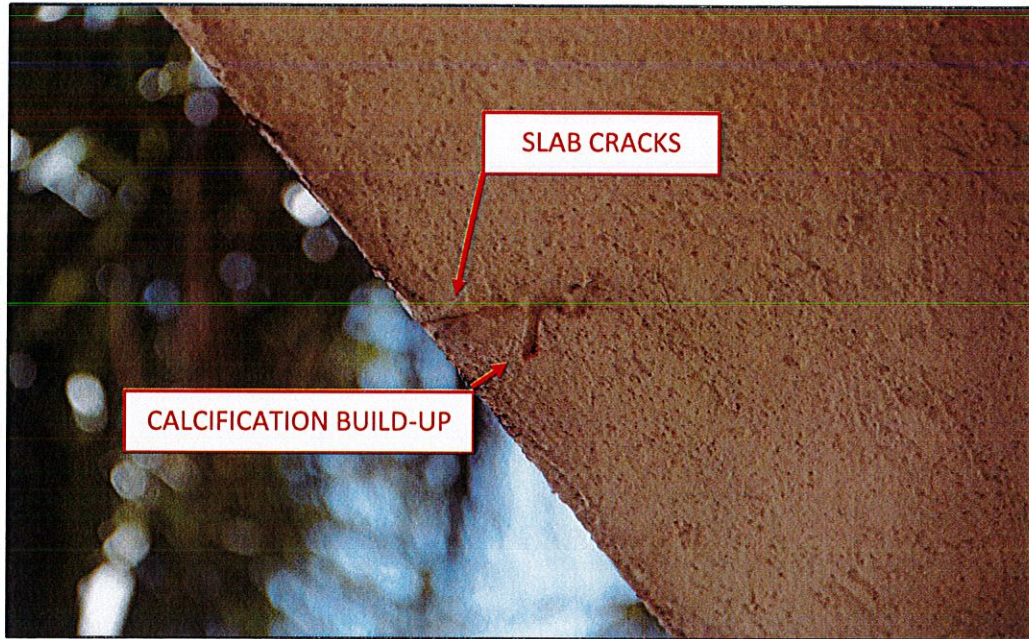
- At various locations we observed a calcification build-up at the underside of the slabs directly through the visible cracks. This build-up corresponds with mineral deposits from moisture migration through the cracks (See **Photo #13**).

Photo #13. View calcification deposits directly under visible slab cracks. (Unit 205 corridor shown).
