January 31, 2023

■
1806 Old Okeechobee Road
Suite A
West Palm Beach, FL 33409
Ph: 561-581-8800
www.epicforensics.com

**Re: Milestone Inspection Report – Phase One.
Building 12.
1201 Tidal Pointe Boulevard, Jupiter, FL 33477**

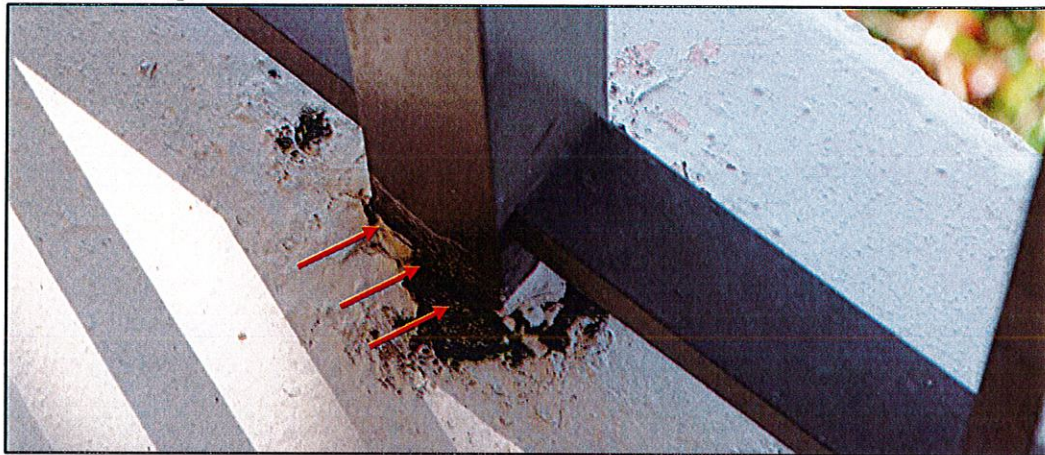
- Balcony guardrail vertical posts with visible separation and/or gaps between the concrete wall of the concrete pocket and the post (see **Photos #1 and #2**). Also, moisture was observed ponding in low spots around the post base. This condition indicates moisture has penetrated the base of the post and could cause damage to the concrete and corrosion of the reinforcement in the slab. Further evidence of moisture within the railing post base can be observed at locations with vegetation and/or organic growth. Also, at several locations, the degree of deterioration of the post base grout allows unwanted lateral movement of the guardrail system top member or top rail.

Photo #1. View of post base deteriorated grout with gaps and organic growth (unit 202 corridor).

Since the existing guardrail system is not “current” code compliant, the guardrail system cannot be removed or un-installed from the current location. If the guardrail is removed, a new current code compliant system shall be installed in its place. For that reason, we recommend the following remedial actions:

- At locations where concrete/grout cracks, delamination, and/or spalling is identified, remove all grout to expose the embedded portion of railing post and remove adjoining cracked, delaminated and/or spalled concrete.
- Remove all grout, corrosion, scale, slurry, and other bond-inhibiting material from exposed railing post by thorough wire-brushing or high-pressure water blasting.
- Install weep hole at post base above finishes.
- Replace removed concrete non-shrink non-metallic grout around the post.
- Prime railing posts to a minimum of 1-inch above the finish concrete surface to provide adequate grout-to-aluminum isolation.
- Seal around post base with sealant.
- Plaster finish and paint the repair area to match the surroundings.

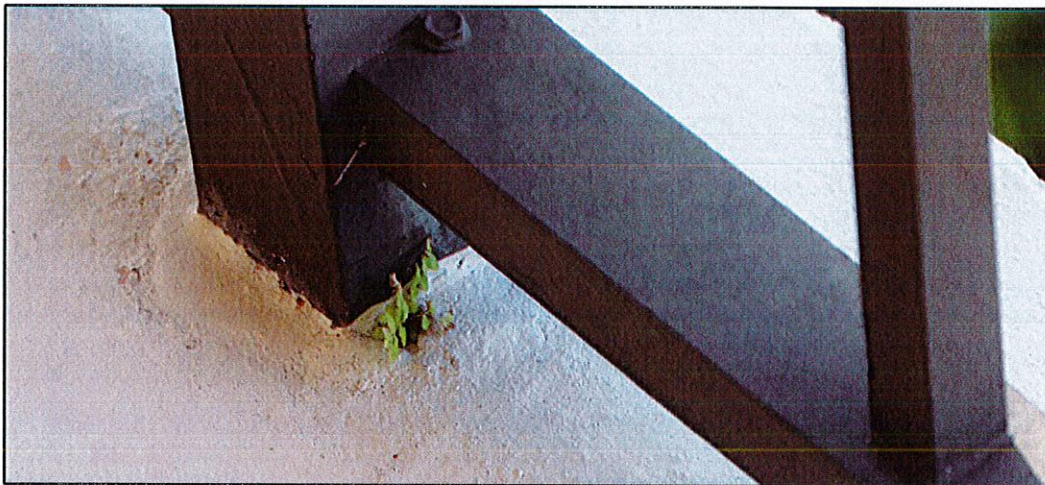
Photo #2. View of post base deteriorated grout and visible vegetation growth (unit 301 corridor).

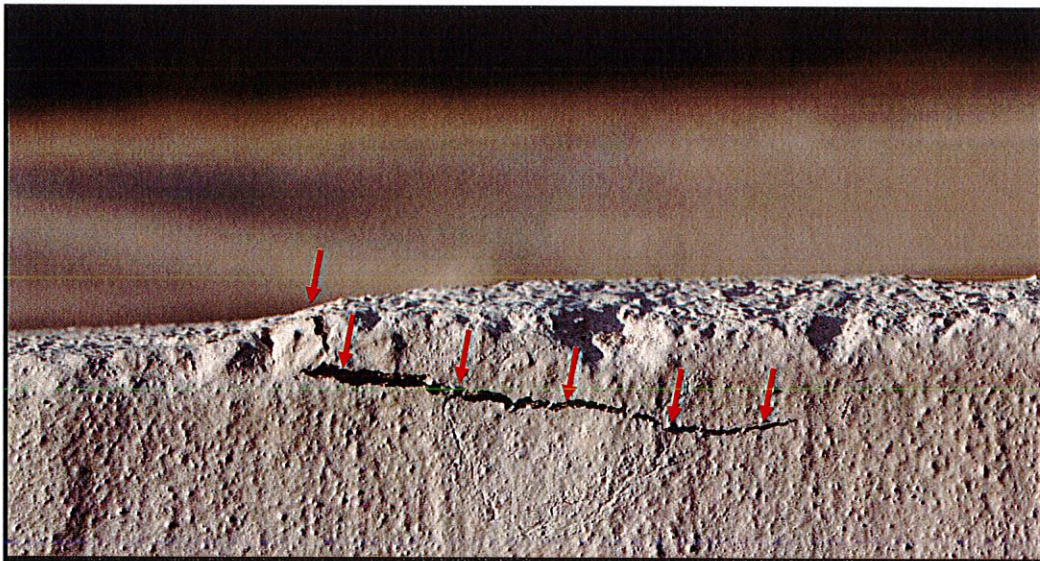
- Balcony floors and exterior edges with imminent concrete spalls. This condition can also be caused by insufficient rebar concrete coverage and by superficial cracks that allow moisture intrusion. Corrosion present at reinforcing steel produces expansion of the diameter of the bar which leads to displacement of surface materials, in this case, concrete (See **Photo #3**). Due to the uncertainty of this condition, it is not possible to predict if or when the finishes will fall. We recommend removing the deficient portions of the finishes or concrete elements from the slab edges or ceilings to prevent pieces of debris from falling down and hurting residents.

Photo #3. View of imminent spalling of south concrete edge observed at exterior floor slab edge (unit 506 corridor).

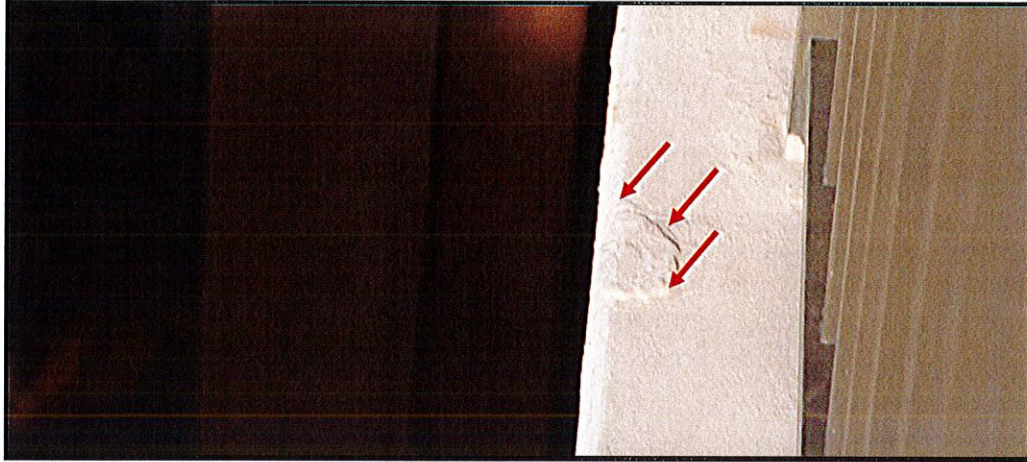
- Balcony ceiling and exterior edges with exposed and corroded reinforcement bars. This condition can be caused by insufficient rebar concrete coverage and by superficial cracks that allow moisture intrusion. Corrosion present at reinforcing steel produces expansion of the diameter of the bar (exfoliation) which leads to displacement (jacking) of surface finishes, such as stucco. This condition can be observed prior to stucco/concrete finishes failure, in the form of bulging of the exterior finishes (see **Photo #4**).

Photo #4. View of deteriorated stucco finishes at exterior edge of slab, signs of concrete spalling due to corroded reinforcing, condition observed at exterior edge of corridor at unit 403.

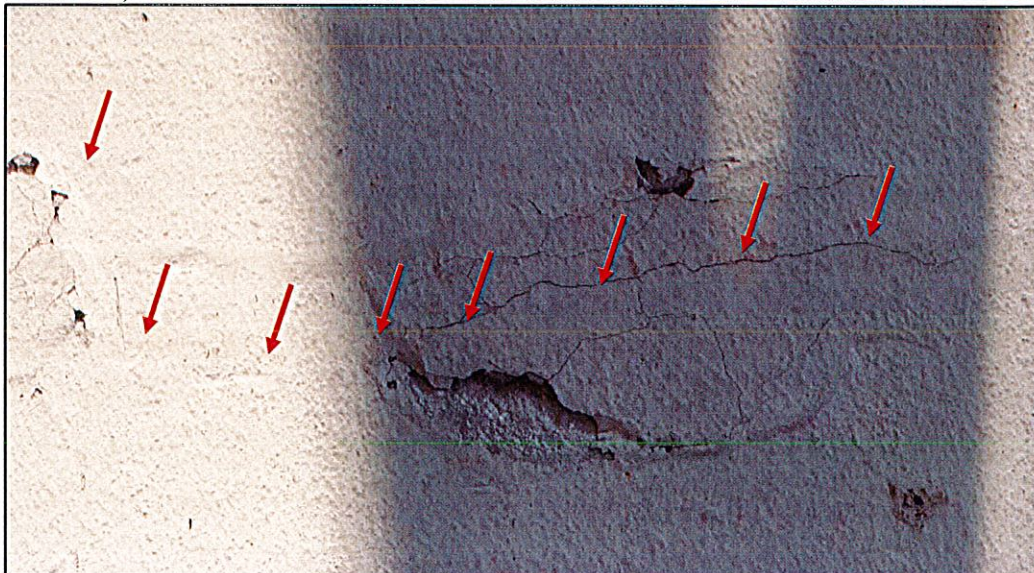
- In certain instances, this condition can be concealed by finishes that have not yet failed or have been covered by previous repairs. This condition requires additional invasive evaluations to clearly define the limits of the deficiency (see **Photo #5**).

Photo #5. View of cracks and deteriorated floor finishes, signs of concrete slab spalling due to corroded reinforcing, condition observed at floor (top of slab) of unit 502 front corridor.

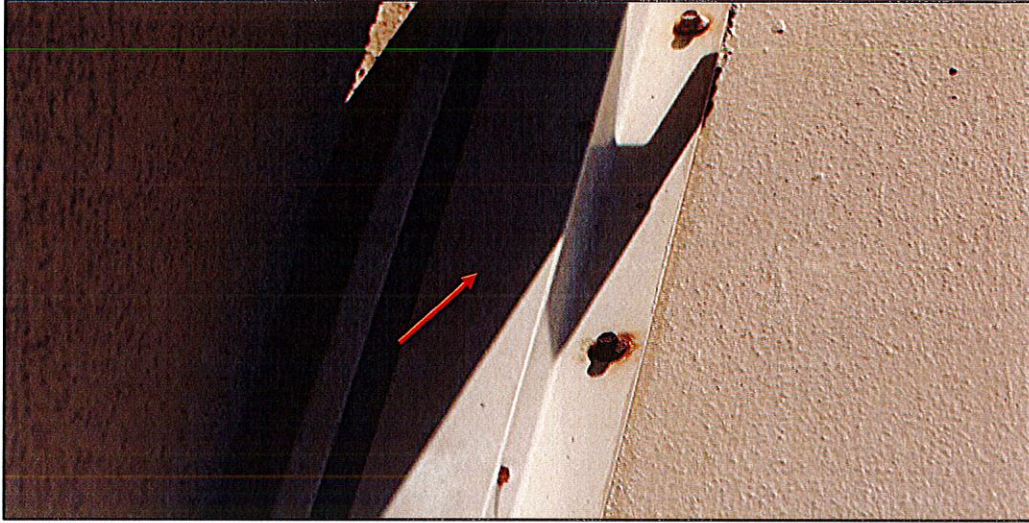
- Anchors for hurricane shutters observed with severe deterioration in the form of corrosion. This condition will compromise the structural integrity of the shutters under severe wind events. Expansion of the anchor due to severe corrosion will damage the concrete and can allow moisture to enter and damage reinforcing bars within the slab. Corroded anchors shall be replaced with corrosion resistant anchors.

Photo #6. View of deteriorated metal anchors for the hurricane shutters. Observed at several units (unit 401 shown).

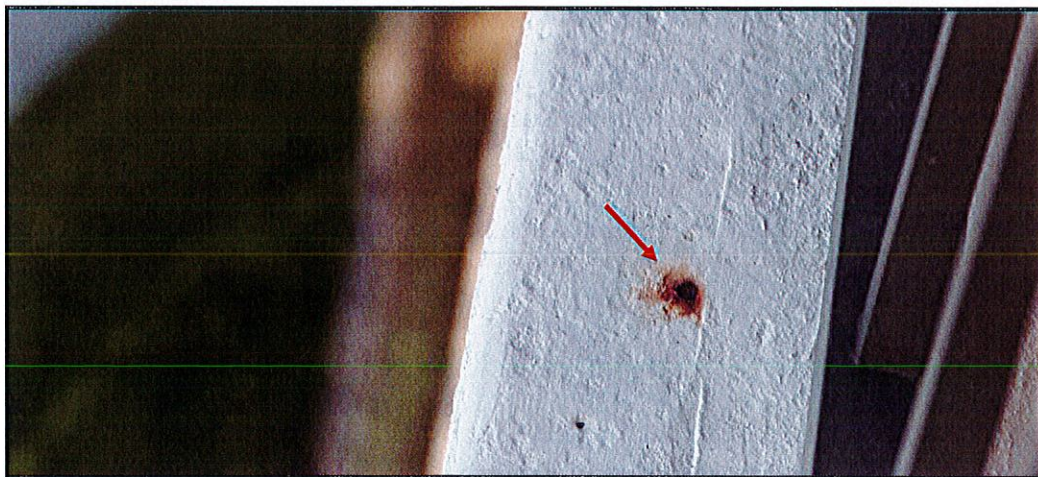
- Balcony ceiling and exterior edges with exposed and corroded metals and corroded steel elements observed at numerous units. This condition refers to metals used in the slab during construction, and also metals installed after construction (see **Photo #7**. Exposed corroded metals shall be removed by grinding metals to a depth of at least 1 inch, coating remains of metal elements in cavity, patching hole and finish or paint to match existing adjacent areas.

Photo #7. View of exterior stucco finishes with localized bulging and embedded metals with corrosion stains (unit 501 front corridor).

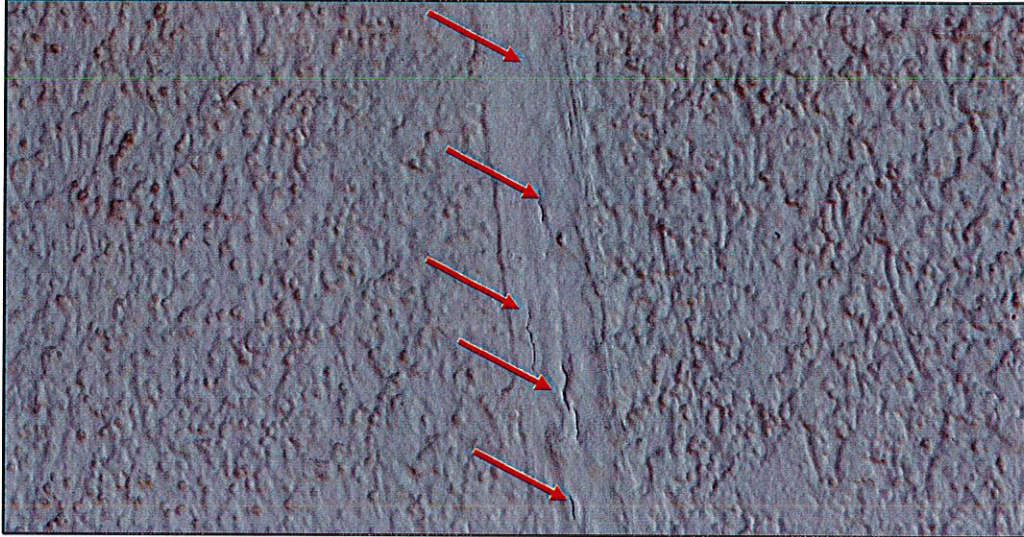
- Exterior sealants around door and window observed with signs of deterioration (cohesion failure). This condition can allow wind driven rain to enter the building envelope and cause damage to the concrete elements as well as damage to interior finishes, personal property and create environmental contamination such as mold and mildew. Sealant shall be removed and replaced preferably with a paintable and UV resistant silicone or hybrid sealant material (See **Photo #8**).

Photo #8. View of deteriorated sealant between wall panels at unit 401.
