January 31, 2023

Board of Directors  
The Marina at the Bluffs Condominium Association, Inc.  
1550 Marina Isle Way  
Jupiter, FL 33477

**Re: Milestone Inspection Report – Phase One.  
Building 13.  
1301 Tidal Pointe Boulevard, Jupiter, FL 33477**

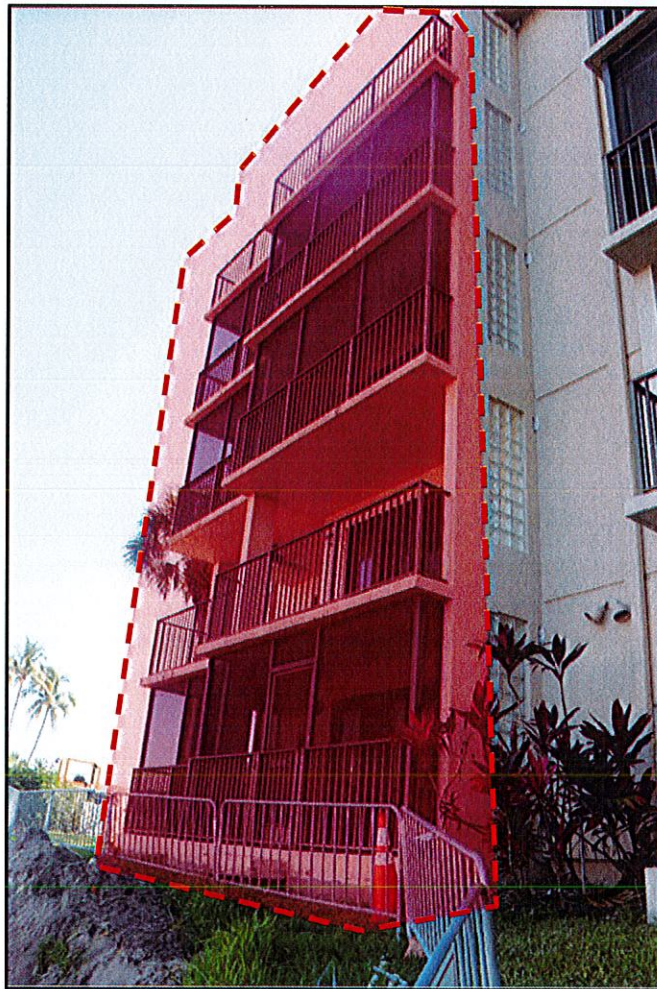
sidewalk have been removed to install new ones. The existing seawall is located approximately 20-25 ft from the building. As required by the seawall repairs (not by EPIC), the soil at the back of the seawall was partially excavated to allow for the installation of new steel sheet pile panels. The sheet piles are installed into the ground with a vibrating hammer that drives the sheet into the ground. It was observed at the line 06 (see **Photo #1**) that the soil adjacent to the structure supporting the ground and elevated slab near the north-west corner of the building has lowered approximately 4-6 inches after the rehabilitation of the existing seawall began last year. It appears that the removal of the soil near the building combined with the vibration of the sheet pile driving led to a soil settlement under portion of the building 1301 (north west) closer to the excavation, specifically the area of the terrace/balconies. Signs of displacement of the structure were observed inside the ground floor terrace as well as elevated balcony slabs, where the sealant at the interface between the wall of the building and the ground floor slab has visible tears and gaps (see **Photo #2**).

**Photo #1.** Building 1301 - View of line 06 balcony area affected by the seawall repairs.

Additional investigation including the verification of the existing foundation system under the added terrace/balconies to the west side of the building, verification of the type of connection of slab members to the existing building and the verification of any differential settlement and potential stresses within the balcony framing system. These will be performed as part of the "Milestone Inspection" phase 2 and will be conducted at a later date (within the next 90 days).

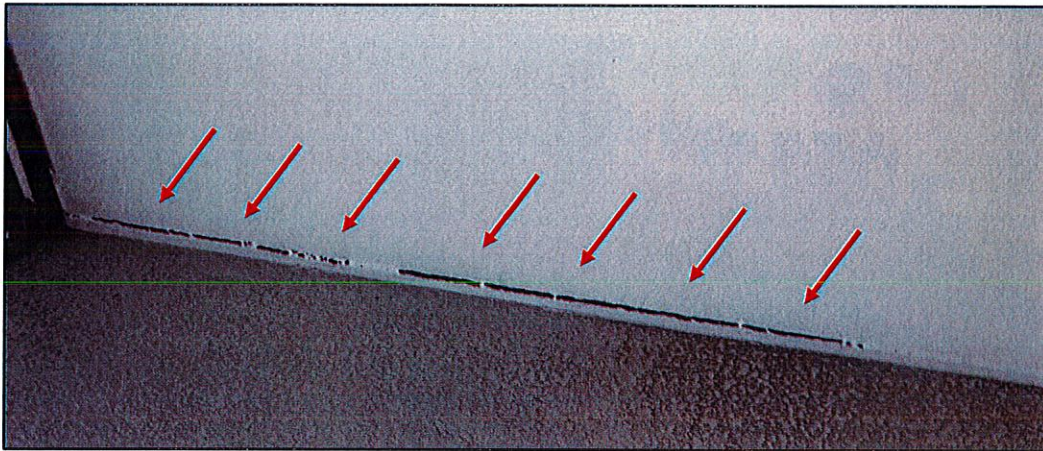
Photo #2. View of ground slab to building wall interface with visible tears and gaps in the sealant material (unit 106).

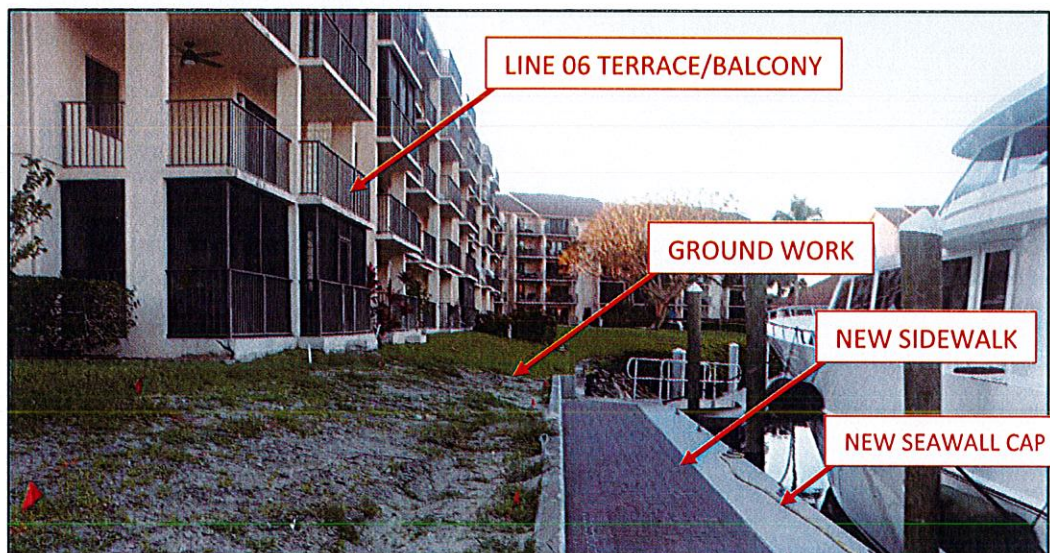
On February 2, 2023, Epic performed an inspection at the Property and observed that the ground work and the seawall repairs appear to be completed at the vicinity of the terrace/balcony structure (see **Photo #3**). Epic documented the displacement/settlement and gaps in the sealant material discussed above and noticed that since May 2022, the gaps have slightly increased. For this reason and as an abundance of caution Epic recommended that the use of the balconies at line 06 be restricted until additional investigations and/or repairs to the terraces are performed.

Photo #3. View of ground slab to building wall interface with visible tears and gaps in the sealant material (unit 106).

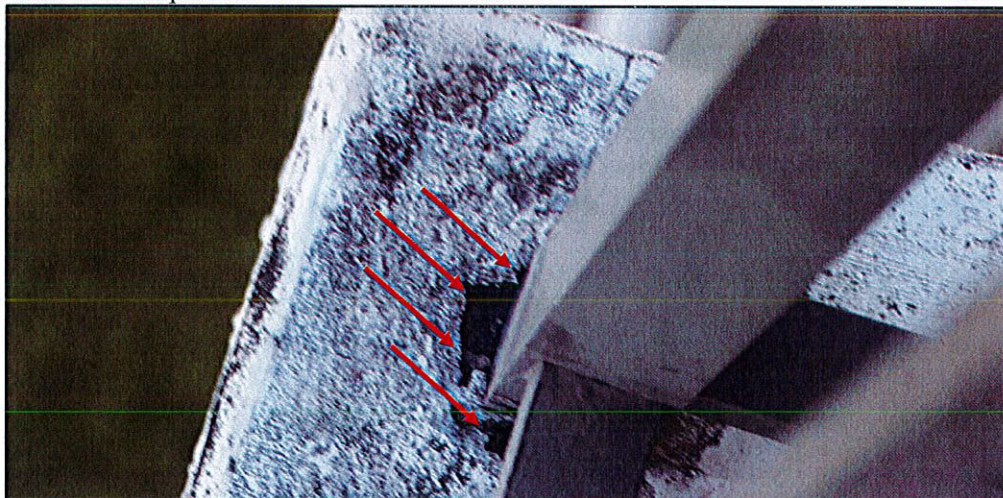
- Balcony guardrail vertical posts with visible separation and/or gaps between the concrete wall of the concrete pocket and the post (see **Photos #4 and #5**). Also, moisture was observed ponding in low spots around the post base. This condition indicates moisture has penetrated the base of the post and could cause damage to the concrete and corrosion of the reinforcement in the slab. Further evidence of moisture within the railing post base can be observed at locations with vegetation and/or organic growth. Also, at several locations, the degree of deterioration of the post base grout allows unwanted lateral movement of the guardrail system top member or top rail.

**Photo #4.** View of post base deteriorated grout with large gaps and metal post with signs of corrosion damage (unit 404 balcony).

Since the existing guardrail system is not “current” code compliant, the guardrail system cannot be removed or un-installed from the current location. If the guardrail is removed, a new current code compliant system shall be installed in its place. For that reason, we recommend the following remedial actions:

- At locations where concrete/grout cracks, delamination, and/or spalling is identified, remove all grout to expose the embedded portion of railing post and remove adjoining cracked, delaminated and/or spalled concrete.
- Remove all grout, corrosion, scale, slurry, and other bond-inhibiting material from exposed railing post by thorough wire-brushing or high-pressure water blasting.
- Install weep hole at post base above finishes.
- Replace removed concrete non-shrink non-metallic grout around the post.
- Prime railing posts to a minimum of 1-inch above the finish concrete surface to provide adequate grout-to-aluminum isolation.
- Seal around post base with sealant.
- Plaster finish and paint the repair area to match the surroundings.

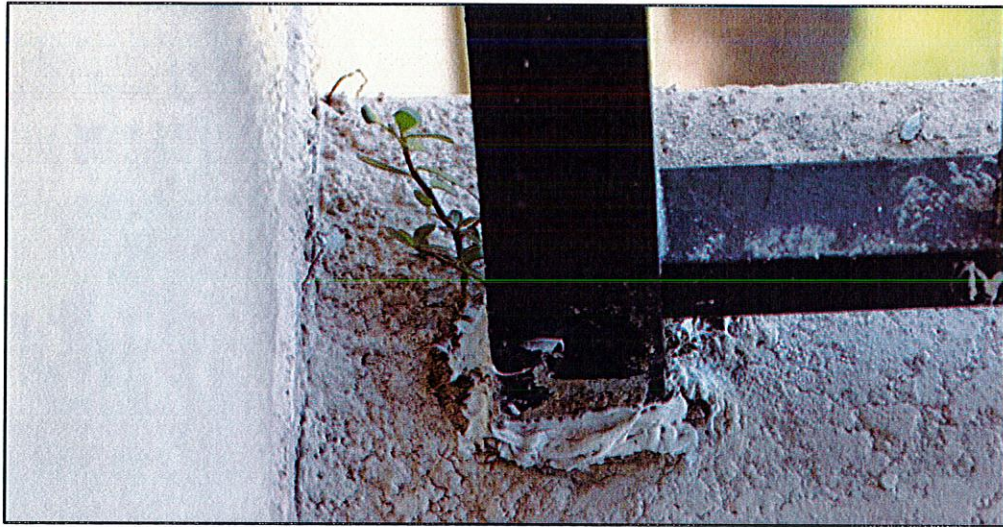
Photo #5. View of post base deteriorated grout and visible vegetation growth (unit 401 balcony).

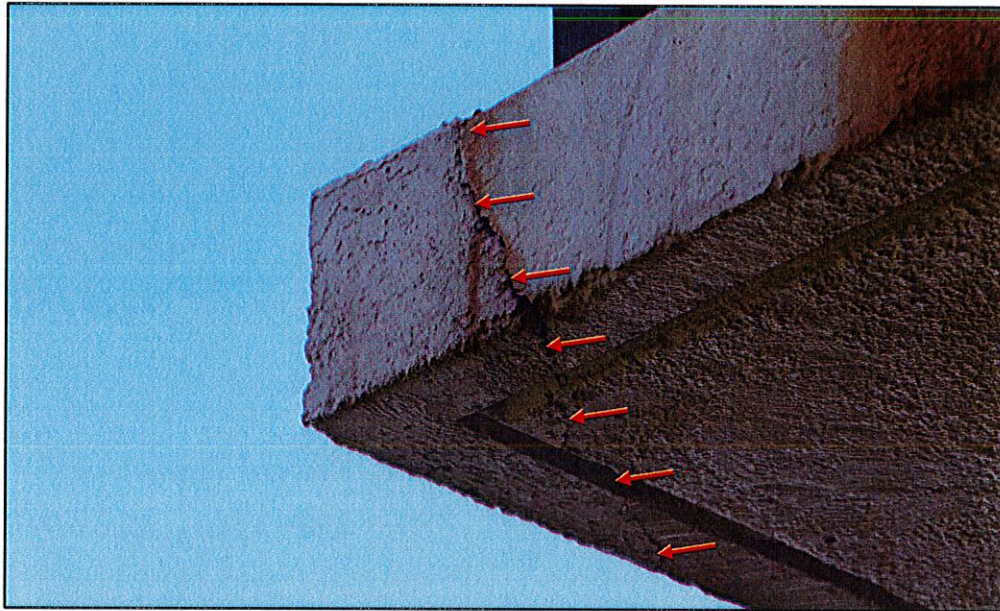
- Balcony floors and exterior edges with imminent concrete spalls. This condition can also be caused by insufficient rebar concrete coverage and by superficial

cracks that allow moisture intrusion. Corrosion present at reinforcing steel produces expansion of the diameter of the bar which leads to displacement of surface materials, in this case, concrete (See **Photos #6 & #7**). Due to the uncertainty of this condition, it is not possible to predict if or when the finishes will fall. We recommend removing the deficient portions of the finishes or concrete elements from the slab edges or ceilings to prevent pieces of debris from falling down and hurting residents.

**Photo #6.** View of imminent spalling of south concrete corner observed at edge of floor slab (unit 501 balcony).

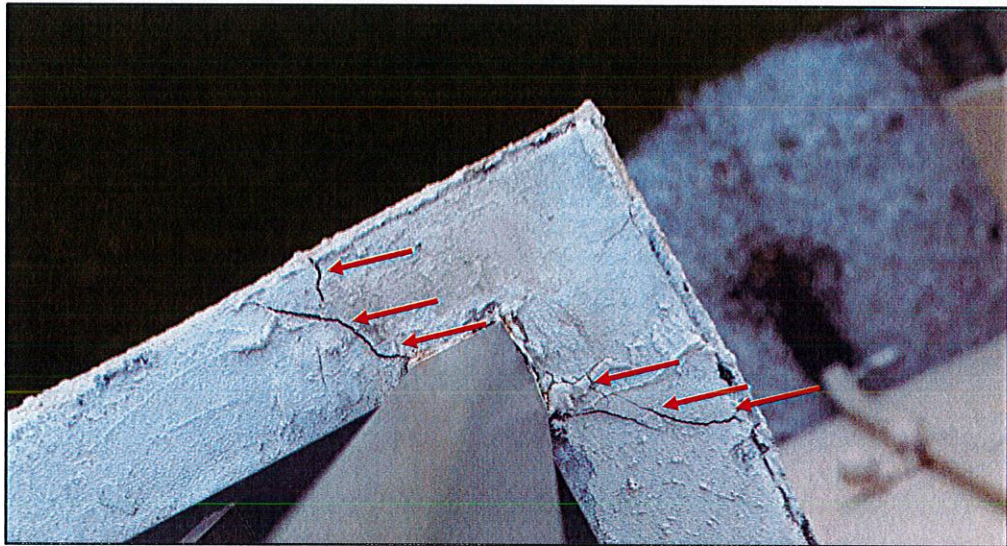
**Photo #7.** View of imminent spalling of north concrete corner observed at edge of floor slab (unit 501 balcony).

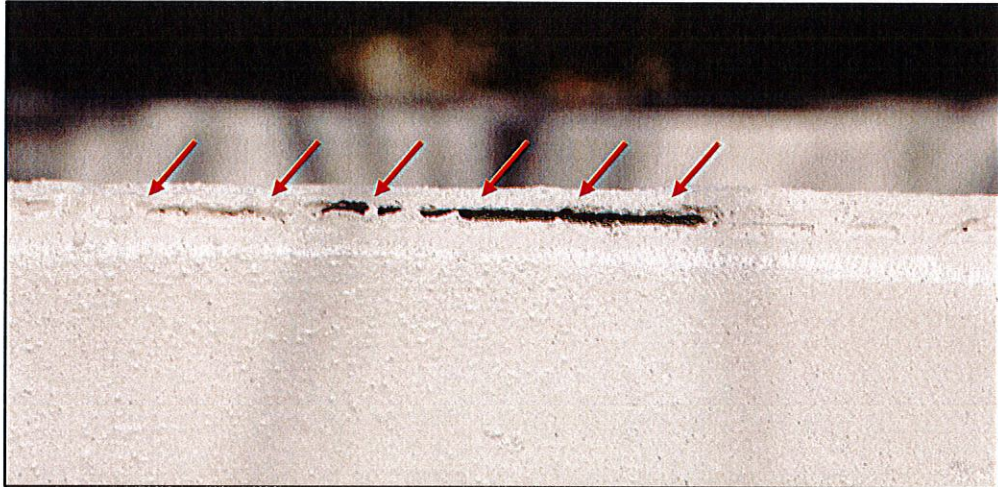
- Balcony ceiling and exterior edges with exposed and corroded reinforcement bars. This condition can be caused by insufficient rebar concrete coverage and by superficial cracks that allow moisture intrusion. Corrosion present at reinforcing steel produces expansion of the diameter of the bar (exfoliation) which leads to displacement (jacking) of surface finishes, such as stucco. This condition can be observed prior to stucco/concrete finishes failure, in the form of bulging of the exterior finishes (see **Photo #8 & #9**).

Photo #8. View of deteriorated stucco finishes at wall in front of stairs, signs of concrete spalling due to corroded reinforcing, condition observed at wall in front of stairs next to unit 402 front corridor.

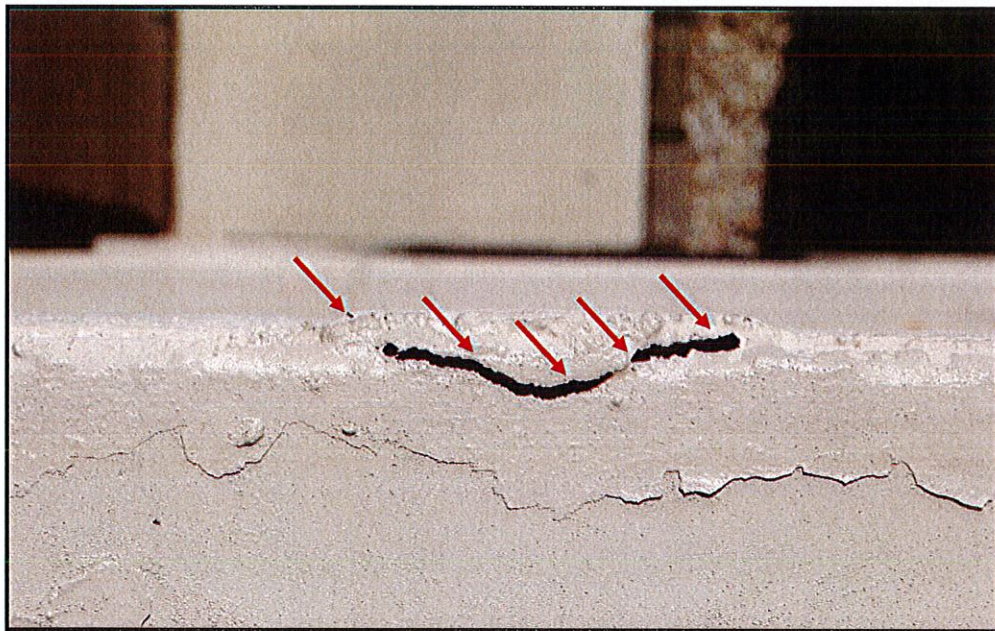
Photo #9. View of exterior stucco finishes with localized bulging (unit 401 front corridor).

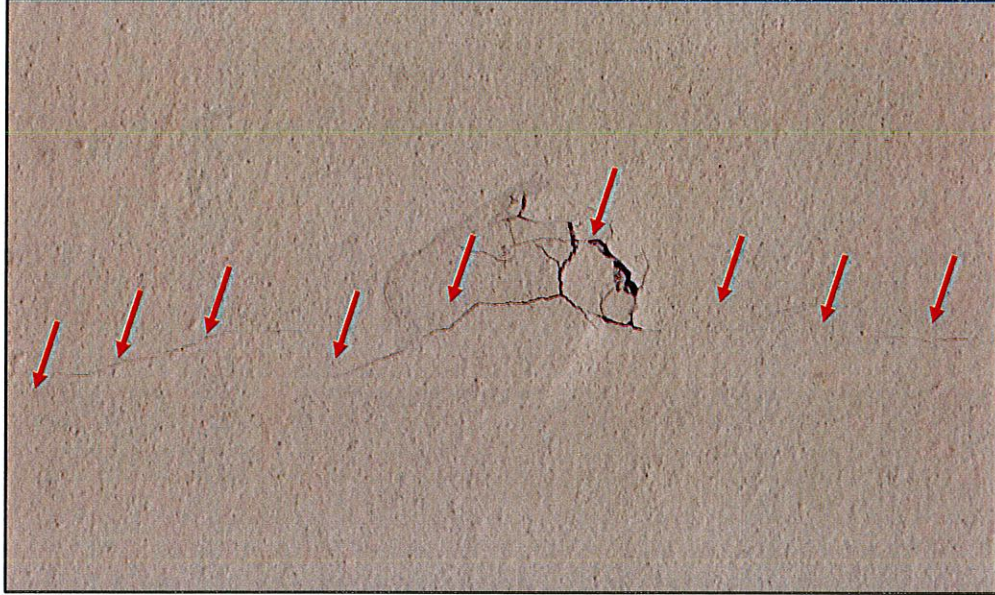
- In certain instances, this condition can be concealed by finishes that have not yet failed or have been covered by previous repairs. This condition requires additional invasive evaluations to clearly define the limits of the deficiency (see **Photo #10**).

**Photo #10.** View of cracks and deteriorated floor finishes, signs of concrete slab spalling due to corroded reinforcing, condition observed at floor (top of slab) of unit 303 front corridor.

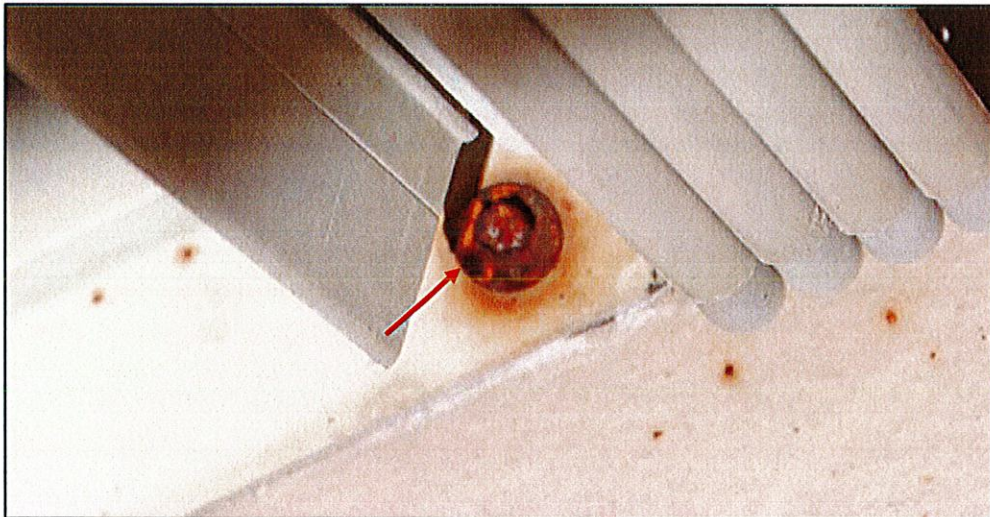
- Anchors for hurricane shutters observed with severe deterioration in the form of corrosion. This condition will compromise the structural integrity of the shutters under severe wind events. Expansion of the anchor due to severe corrosion will damage the concrete and can allow moisture to enter and damage reinforcing bars within the slab (see **Photo #11**). Corroded anchors shall be replaced with corrosion resistant anchors.

**Photo #11.** View of deteriorated metal anchors for the hurricane shutters. Observed at several units (unit 305 shown).

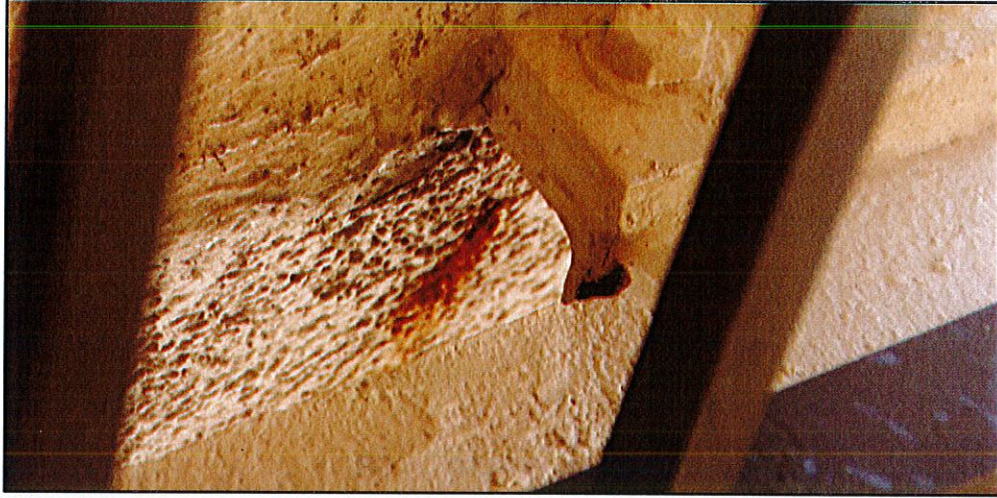
- Balcony ceiling and exterior edges with exposed and corroded metals and corroded steel elements observed at numerous units. This condition refers to metals used in the slab during construction, and also metals installed after construction (see **Photo #12**). Exposed corroded metals shall be removed by grinding metals to a depth of at least 1 inch, coating remains of metal elements in cavity, patching hole and finish or paint to match existing adjacent areas.

**Photo #12.** Close up view of embedded metals within concrete elements with visible corrosion stains (between units 403 and 404 corridor wall in front of elevator).

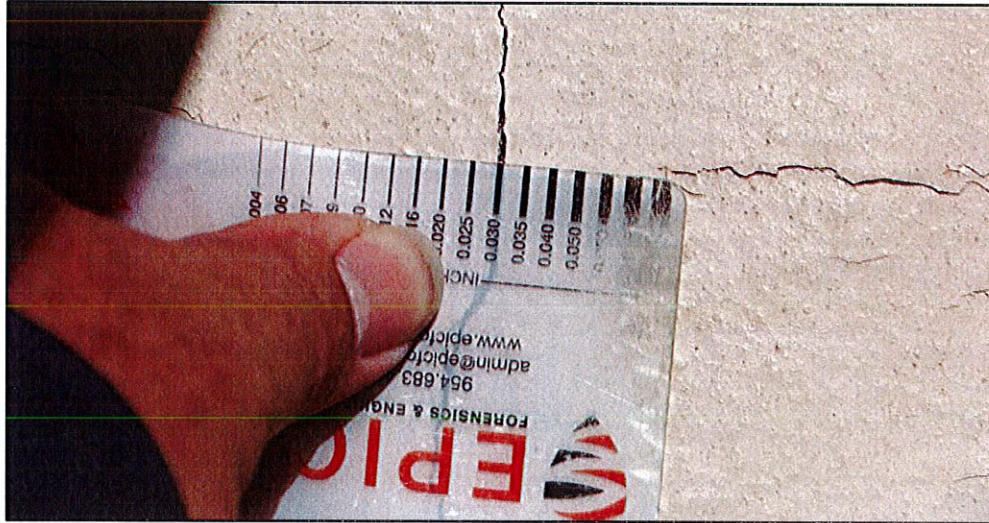
- Floor slab with unsealed penetrations and floor cracks. Unsealed penetrations allow rainwater to penetrate and usually leads to corrosion of member reinforcement and spalling of concrete (Long term). Unsealed penetrations shall be filled with epoxy materials. Medium to large cracks shall be repaired by epoxy injection. (See **Photo #13**).

**Photo #13.** View of medium slab cracks at floor slab (unit 303 front corridor shown).

- The majority of the cracks observed are hairline cracks and do not represent a structural concern, however if not repaired they can cause future damage to the structure. Cracks shall be routed, sealed and surfaces finished with waterproofing membrane.
