January 31, 2023

Board of Directors  
The Marina at the Bluffs Condominium Association, Inc.  
1550 Marina Isle Way  
Jupiter, FL 33477

**Re: Milestone Inspection Report – Phase One.  
Building 14.  
1401 Tidal Pointe Boulevard, Jupiter, FL 33477**

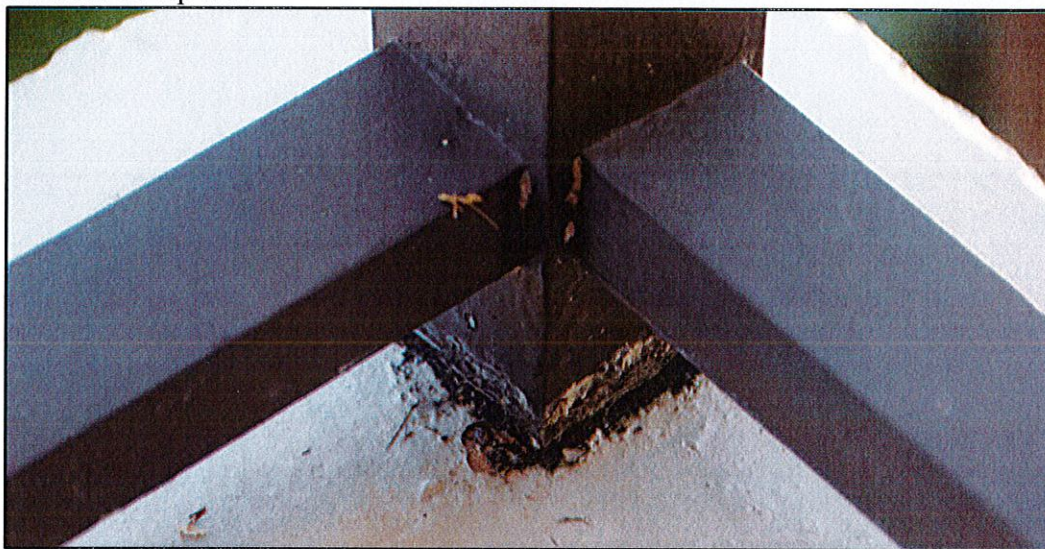
- Balcony guardrail vertical posts with visible separation and/or gaps between the concrete wall of the concrete pocket and the post (see **Photos #1 and #2**). Also, moisture was observed ponding in low spots around the post base. This condition indicates moisture has penetrated the base of the post and could cause damage to the concrete and corrosion of the reinforcement in the slab. Further evidence of moisture within the railing post base can be observed at locations with vegetation and/or organic growth. Also, at several locations, the degree of deterioration of the post base grout allows unwanted lateral movement of the guardrail system top member or top rail.

**Photo #1.** View of post base deteriorated grout with large gaps and metal post with signs of corrosion damage (unit 301 corridor).

Since the existing guardrail system is not “current” code compliant, the guardrail system cannot be removed or un-installed from the current location. If the guardrail is removed, a new current code compliant system shall be installed in its place. For that reason, we recommend the following remedial actions:

- At locations where concrete/grout cracks, delamination, and/or spalling is identified, remove all grout to expose the embedded portion of railing post and remove adjoining cracked, delaminated and/or spalled concrete.
- Remove all grout, corrosion, scale, slurry, and other bond-inhibiting material from exposed railing post by thorough wire-brushing or high-pressure water blasting.
- Install weep hole at post base above finishes.
- Replace removed concrete non-shrink non-metallic grout around the post.
- Prime railing posts to a minimum of 1-inch above the finish concrete surface to provide adequate grout-to-aluminum isolation.
- Seal around post base with sealant.
- Plaster finish and paint the repair area to match the surroundings.

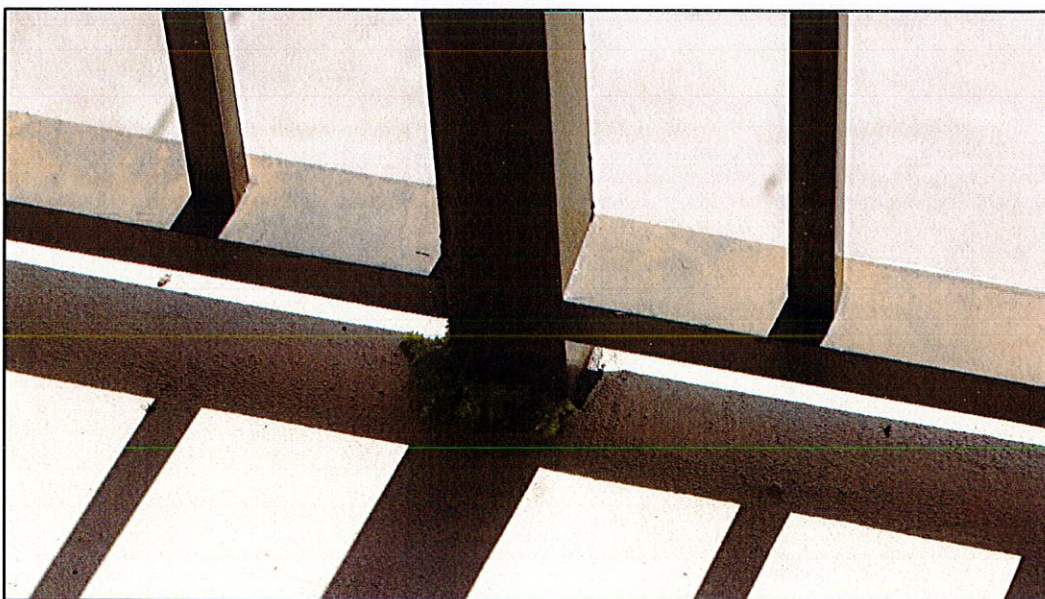
**Photo #2.** View of post base deteriorated grout and visible vegetation growth (unit 402 balcony).

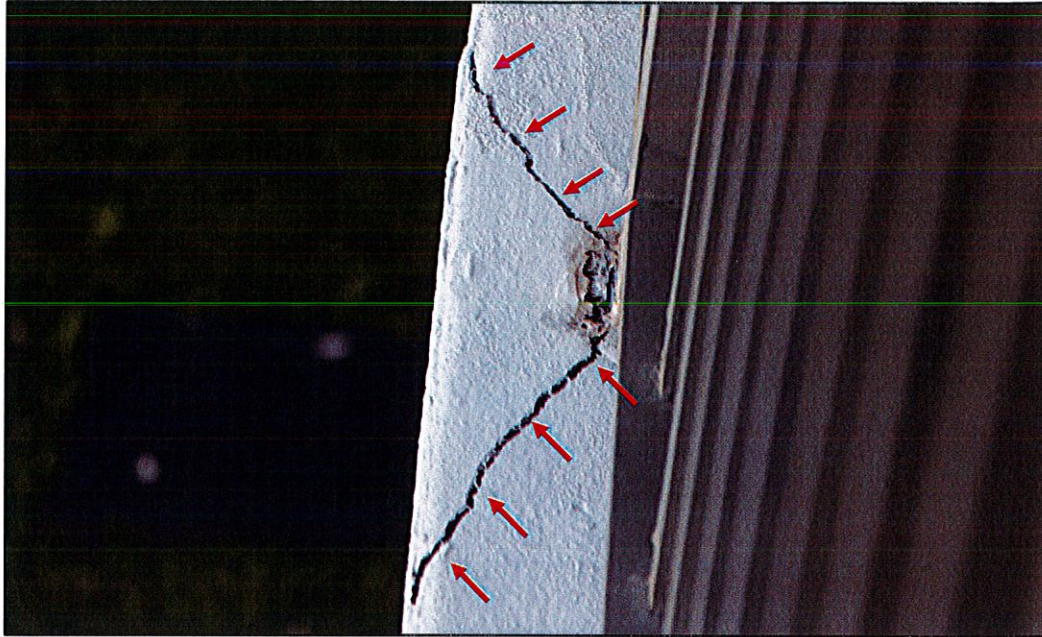
- Balcony floors and exterior edges with imminent concrete spalls. This condition can also be caused by insufficient rebar concrete coverage and by superficial cracks that allow moisture intrusion. Corrosion present at reinforcing steel produces expansion of the diameter of the bar which leads to displacement of surface materials, in this case, concrete (See **Photos #3 & #4**). Due to the uncertainty of this condition, it is not possible to predict if or when the finishes will fall. We recommend removing the deficient portions of the finishes or concrete elements from the slab edges or ceilings to prevent pieces of debris from falling down and hurting residents.

Photo #3. View of imminent spalling of concrete edge observed at floor slab (unit 204 balcony).

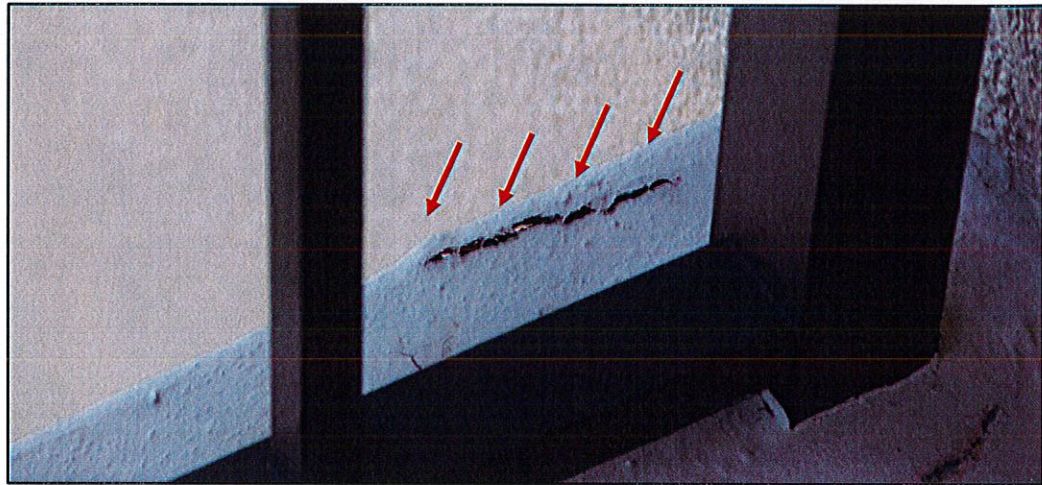
Photo #4. View of imminent spalling of concrete section observed at edge of floor slab (unit 401 corridor).

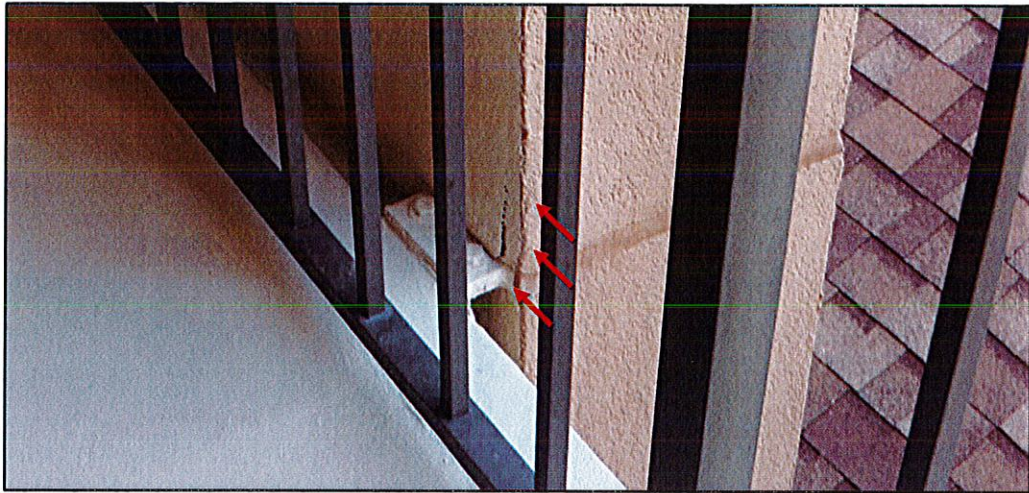
**Photo #5.** View of deteriorated stucco finishes at wall in front of stairs, signs of concrete spalling due to corroded reinforcing, condition observed at wall in front of elevator next to unit 303 front corridor.

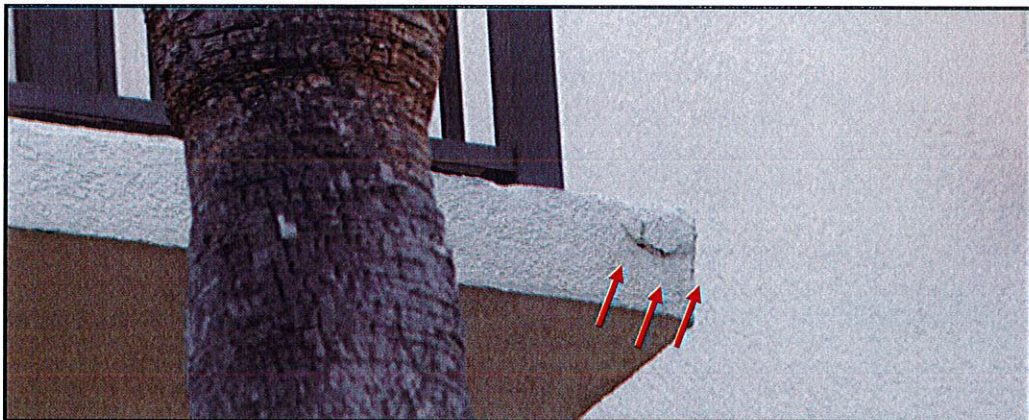
**Photo #6.** View of exterior stucco finishes with localized bulging (ceiling of unit 206 front corridor).

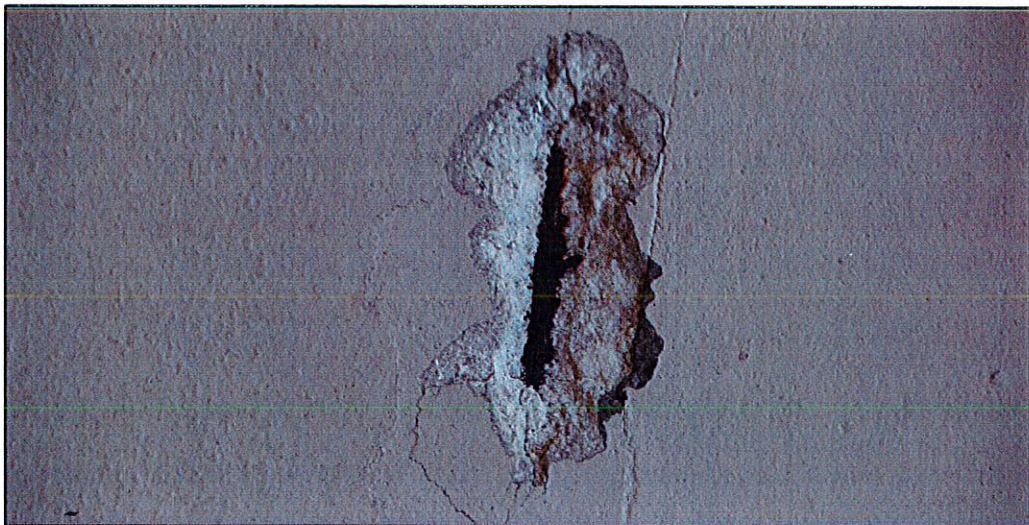
- Balcony ceiling and exterior edges with exposed and corroded reinforcement bars. This condition can be caused by insufficient rebar concrete coverage and by superficial cracks that allow moisture intrusion. Corrosion present at reinforcing steel produces expansion of the diameter of the bar (exfoliation) which leads to displacement (jacking) of surface finishes, such as stucco. This condition can be observed prior to stucco/concrete finishes failure, in the form of bulging of the exterior finishes (see **Photo #5 & #6**) and after finishes have been removed or displaced by the expansion of the reinforcing bar due to corrosion (see **Photo #7**).

**Photo #7.** View of spalled concrete and exposed and corroded slab reinforcing bars observed at floor of unit 402 corridor.

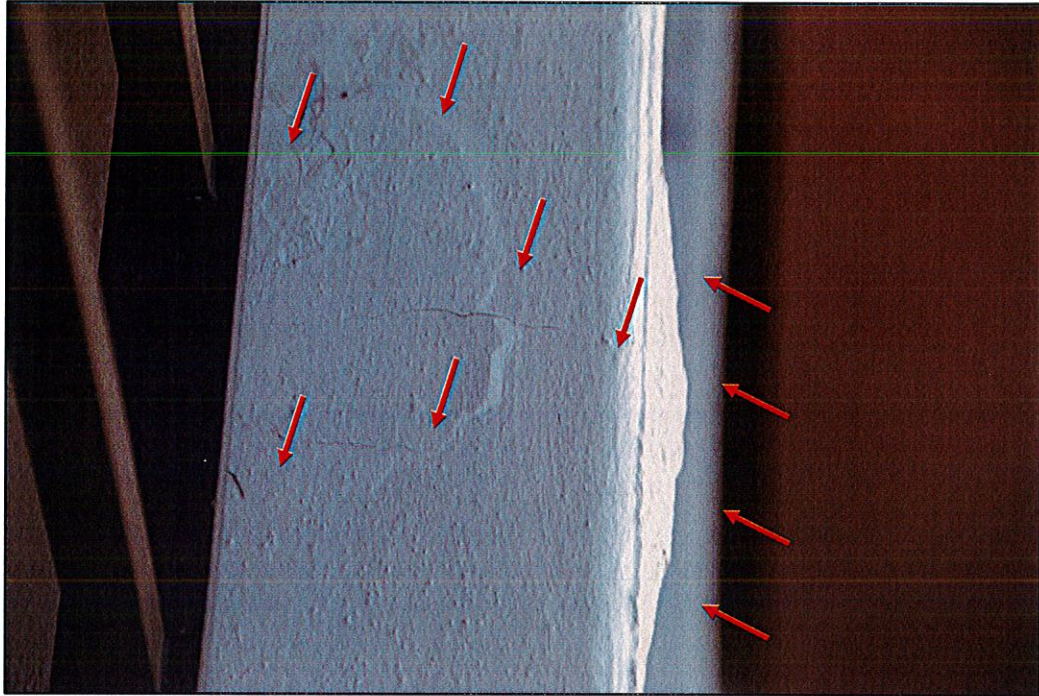
- In certain instances, this condition can be concealed by finishes that have not yet failed or have been covered by previous repairs. This condition requires additional invasive evaluations to clearly define the limits of the deficiency (see **Photo #8**).

**Photo #8.** View of cracks and deteriorated floor finishes, signs of concrete slab spalling due to corroded reinforcing, condition observed at floor (top and edge of slab) of unit 503 front corridor.

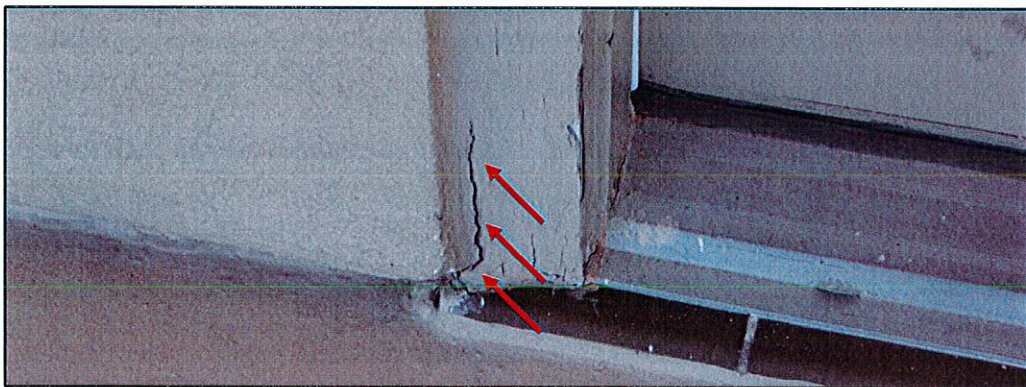
- Exterior sealants around door and window observed with signs of deterioration (cohesion failure). This condition can allow wind driven rain to enter the building envelope and cause damage to the concrete elements as well as damage to interior finishes, personal property and create environmental contamination such as mold and mildew. Sealant shall be removed and replaced preferably with a paintable and UV resistant silicone or hybrid sealant material (See **Photo #9**).

**Photo #9.** View of deteriorated sealant around the front door of unit 403.

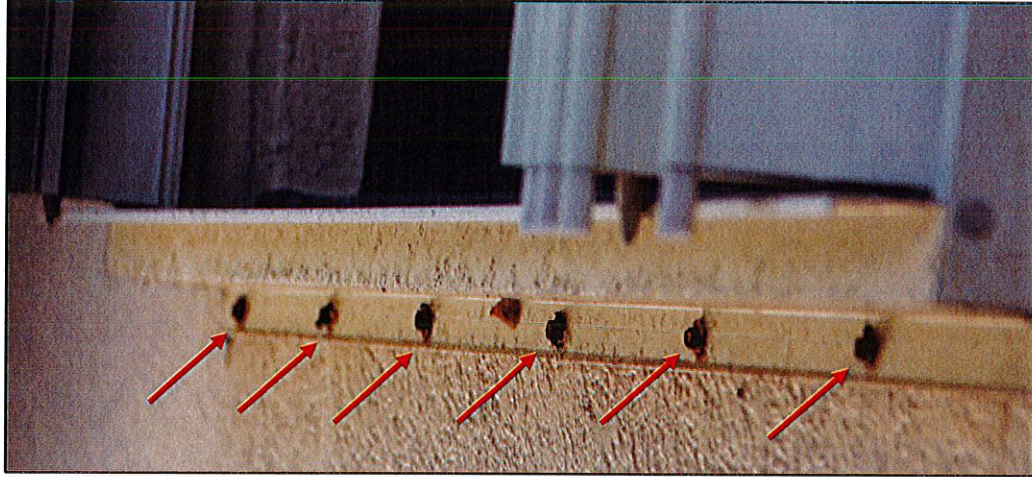
- Anchors for hurricane shutters observed with severe deterioration in the form of corrosion. This condition will compromise the structural integrity of the shutters under severe wind events. Expansion of the anchor due to severe corrosion will damage the concrete and can allow moisture to enter and damage reinforcing bars within the slab. Corroded anchors shall be replaced with corrosion resistant anchors.

Photo #10. View of deteriorated metal anchors for the hurricane shutters. Observed at several units (unit 301 shown).

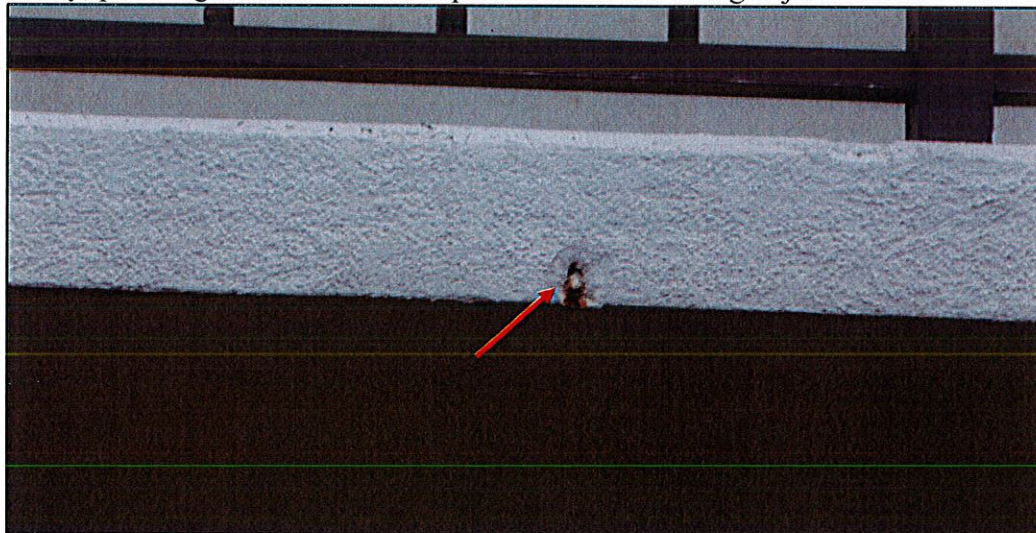
- Balcony ceiling and exterior edges with exposed and corroded metals and corroded steel elements observed at numerous units. This condition refers to metals used in the slab during construction, and also metals installed after construction (see **Photo #11**). Exposed corroded metals shall be removed by grinding metals to a depth of at least 1 inch, coating remains of metal elements in cavity, patching hole and finish or paint to match existing adjacent areas.

Photo #11. Close up view of embedded metals within concrete slabs with visible corrosion stains (unit 204 front corridor).

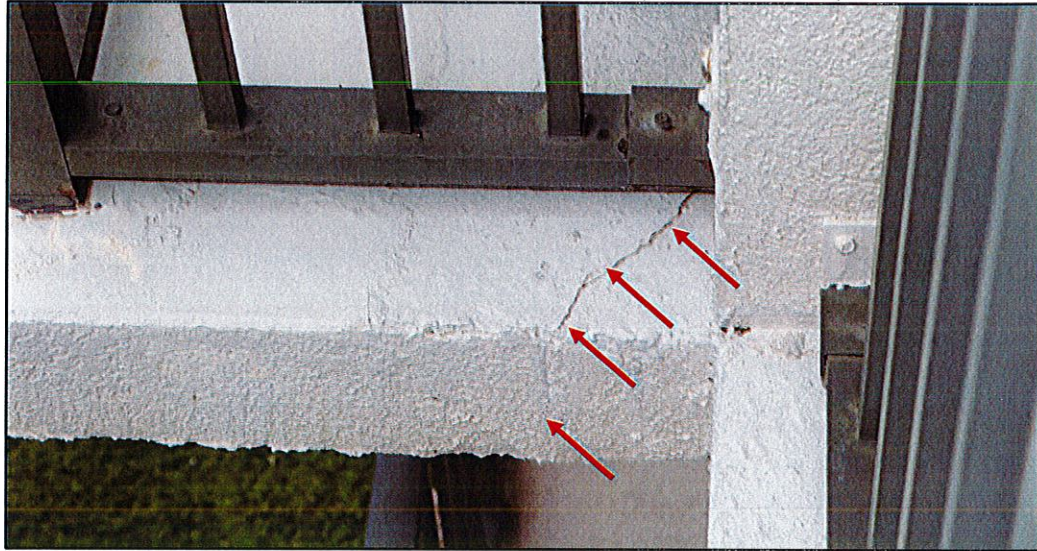
- Floor slabs with unsealed penetrations and cracks. Unsealed penetrations allow rainwater to penetrate and usually leads to corrosion of member reinforcement and spalling of concrete (Long term). The majority of the cracks observed are hairline cracks and do not represent a structural concern, however if not repaired they can cause future damage to the structure. Cracks shall be routed, sealed and surfaces finished with waterproofing membrane. (See **Photo #12**).

Photo #12. View of unsealed cracks at edge of concrete slab (unit 306 balcony shown).

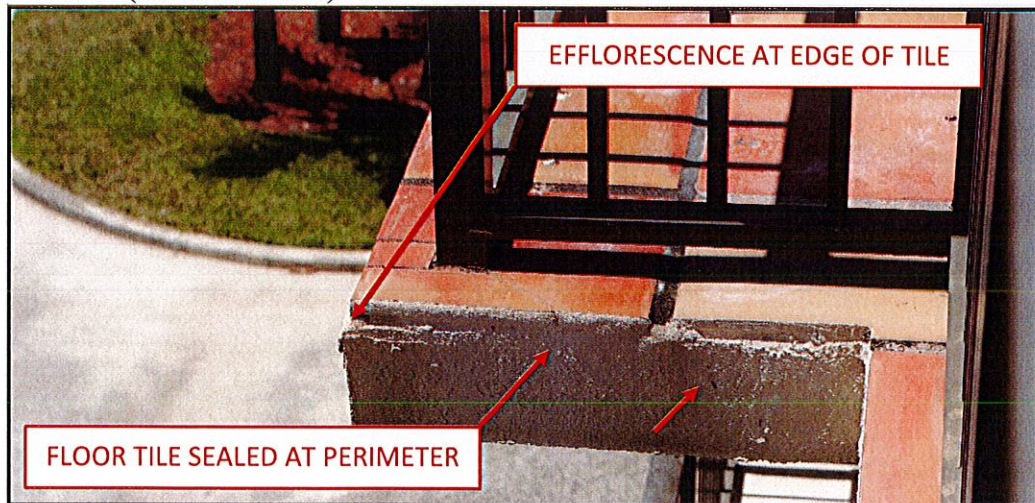
- Balcony units with floor finishes (i.e. tile), it was observed, at private balcony units with floor finishes (i.e. tile) installed up to the edge of the slab and the edge of the tile perimeter completely sealed preventing water that enters through grout lines or cracks to escape. In many cases water accumulates with no way to drain out damaging the finishes and potentially the concrete and reinforcement within the slabs (See **Photo #13**).

Photo #13. View of floor finishes (tile) with edges sealed (Unit 505 balcony shown).
