January 31, 2023

**Re: Milestone Inspection Report – Phase One.  
Building 15.  
1501 Marina Isle Way, Jupiter, FL 33477**

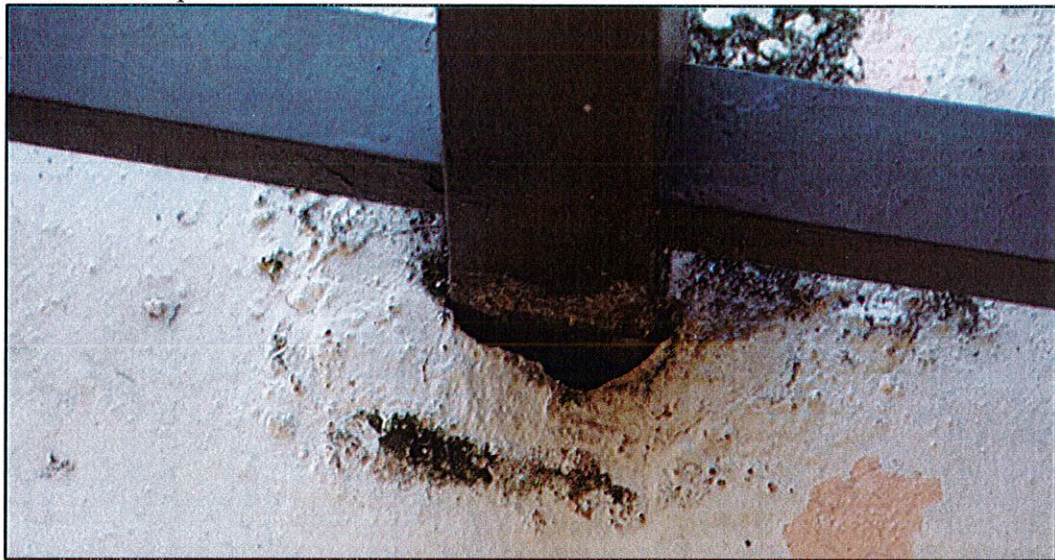
- Balcony guardrail vertical posts with visible separation and/or gaps between the concrete wall of the concrete pocket and the post (see **Photos #1 and #2**). Also, moisture was observed ponding in low spots around the post base. This condition indicates moisture has penetrated the base of the post and could cause damage to the concrete and corrosion of the reinforcement in the slab. Further evidence of moisture within the railing post base can be observed at locations with vegetation and/or organic growth. Also, at several locations, the degree of deterioration of the post base grout allows unwanted lateral movement of the guardrail system top member or top rail.

**Photo #1.** View of post base deteriorated grout with large gaps and metal post with signs of corrosion damage (unit 201 corridor).

Since the existing guardrail system is not “current” code compliant, the guardrail system cannot be removed or un-installed from the current location. If the guardrail is removed, a new current code compliant system shall be installed in its place. For that reason, we recommend the following remedial actions:

- At locations where concrete/grout cracks, delamination, and/or spalling is identified, remove all grout to expose the embedded portion of railing post and remove adjoining cracked, delaminated and/or spalled concrete.
- Remove all grout, corrosion, scale, slurry, and other bond-inhibiting material from exposed railing post by thorough wire-brushing or high-pressure water blasting.
- Install weep hole at post base above finishes.
- Replace removed concrete non-shrink non-metallic grout around the post.
- Prime railing posts to a minimum of 1-inch above the finish concrete surface to provide adequate grout-to-aluminum isolation.
- Seal around post base with sealant.
- Plaster finish and paint the repair area to match the surroundings.

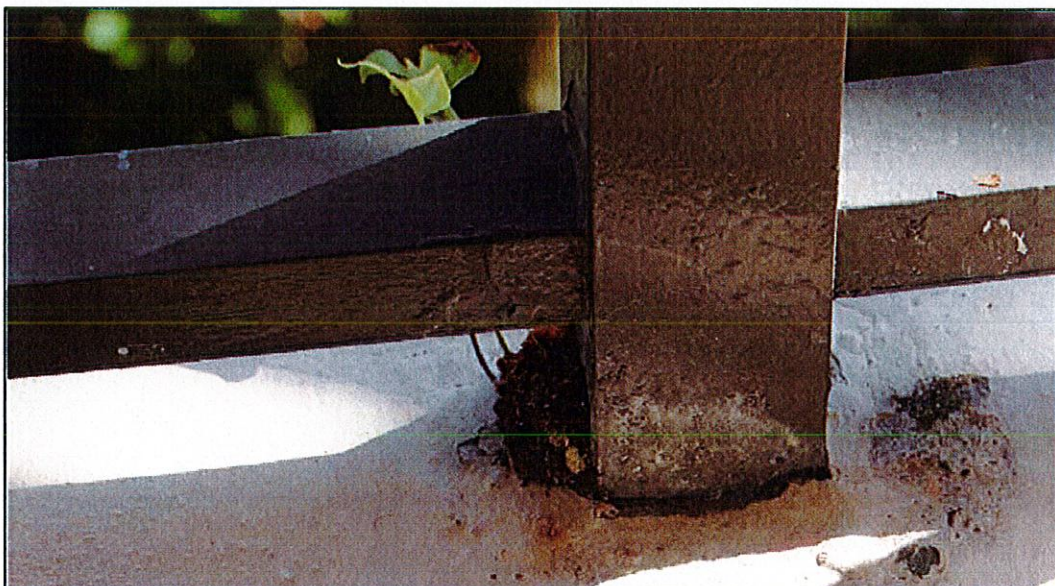
**Photo #2.** View of post base deteriorated grout and visible vegetation growth (unit 204 front corridor).

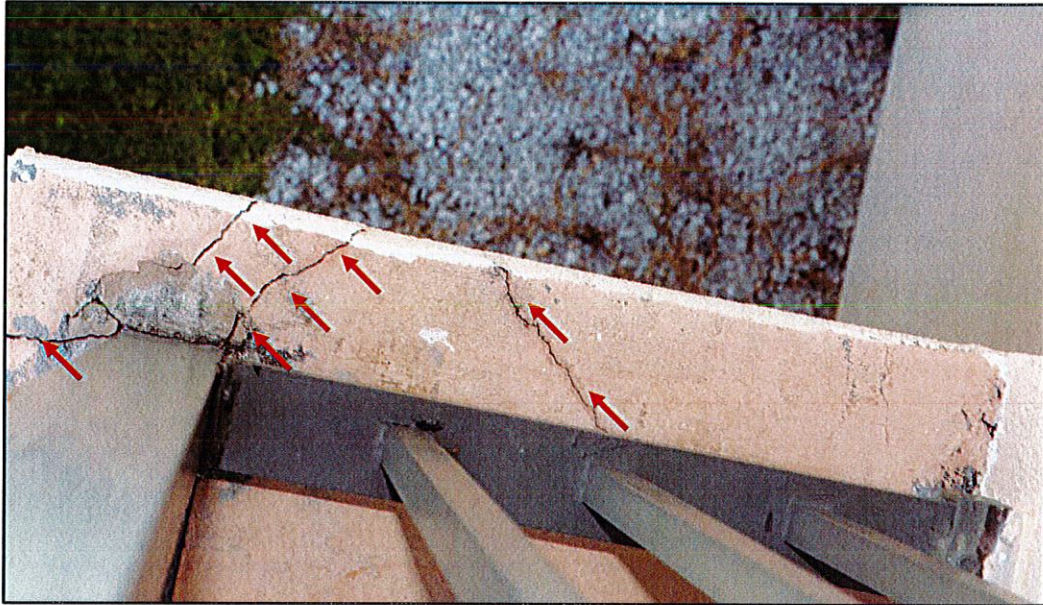
- Balcony floors and exterior edges with imminent concrete spalls. This condition can also be caused by insufficient rebar concrete coverage and by superficial cracks that allow moisture intrusion. Corrosion present at reinforcing steel produces expansion of the diameter of the bar which leads to displacement of surface materials, in this case, concrete (See **Photos #3 & #4**). Due to the uncertainty of this condition, it is not possible to predict if or when the finishes will fall. We recommend removing the deficient portions of the finishes or concrete elements from the slab edges or ceilings to prevent pieces of debris from falling down and hurting residents.

Photo #3. View of imminent spalling of concrete corner observed at edge of floor slab (unit 305 balcony).

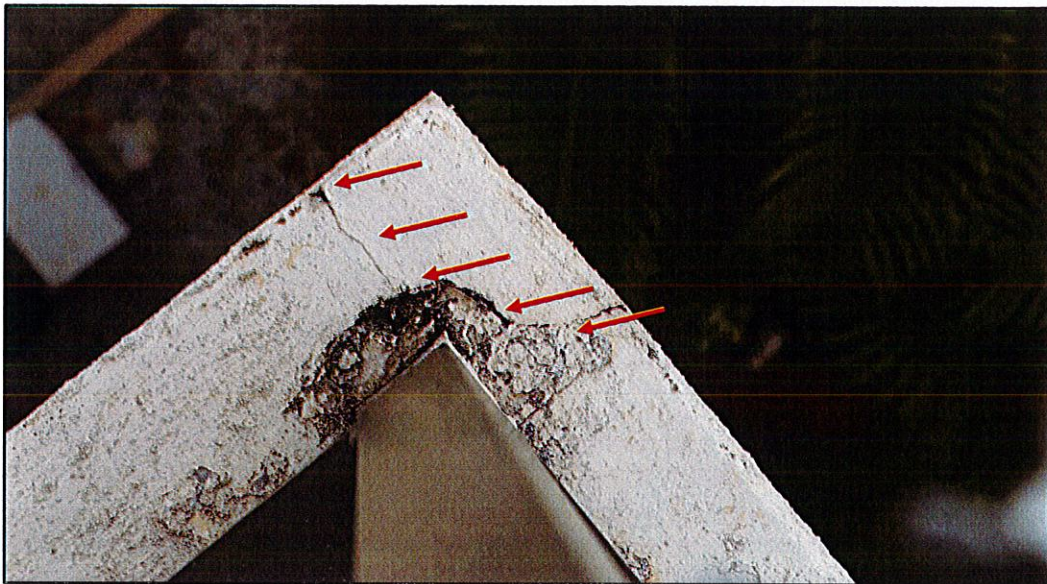
Photo #4. View of imminent spalling of concrete corner observed at edge of floor slab (unit 504 balcony).

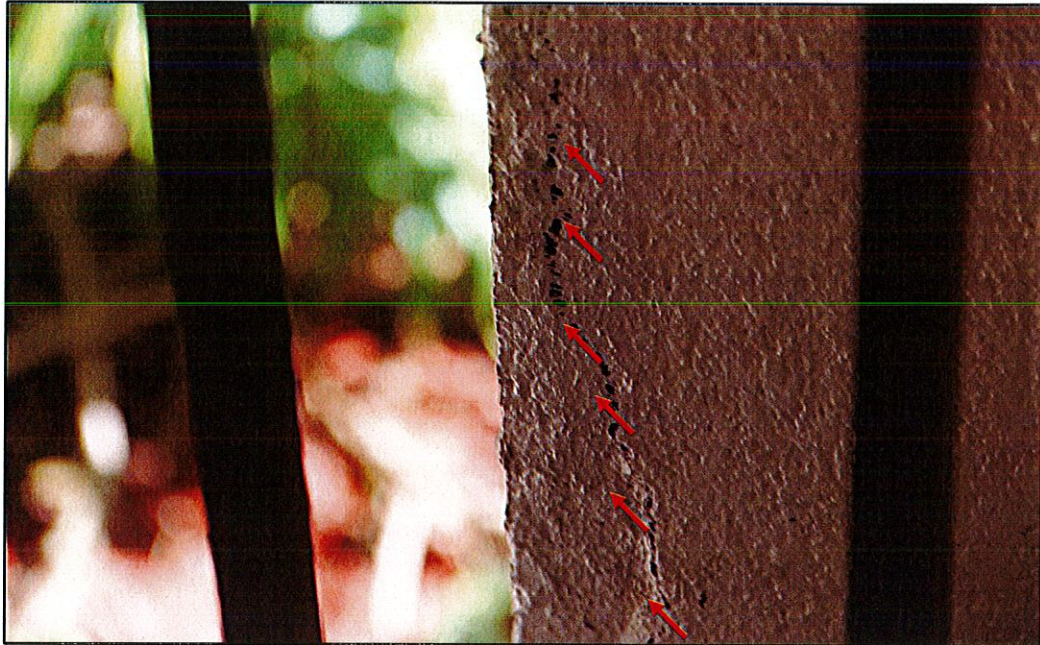
- Balcony ceiling and exterior edges with exposed and corroded reinforcement bars. This condition can be caused by insufficient rebar concrete coverage and by superficial cracks that allow moisture intrusion. Corrosion present at reinforcing steel produces expansion of the diameter of the bar (exfoliation) which leads to displacement (jacking) of surface finishes, such as stucco. This condition can be observed prior to stucco/concrete finishes failure, in the form of bulging of the exterior finishes (see **Photo #5 & #6**).

**Photo #5.** View of deteriorated stucco finishes at wall in front of stairs, signs of concrete spalling due to corroded reinforcing, condition observed at wall in front of stairs next to unit 202 front corridor.

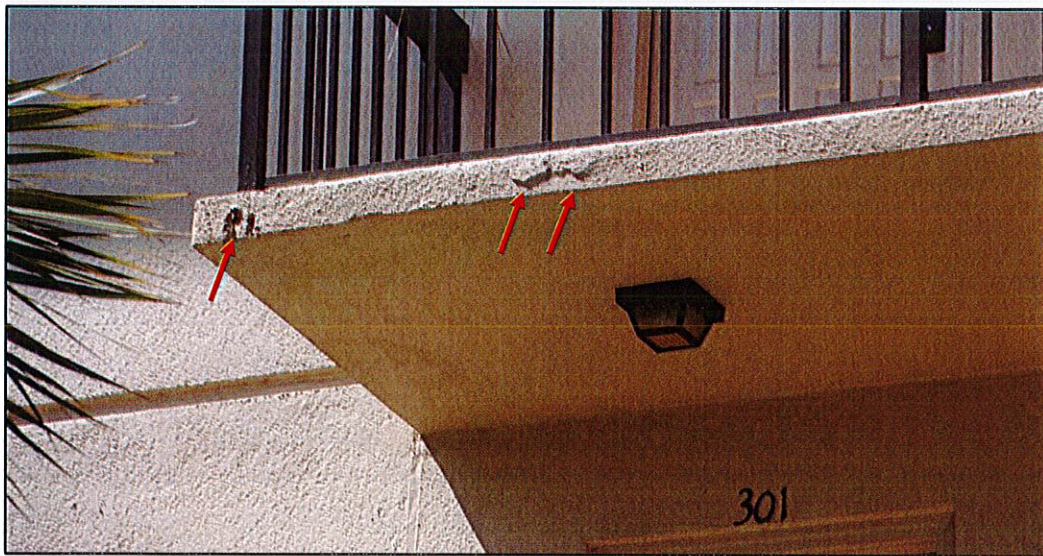
**Photo #6.** View of exterior stucco finishes with localized bulging (ceiling of unit 301 front corridor).

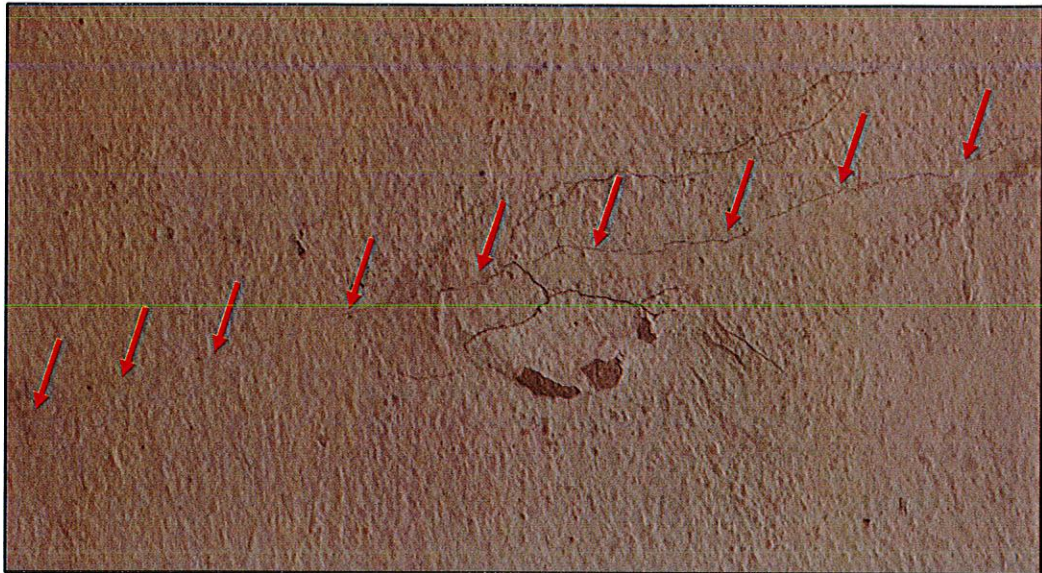
- In certain instances, this condition can be concealed by finishes that have not yet failed or have been covered by previous repairs. This condition requires additional invasive evaluations to clearly define the limits of the deficiency (see **Photo #7**).

**Photo #7.** View of cracks and deteriorated floor finishes, signs of concrete slab spalling due to corroded reinforcing, condition observed at floor (top of slab) of unit 505 front corridor.

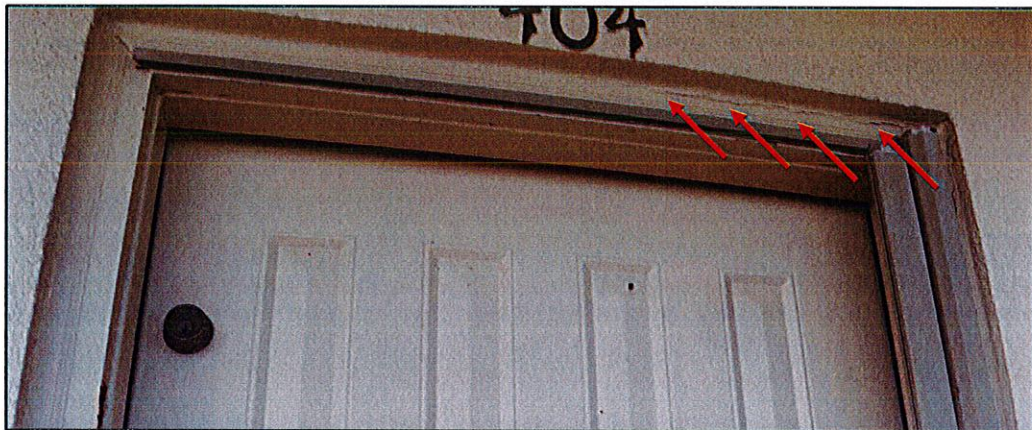
- Exterior sealants around door and window observed with signs of deterioration (cohesion failure). This condition can allow wind driven rain to enter the building envelope and cause damage to the concrete elements as well as damage to interior finishes, personal property and create environmental contamination such as mold and mildew. Sealant shall be removed and replaced preferably with a paintable and UV resistant silicone or hybrid sealant material (See **Photo #8**).

**Photo #8.** View of deteriorated sealant around the front door of unit 404.

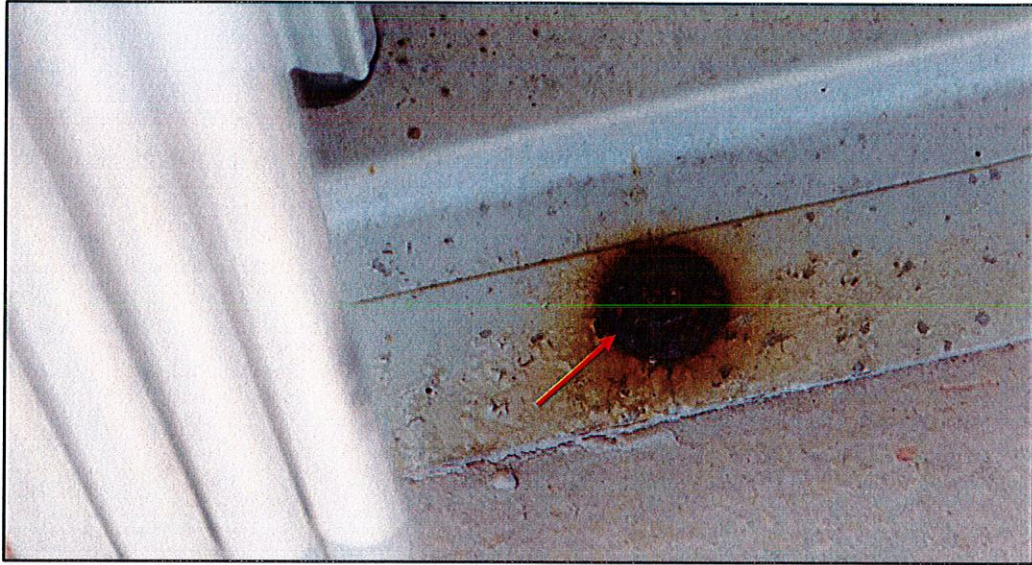
- Anchors for hurricane shutters observed with severe deterioration in the form of corrosion. This condition will compromise the structural integrity of the shutters under severe wind events. Expansion of the anchor due to severe corrosion will damage the concrete and can allow moisture to enter and damage reinforcing bars within the slab. Corroded anchors shall be replaced with corrosion resistant anchors.

Photo #9. View of deteriorated metal anchors for the hurricane shutters. Observed at several units (unit 201 shown).

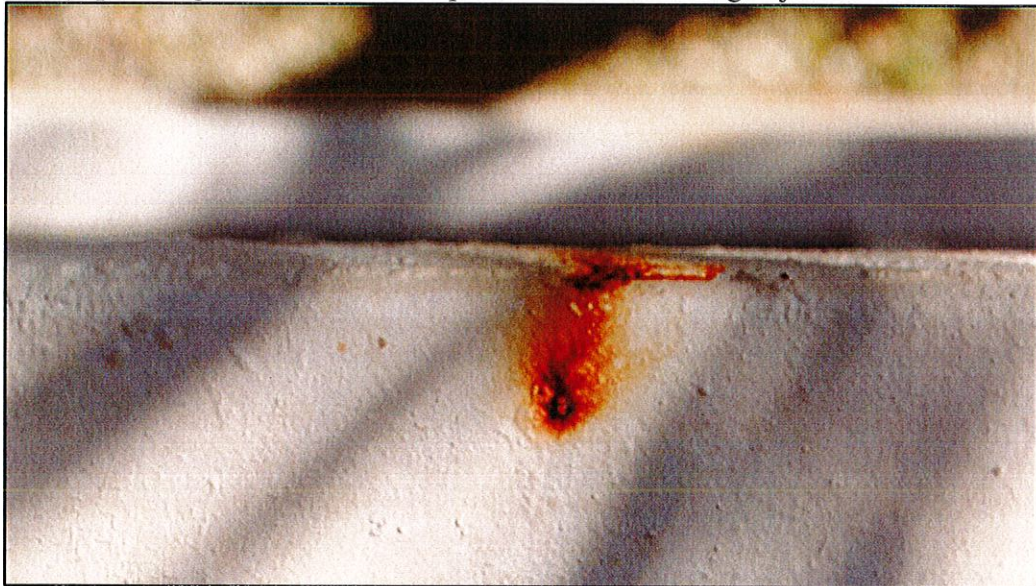
- Balcony ceiling and exterior edges with exposed and corroded metals and corroded steel elements observed at numerous units. This condition refers to metals used in the slab during construction, and also metals installed after construction (see **Photo #10**). Exposed corroded metals shall be removed by grinding metals to a depth of at least 1 inch, coating remains of metal elements in cavity, patching hole and finish or paint to match existing adjacent areas.

Photo #10. Close up view of embedded metals within concrete slabs with visible corrosion stains (unit 302 front corridor).

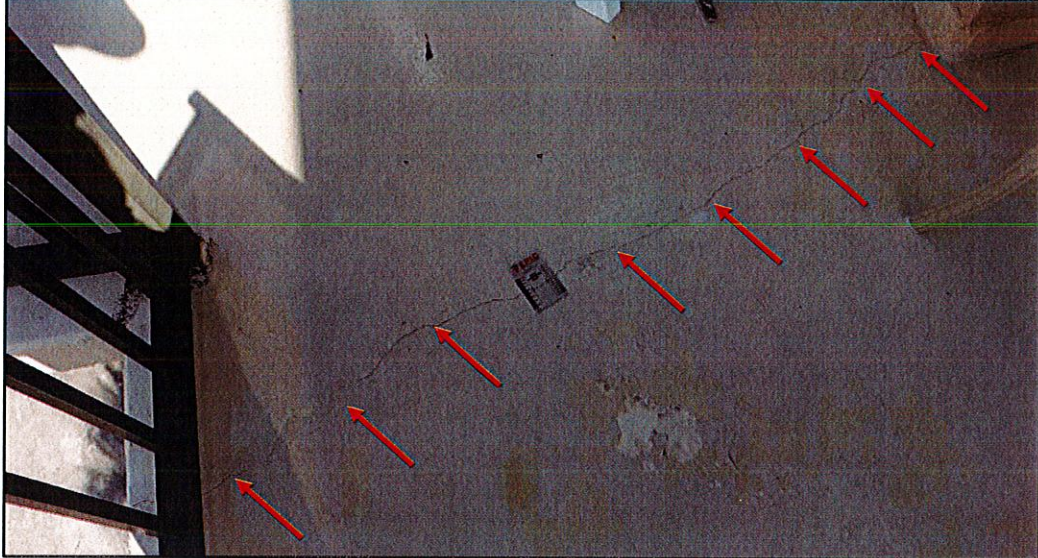
- Floor slabs with unsealed penetrations and cracks. Unsealed penetrations allow rainwater to penetrate and usually leads to corrosion of member reinforcement and spalling of concrete (Long term). The majority of the cracks observed are hairline cracks and do not represent a structural concern, however if not repaired

Photo #11. Close up view of embedded metals within concrete slabs with visible corrosion stains (unit 501 balcony shown).

they can cause future damage to the structure. Cracks shall be routed, sealed and surfaces finished with waterproofing membrane. (See **Photo #11**).

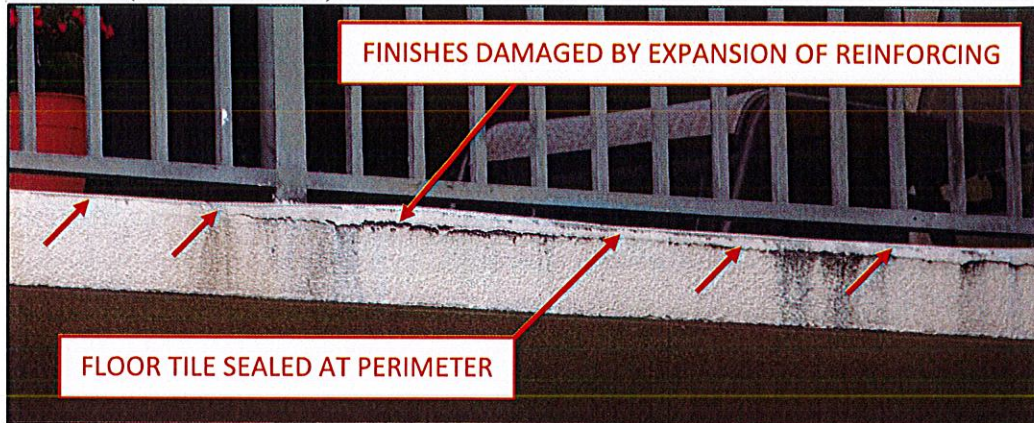
- Balcony units with floor finishes (i.e. tile), it was observed, at private balcony units with floor finishes (i.e. tile) installed up to the edge of the slab and the edge of the tile perimeter completely sealed preventing water that enters through grout lines or cracks to escape. In many cases water accumulates with no way to drain out damaging the finishes and potentially the concrete and reinforcement within the slabs (See **Photo #12**).

Photo #12. View of floor finishes (tile) with edges sealed (Unit 204 balcony shown).
