January 31, 2023

**Re: Milestone Inspection Report – Phase One.  
Building 16.  
1601 Marina Isle Way, Jupiter, FL 33477**

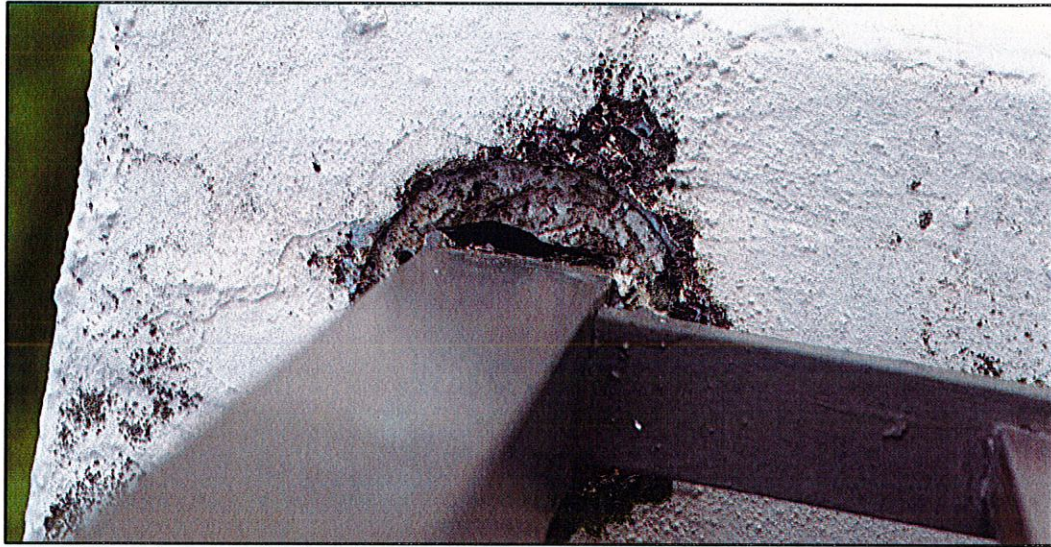
- Balcony guardrail vertical posts with visible separation and/or gaps between the concrete wall of the concrete pocket and the post (see **Photos #1 and #2**). Also, moisture was observed ponding in low spots around the post base. This condition indicates moisture has penetrated the base of the post and could cause damage to the concrete and corrosion of the reinforcement in the slab. Further evidence of moisture within the railing post base can be observed at locations with vegetation and/or organic growth. Also, at several locations, the degree of deterioration of the post base grout allows unwanted lateral movement of the guardrail system top member or top rail.

Photo #1. View of post base deteriorated grout and metal post with signs of corrosion damage (unit 506 balcony).

Since the existing guardrail system is not “current” code compliant, the guardrail system cannot be removed or un-installed from the current location. If the guardrail is removed, a new current code compliant system shall be installed in its place. For that reason, we recommend the following remedial actions:

- At locations where concrete/grout cracks, delamination, and/or spalling is identified, remove all grout to expose the embedded portion of railing post and remove adjoining cracked, delaminated and/or spalled concrete.
- Remove all grout, corrosion, scale, slurry, and other bond-inhibiting material from exposed railing post by thorough wire-brushing or high-pressure water blasting.
- Install weep hole at post base above finishes.
- Replace removed concrete non-shrink non-metallic grout around the post.
- Prime railing posts to a minimum of 1-inch above the finish concrete surface to provide adequate grout-to-aluminum isolation.
- Seal around post base with sealant.
- Plaster finish and paint the repair area to match the surroundings.

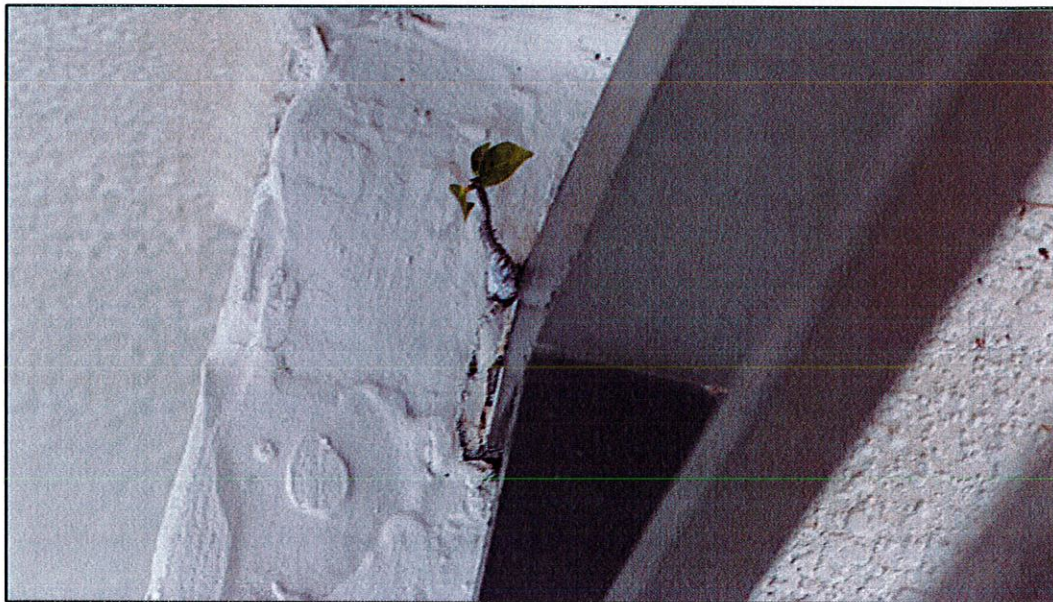
Photo #2. View of post base deteriorated grout and visible vegetation growth (unit 506 balcony).

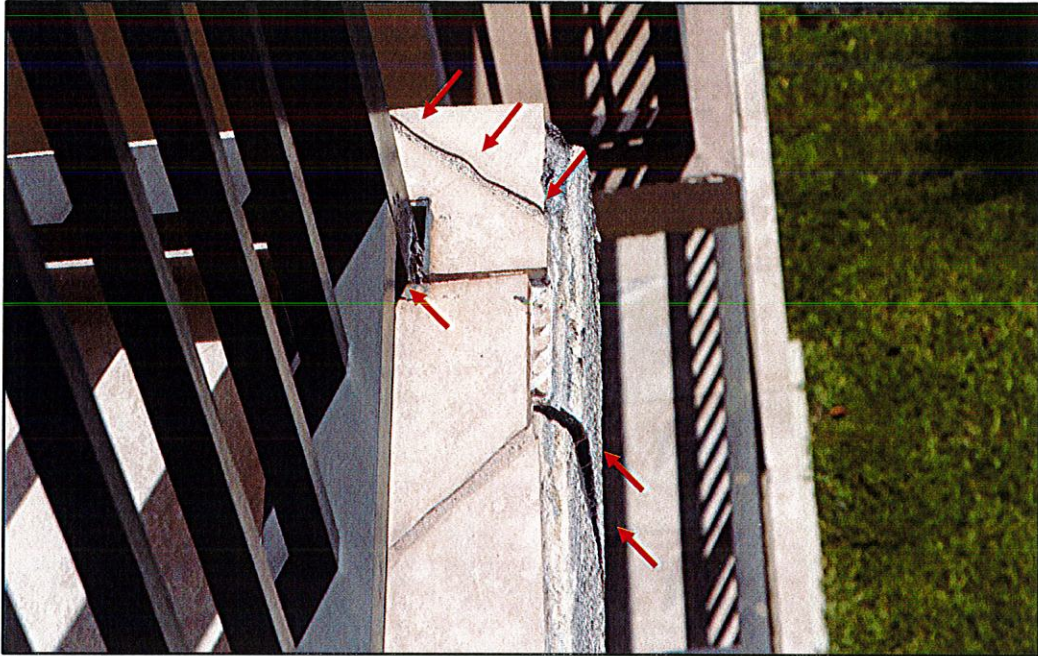
- Balcony floors and exterior edges with imminent concrete spalls. This condition can also be caused by insufficient rebar concrete coverage and by superficial cracks that allow moisture intrusion. Corrosion present at reinforcing steel produces expansion of the diameter of the bar which leads to displacement of surface materials, in this case, concrete (See **Photos #3 & #4**). Due to the uncertainty of this condition, it is not possible to predict if or when the finishes will fall. We recommend removing the deficient portions of the finishes or concrete elements from the slab edges or ceilings to prevent pieces of debris from falling down and hurting residents.

Photo #3. View of imminent spalling of concrete corner observed at edge of floor slab (unit 404 balcony shown).

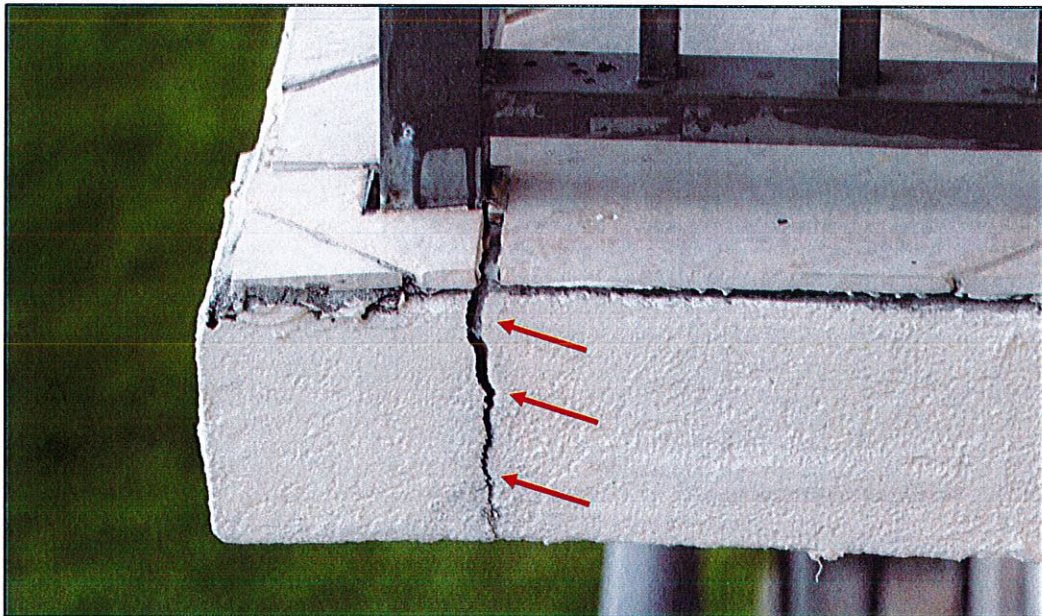
Photo #4. View of imminent spalling of concrete corner observed at edge of floor slab (unit 404 balcony shown).

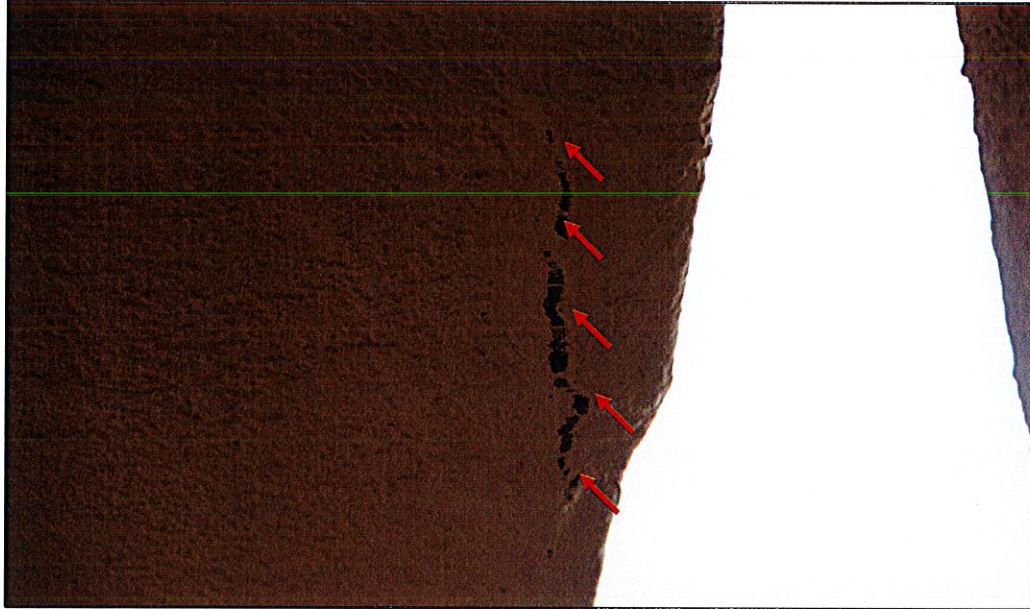
- Balcony ceiling and exterior edges with exposed and corroded reinforcement bars. This condition can be caused by insufficient rebar concrete coverage and by superficial cracks that allow moisture intrusion. Corrosion present at reinforcing steel produces expansion of the diameter of the bar (exfoliation) which leads to

displacement (jacking) of surface finishes, such as stucco. This condition can be observed prior to stucco/concrete finishes failure, in the form of bulging of the exterior finishes (see **Photo #5 & #6**).

**Photo #5.** View of deteriorated ceiling stucco finishes, signs of concrete slab spalling due to corroded reinforcing, condition observed at ceiling of unit 502 front corridor in front of stairs.

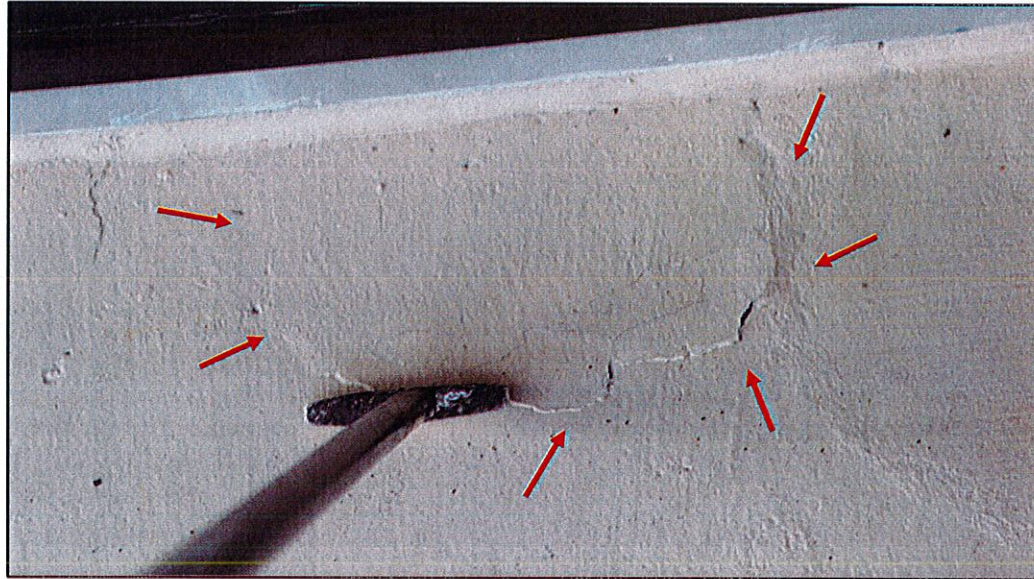
**Photo #5.** View of exterior slab finishes with localized bulging (unit 506 balcony).

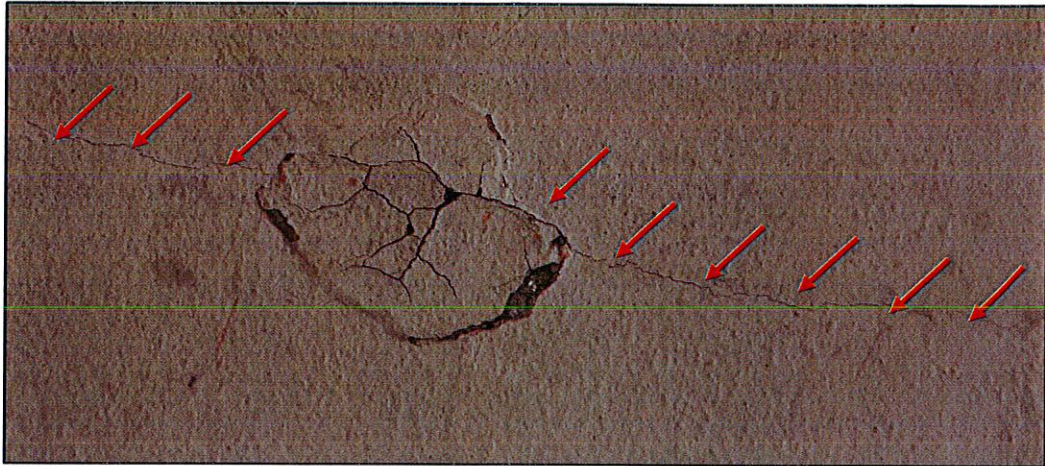
- In certain instances, this condition can be concealed by finishes that have not yet failed or have been covered by previous repairs. This condition requires additional invasive evaluations to clearly define the limits of the deficiency (see **Photo #7**).

**Photo #7.** View of cracks and deteriorated floor finishes, signs of concrete slab spalling due to corroded reinforcing, condition observed at floor (top of slab) of unit 303 front corridor.

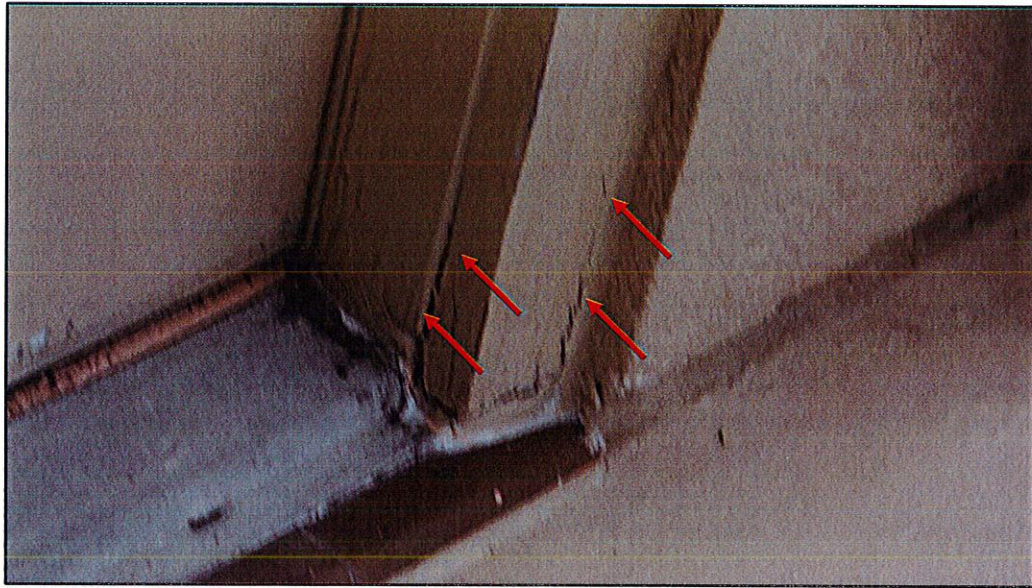
- Exterior sealants around door and window observed with signs of deterioration (cohesion failure). This condition can allow wind driven rain to enter the building envelope and cause damage to the concrete elements as well as damage to interior finishes, personal property and create environmental contamination such as mold and mildew. Sealant shall be removed and replaced preferably with a paintable and UV resistant silicone or hybrid sealant material (See **Photo #8**).

**Photo #8.** View of deteriorated sealant around the front door of unit 306.

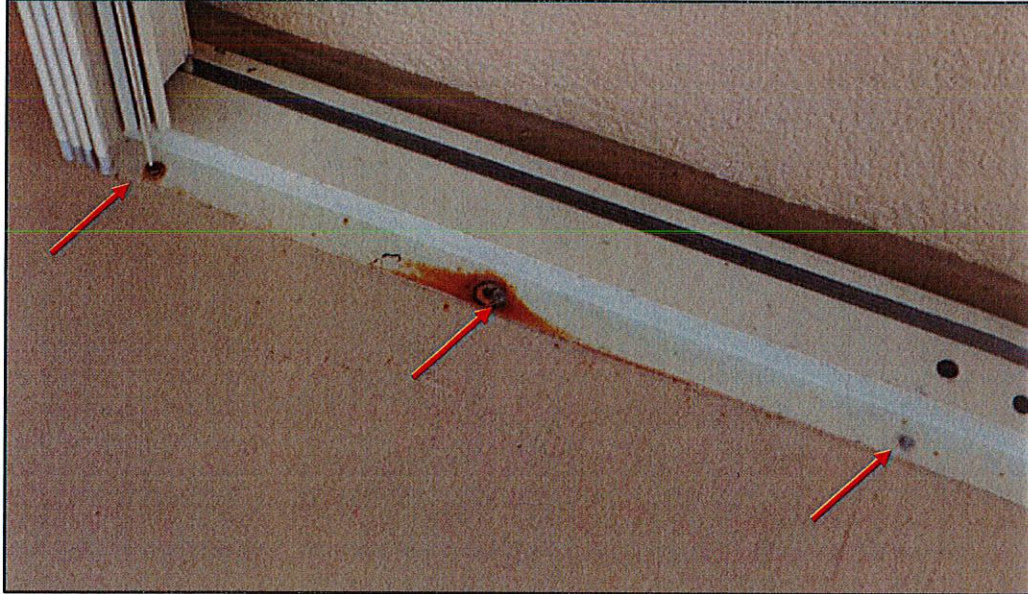
- Anchors for hurricane shutters observed with severe deterioration in the form of corrosion. This condition will compromise the structural integrity of the shutters under severe wind events. Expansion of the anchor due to severe corrosion will damage the concrete and can allow moisture to enter and damage reinforcing bars

**Photo #8.** View of deteriorated metal anchors for the hurricane shutters. Observed at several units (unit 406 shown).

within the slab. Corroded anchors shall be replaced with corrosion resistant anchors

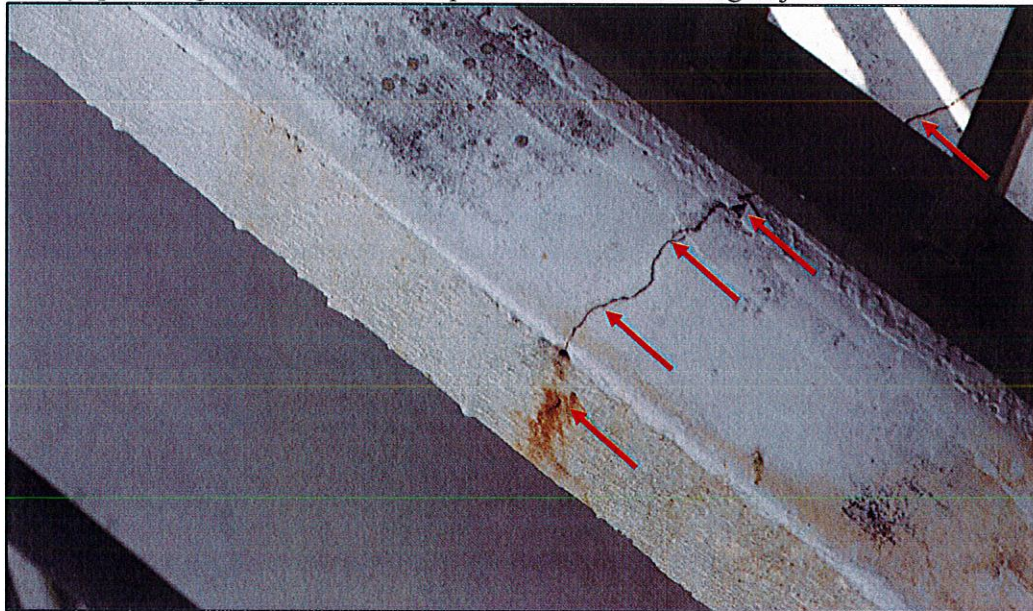
- Balcony ceiling and exterior edges with exposed and corroded metals and corroded steel elements observed at numerous units. This condition refers to metals used in the slab during construction, and also metals installed after construction (see **Photo #9**. Exposed corroded metals shall be removed by grinding metals to a depth of at least 1 inch, coating remains of metal elements in cavity, patching hole and finish or paint to match existing adjacent areas.

**Photo #9.** Close up view of embedded metals within concrete slabs with visible corrosion stains (unit 506 balcony shown).

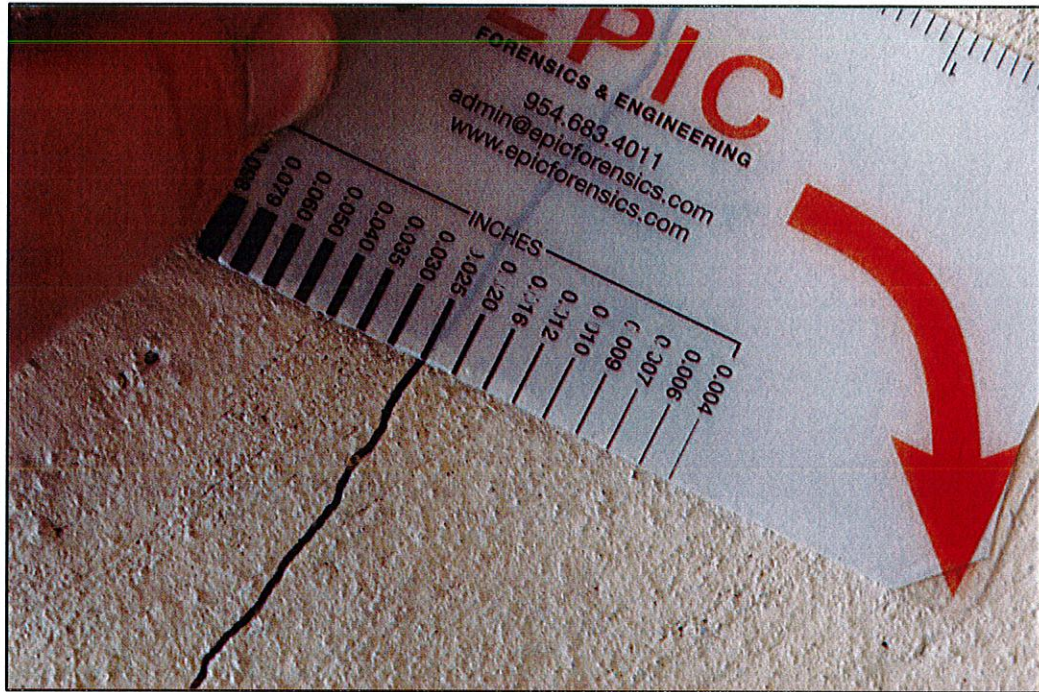
- View of floor slab with unsealed penetrations and floor cracks. Unsealed penetrations allow rainwater to penetrate and usually leads to corrosion of member reinforcement and spalling of concrete (Long term). Unsealed penetrations shall be filled with epoxy materials. Medium to large cracks shall be repaired by epoxy injection. (See **Photo #10**). At several locations signs of calcification deposits are visible immediately under the cracks (See **Photo #11**).

Photo #10. View slab cracks with visible corrosion stains and damages to stucco finishes (Unit 202 front corridor shown).

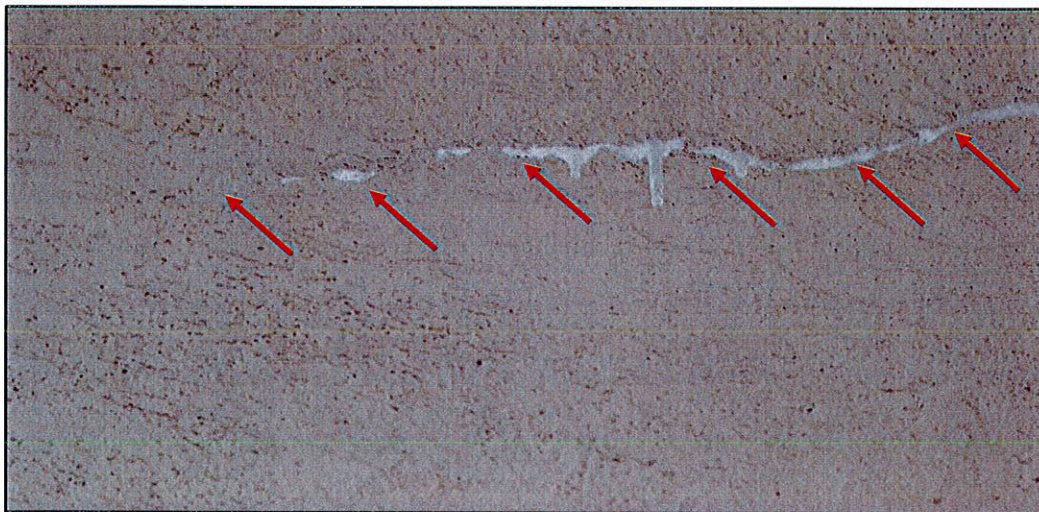
Photo #11. View slab cracks with visible signs of efflorescence (ceiling of unit 202 front balcony).

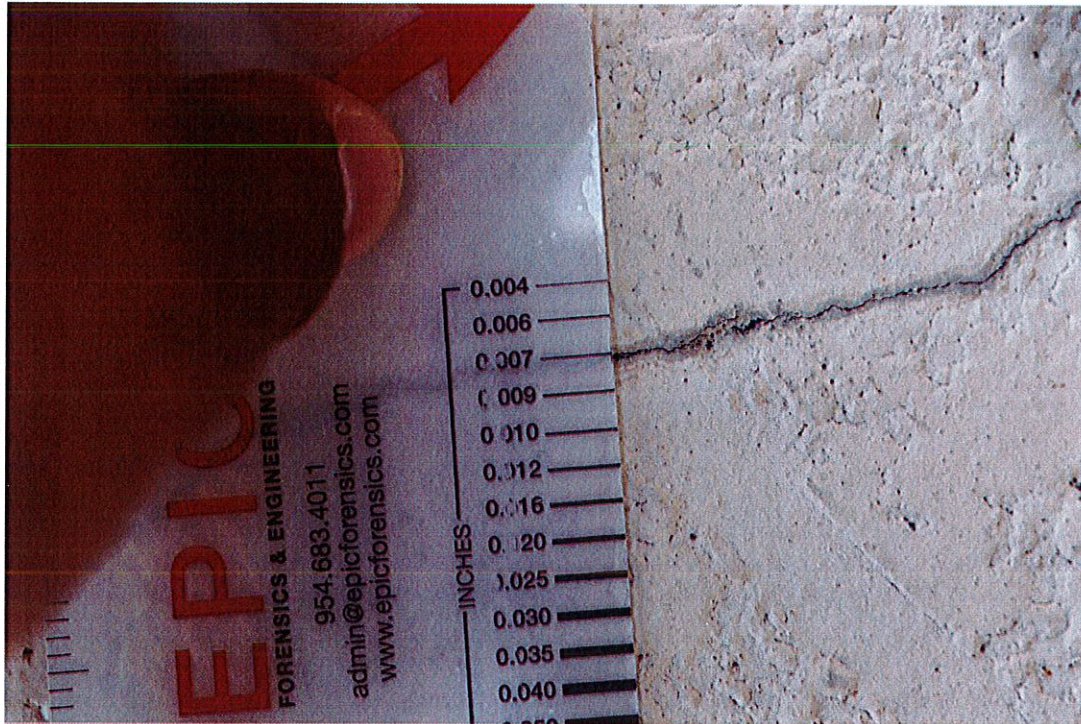
- The majority of the cracks observed are hairline cracks and do not represent a structural concern, however if not repaired they can cause future damage to the structure. Cracks shall be routed, sealed and surfaces finished with waterproofing membrane. (See **Photo #12**).

Photo #12. View of hairline slab cracks (floor of unit 506 front balcony).
