January 31, 2023

Board of Directors  
The Marina at the Bluffs Condominium Association, Inc.  
1550 Marina Isle Way  
Jupiter, FL 33477

**Re: Milestone Inspection Report – Phase One.  
Building 17.  
1701 Marina Isle Way, Jupiter, FL 33477**

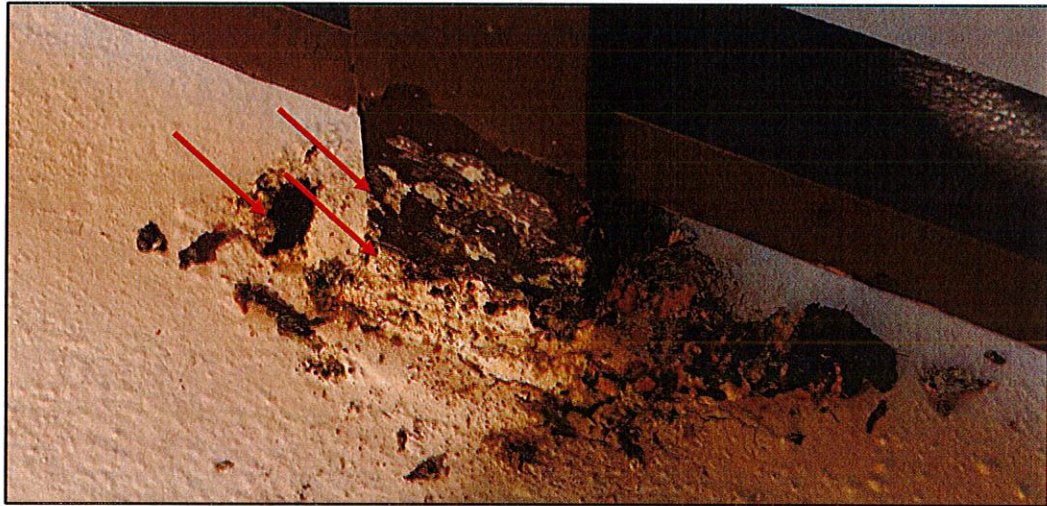
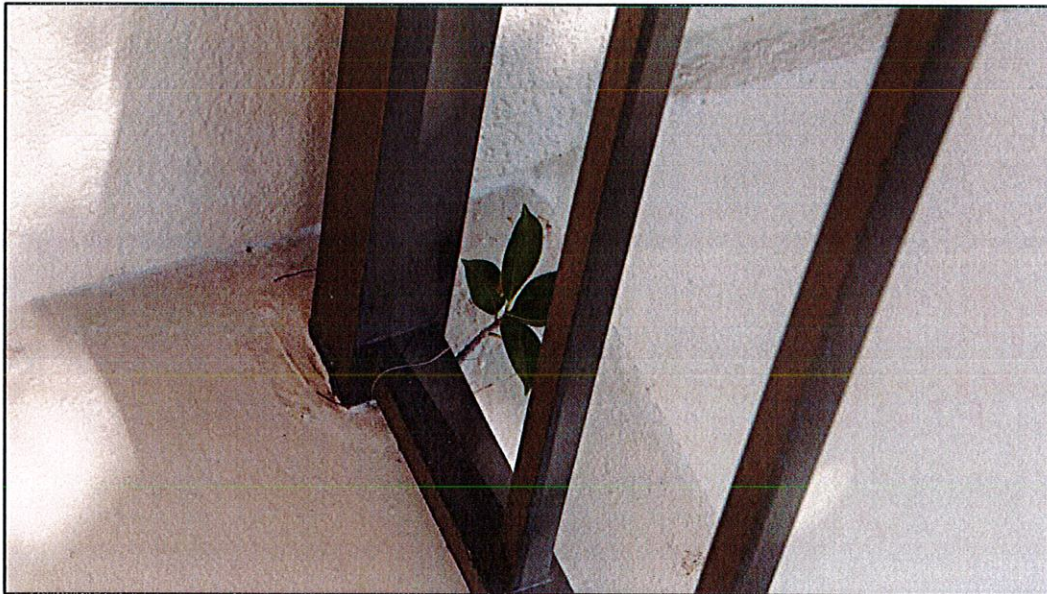
- Balcony guardrail vertical posts with visible separation and/or gaps between the concrete wall of the concrete pocket and the post (see **Photos #1 and #2**). Also, moisture was observed ponding in low spots around the post base. This condition indicates moisture has penetrated the base of the post and could cause damage to the concrete and corrosion of the reinforcement in the slab. Further evidence of moisture within the railing post base can be observed at locations with vegetation and/or organic growth. Also, at several locations, the degree of deterioration of the post base grout allows unwanted lateral movement of the guardrail system top member or top rail.

**Photo #1.** View of post base deteriorated grout with large gaps and metal post with signs of corrosion damage (unit 305 corridor).

**Photo #2.** View of post base deteriorated grout and visible vegetation growth (unit 206 corridor).

Since the existing guardrail system is not “current” code compliant, the guardrail system cannot be removed or un-installed from the current location. If the guardrail is removed, a new current code compliant system shall be installed in its place. For that reason, we recommend the following remedial actions:

- At locations where concrete/grout cracks, delamination, and/or spalling is identified, remove all grout to expose the embedded portion of railing post and remove adjoining cracked, delaminated and/or spalled concrete.
- Remove all grout, corrosion, scale, slurry, and other bond-inhibiting material from exposed railing post by thorough wire-brushing or high-pressure water blasting.
- Install weep hole at post base above finishes.
- Replace removed concrete non-shrink non-metallic grout around the post.
- Prime railing posts to a minimum of 1-inch above the finish concrete surface to provide adequate grout-to-aluminum isolation.
- Seal around post base with sealant.
- Plaster finish and paint the repair area to match the surroundings.

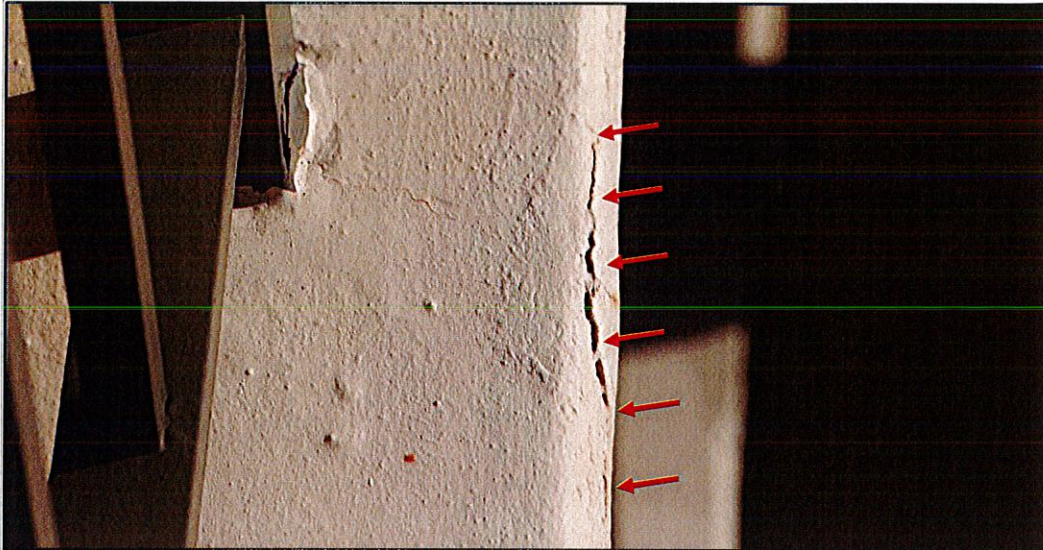
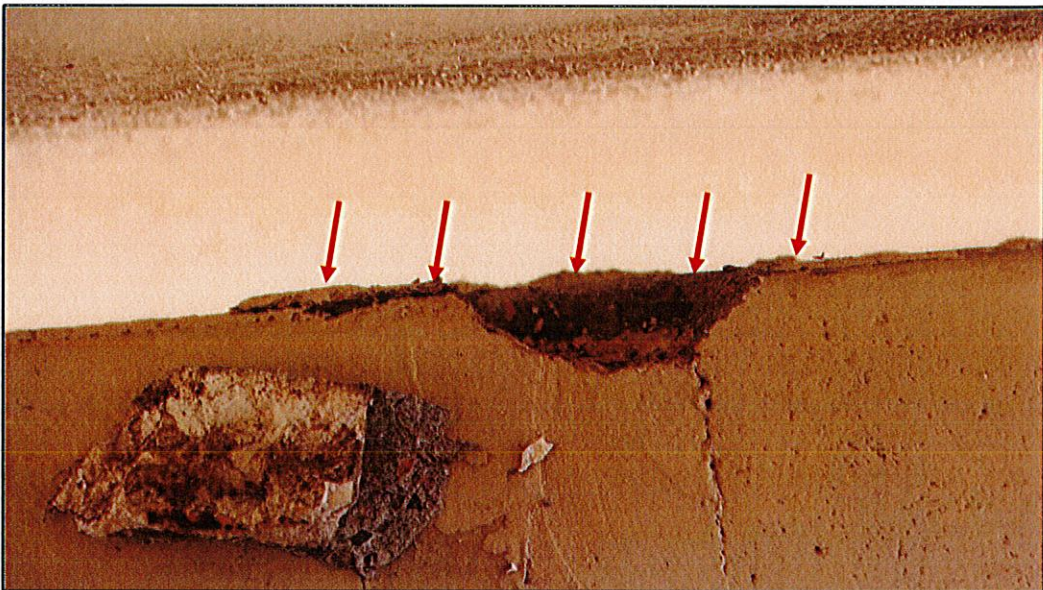
- Balcony floors and exterior edges with imminent concrete spalls. This condition can also be caused by insufficient rebar concrete coverage and by superficial cracks that allow moisture intrusion. Corrosion present at reinforcing steel produces expansion of the diameter of the bar which leads to displacement of surface materials, in this case, concrete (See **Photos #3 & #4**). Due to the uncertainty of this condition, it is not possible to predict if or when the finishes will fall. We recommend removing the deficient portions of the finishes or concrete elements from the slab edges or ceilings to prevent pieces of debris from falling down and hurting residents.

Photo #3. View of imminent spalling of south concrete edge observed at exterior floor slab edge (unit 503 corridor).

Photo #4. View of imminent spalling of concrete edge observed at balcony behind wall in front of stairs (between units 501 and 502).

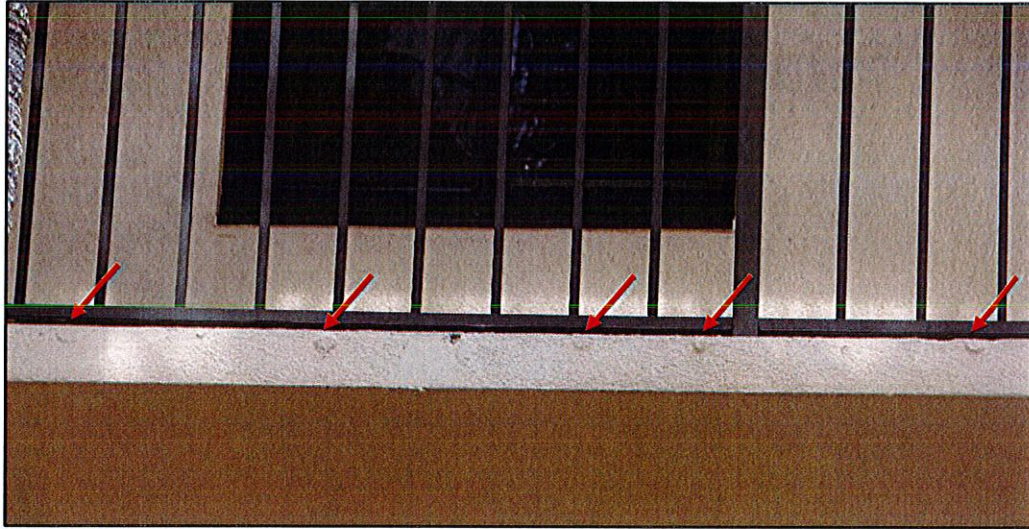
- Balcony ceiling and exterior edges with exposed and corroded reinforcement bars. This condition can be caused by insufficient rebar concrete coverage and by superficial cracks that allow moisture intrusion. Corrosion present at reinforcing steel produces expansion of the diameter of the bar (exfoliation) which leads to displacement (jacking) of surface finishes, such as stucco. This condition can be observed prior to stucco/concrete finishes failure, in the form of bulging of the exterior finishes (see **Photo #5**).

**Photo #5.** View of deteriorated stucco finishes at wall in front of stairs, signs of concrete spalling due to corroded reinforcing, condition observed at exterior edge of corridor at unit 305.

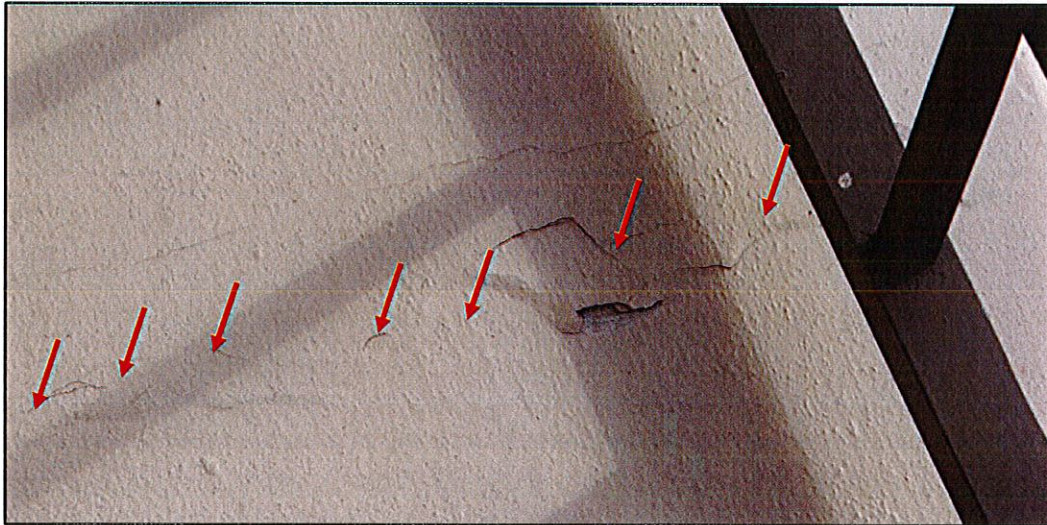
- In certain instances, this condition can be concealed by finishes that have not yet failed or have been covered by previous repairs. This condition requires additional invasive evaluations to clearly define the limits of the deficiency (see **Photo #6**).

**Photo #6.** View of cracks and deteriorated floor finishes, signs of concrete slab spalling due to corroded reinforcing, condition observed at floor (top of slab) of unit 404 front corridor.

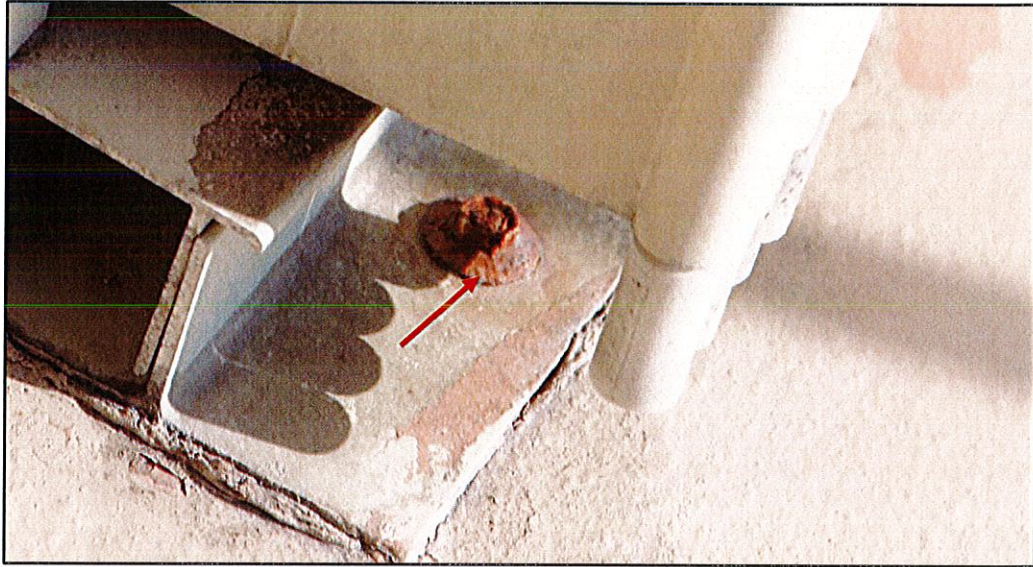
- Anchors for hurricane shutters observed with severe deterioration in the form of corrosion. This condition will compromise the structural integrity of the shutters under severe wind events. Expansion of the anchor due to severe corrosion will damage the concrete and can allow moisture to enter and damage reinforcing bars within the slab. Corroded anchors shall be replaced with corrosion resistant anchors.

**Photo #7.** View of deteriorated metal anchors for the hurricane shutters. Observed at several units (unit 405 shown).

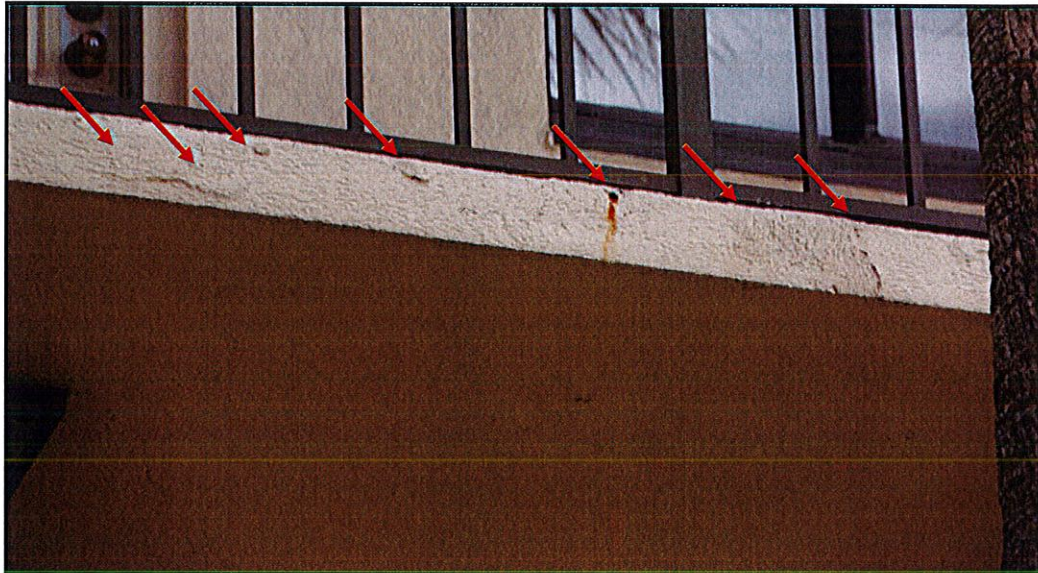
- Balcony ceiling and exterior edges with exposed and corroded metals and corroded steel elements observed at numerous units. This condition refers to metals used in the slab during construction, and also metals installed after construction (see **Photo #8**). Exposed corroded metals shall be removed by grinding metals to a depth of at least 1 inch, coating remains of metal elements in cavity, patching hole and finish or paint to match existing adjacent areas.

**Photo #8.** View of exterior stucco finishes with localized bulging and embedded metals with corrosion stains (unit 301 front corridor).

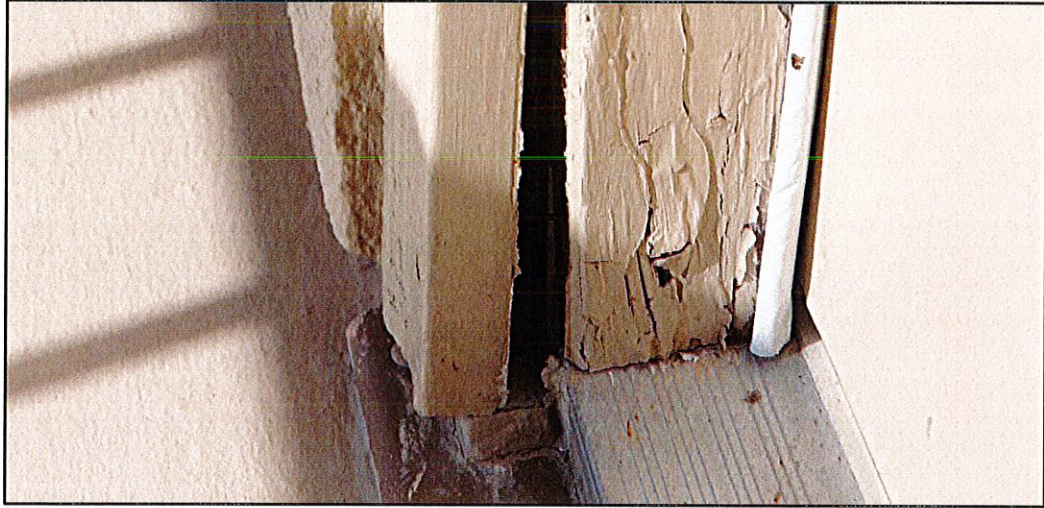
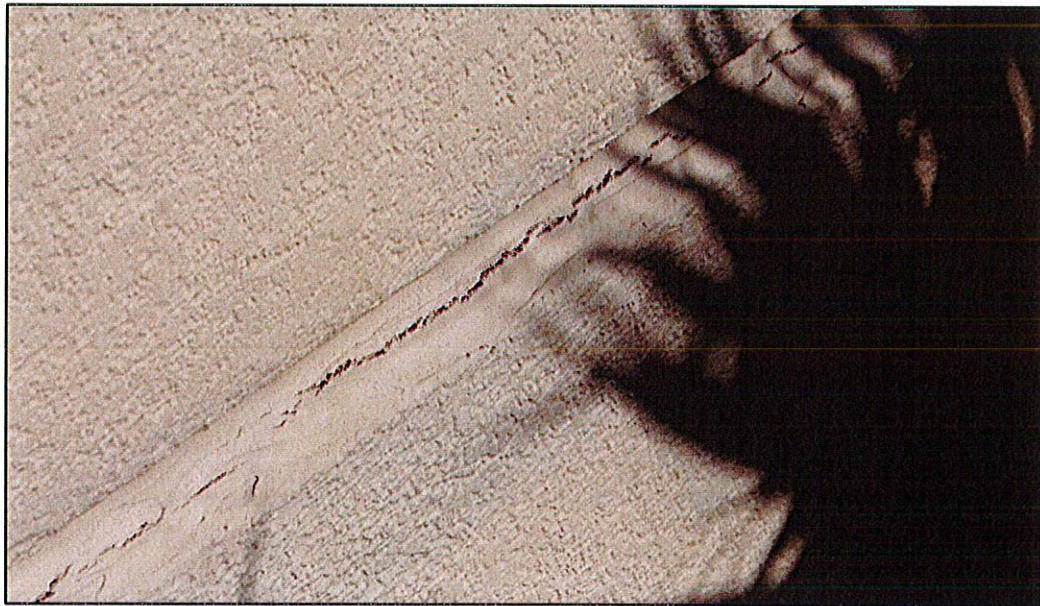
- Exterior sealants around door and window observed with signs of deterioration (cohesion failure). This condition can allow wind driven rain to enter the building

envelope and cause damage to the concrete elements as well as damage to interior finishes, personal property and create environmental contamination such as mold and mildew. Sealant shall be removed and replaced preferably with a paintable and UV resistant silicone or hybrid sealant material (See **Photos #9 & #10**).

Photo #9. View of deteriorated sealant around the front door of unit 406.

Photo #10. View of deteriorated sealant at floor level just outside of balcony edge of unit 406.
