January 31, 2023

■
1806 Old Okeechobee Road
Suite A
West Palm Beach, FL 33409
Ph: 561-581-8800
www.epicforensics.com

**Re: Milestone Inspection Report – Phase One.
Building 18.
1801 Marina Isle Way, Jupiter, FL 33477**

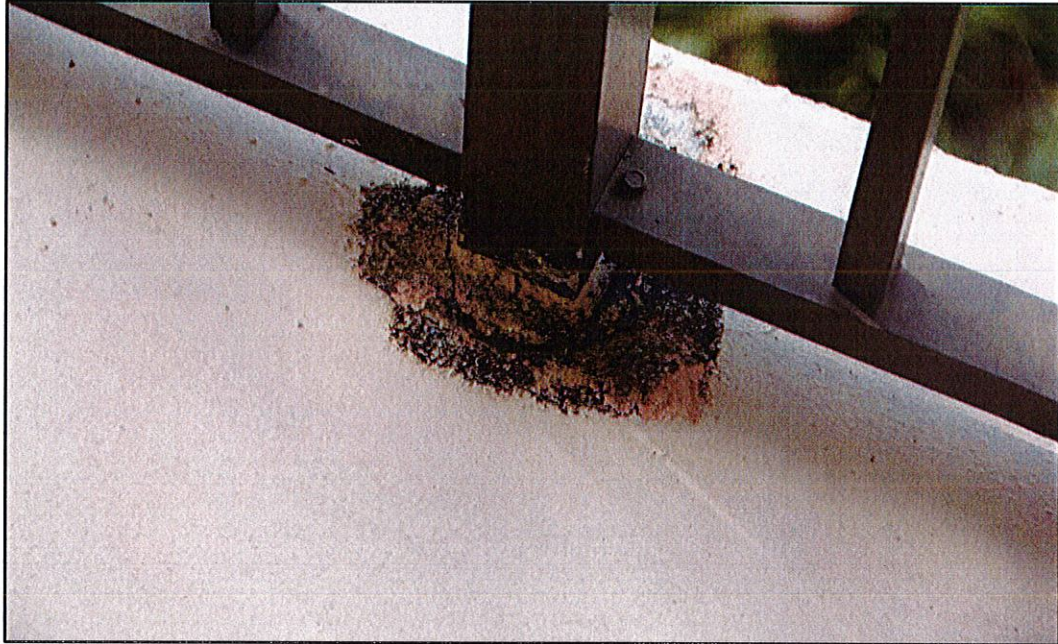
- Balcony guardrail vertical posts with visible separation and/or gaps between the concrete wall of the concrete pocket and the post (see **Photo #1**). In several locations, a metal ruler was able to be inserted to depths of up to 2 inches. Moisture was observed at the end of the ruler upon removal from the gap. Also, moisture was observed ponding in low spots around the post base. This condition indicates moisture has penetrated the base of the post and could cause damage to the concrete and corrosion of the reinforcement in the slab. Further evidence of moisture within the railing post base can be observed at locations with vegetation and/or organic growth (See **Photo #2**). Also, at several locations, the degree of deterioration of the post base grout allows unwanted lateral movement of the guardrail system top member or toprail.

Photo #1. View of post base deteriorated grout and metal post with signs of corrosion damage (unit 402 front corridor).

Since the existing guardrail system is not “current” code compliant, the guardrail system cannot be removed or un-installed from the current location. If the guardrail is removed, a new current code compliant system shall be installed in its place. For that reason, we recommend the following remedial actions:

- At locations where concrete/grout cracks, delamination, and/or spalling is identified, remove all grout to expose the embedded portion of railing post and remove adjoining cracked, delaminated and/or spalled concrete.
- Remove all grout, corrosion, scale, slurry, and other bond-inhibiting material from exposed railing post by thorough wire-brushing or high-pressure water blasting.
- Install weep hole at post base above finishes.
- Replace removed concrete non-shrink non-metallic grout around the post.
- Prime railing posts to a minimum of 1-inch above the finish concrete surface to provide adequate grout-to-aluminum isolation.
- Seal around post base with sealant.
- Plaster finish and paint the repair area to match the surroundings.

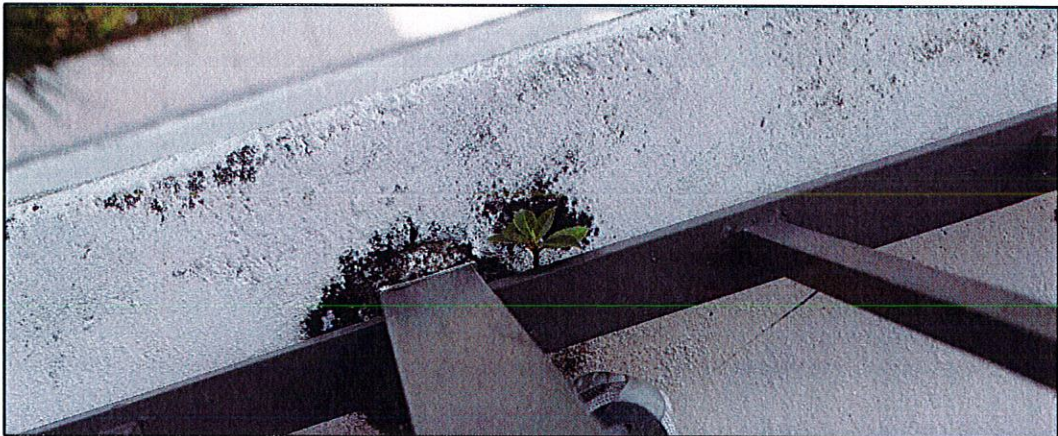
Photo #2. View of post base deteriorated grout and signs of organic growth (unit 506 balcony).

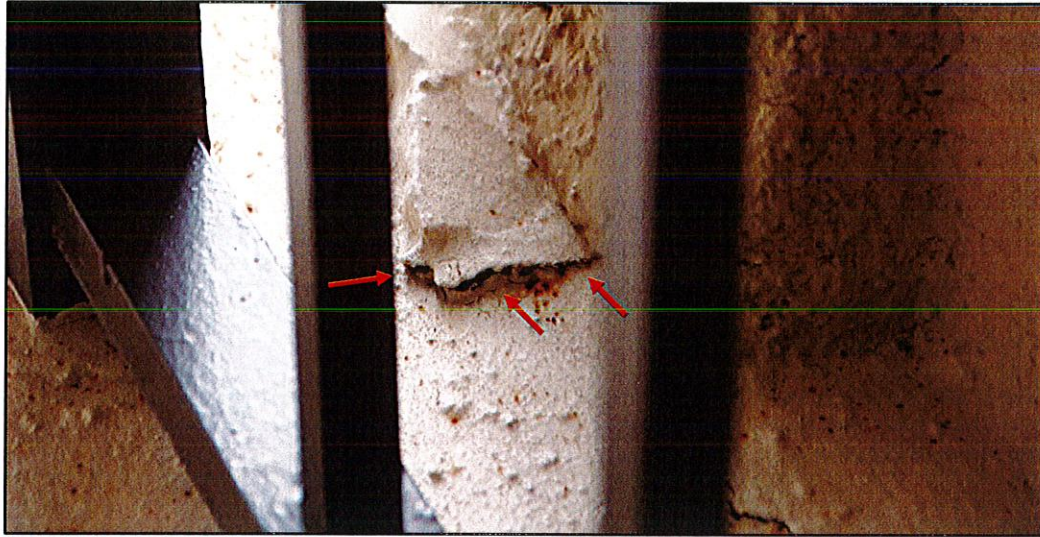
- Balcony floors and exterior edges with imminent concrete spalls. This condition can also be caused by insufficient rebar concrete coverage and by superficial cracks that allow moisture intrusion. Corrosion present at reinforcing steel produces expansion of the diameter of the bar which leads to displacement of surface materials, in this case, concrete (See **Photo #3**). Due to the uncertainty of this condition, it is not possible to predict if or when the finishes will fall. We recommend removing the deficient portions of the finishes or concrete elements from the slab edges or ceilings to prevent pieces of debris from falling down and hurting residents.

Photo #3. View of imminent spalling of concrete observed at floor slab (Unit 404 front corridor shown).

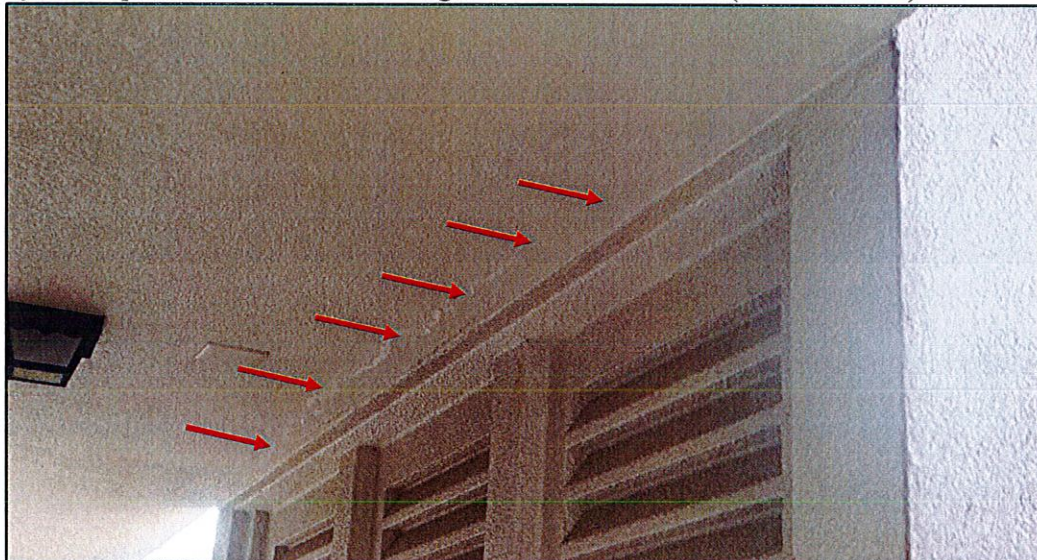
- Balcony ceiling and exterior edges with exposed and corroded reinforcement bars. This condition can be caused by insufficient rebar concrete coverage and by superficial cracks that allow moisture intrusion. Corrosion present at reinforcing steel produces expansion of the diameter of the bar (exfoliation) which leads to displacement (jacking) of surface finishes, such as stucco. This condition can be observed prior to stucco/concrete finishes failure, in the form of bulging of the exterior finishes (see **Photo #4**) and after finishes have been removed or displaced by the expansion of the reinforcing bar due to corrosion (see **Photo #5**).

Photo #4. View of deteriorated ceiling stucco finishes, signs of concrete slab spalling due to corroded reinforcing, condition observed at ceiling between units 401 and 402 front corridor.

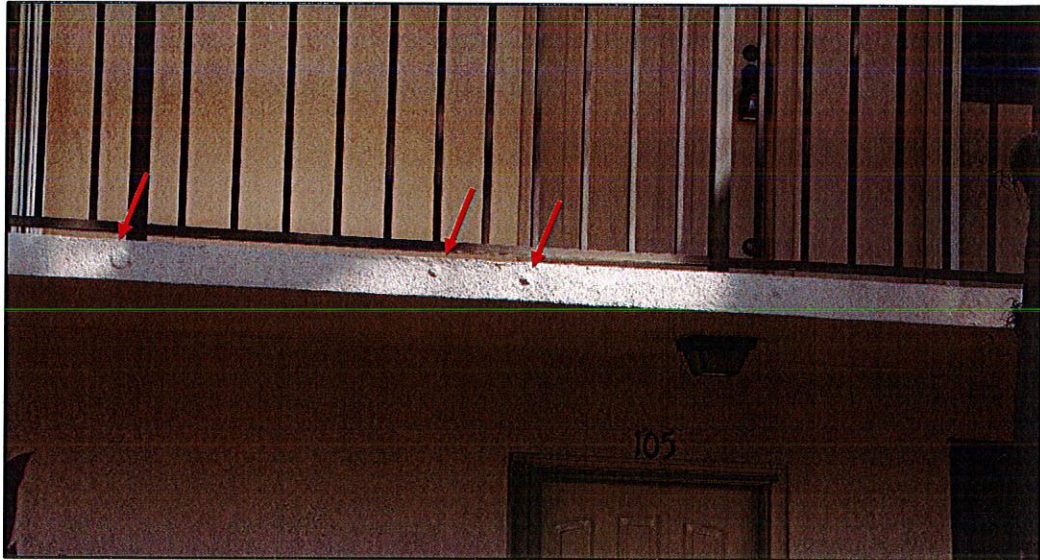
Photo #5. View of exterior stucco finishes with localized bulging (unit 205 front corridor).

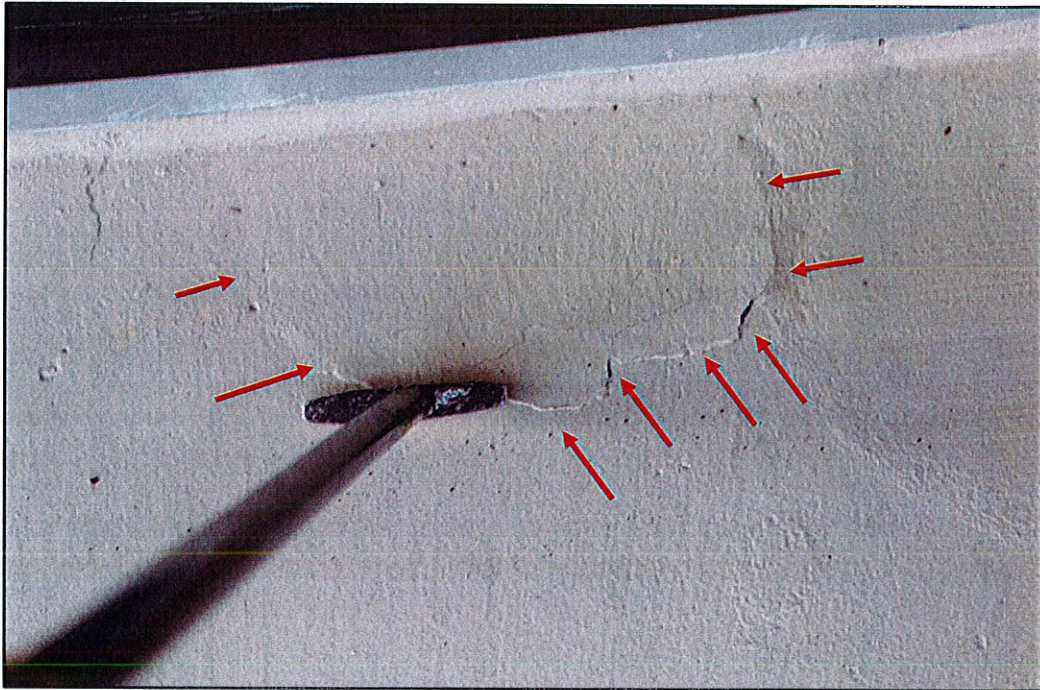
- In certain instances, this condition can be concealed by finishes that have not yet failed or have been covered by previous repairs. This condition requires additional invasive evaluations to clearly define the limits of the deficiency (see **Photo #6**).

Photo #6. View of deteriorated floor finishes, signs of concrete slab spalling due to corroded reinforcing, condition observed at floor (Top of slab) of unit 506 balcony.

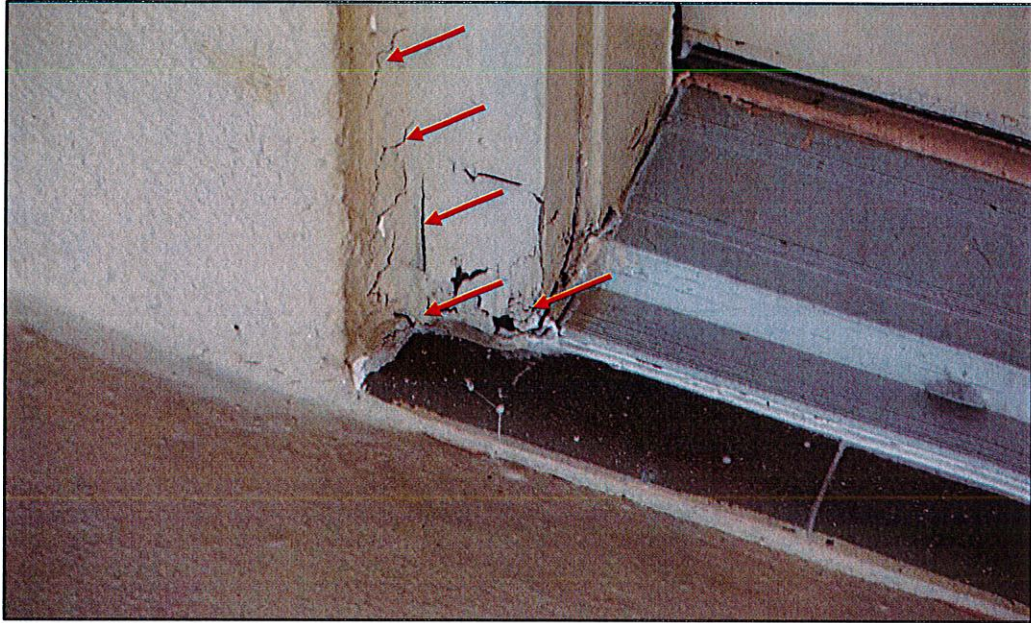
- Exterior sealants around door and window observed with signs of deterioration (cohesion failure). This condition can allow wind driven rain to enter the building envelope and cause damage to the concrete elements as well as damage to interior finishes, personal property and create environmental contamination such as mold and mildew. Sealant shall be removed and replaced preferably with a paintable and UV resistant silicone or hybrid sealant material (See **Photo #7**).

Photo #7. View of deteriorated sealant around the front door of unit 501.

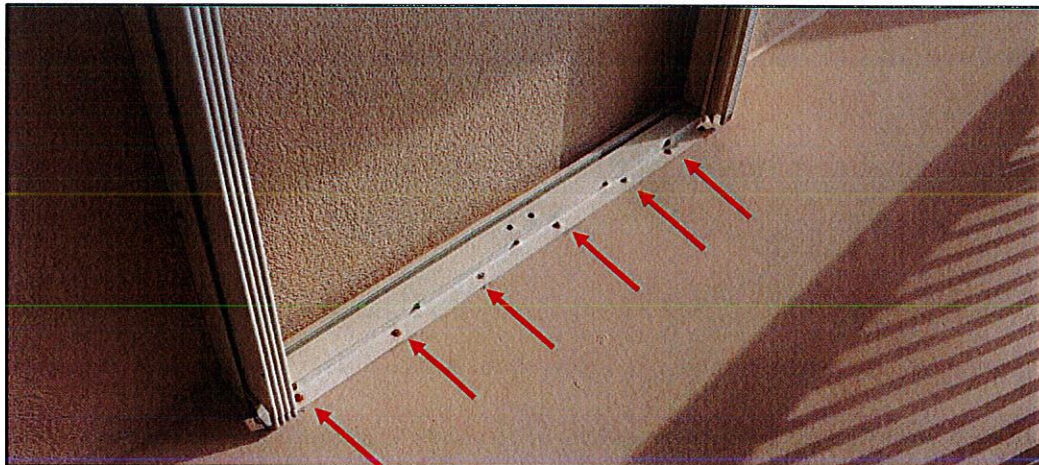
- Anchors for hurricane shutters observed with severe deterioration in the form of corrosion. This condition will compromise the structural integrity of the shutters under severe wind events. Expansion of the anchor due to severe corrosion will damage the concrete and can allow moisture to enter and damage reinforcing bars within the slab. Corroded anchors shall be replaced with corrosion resistant anchors.

Photo #8. View of deteriorated metal anchors for the hurricane shutters. Observed at several units (Unit 403 shown).

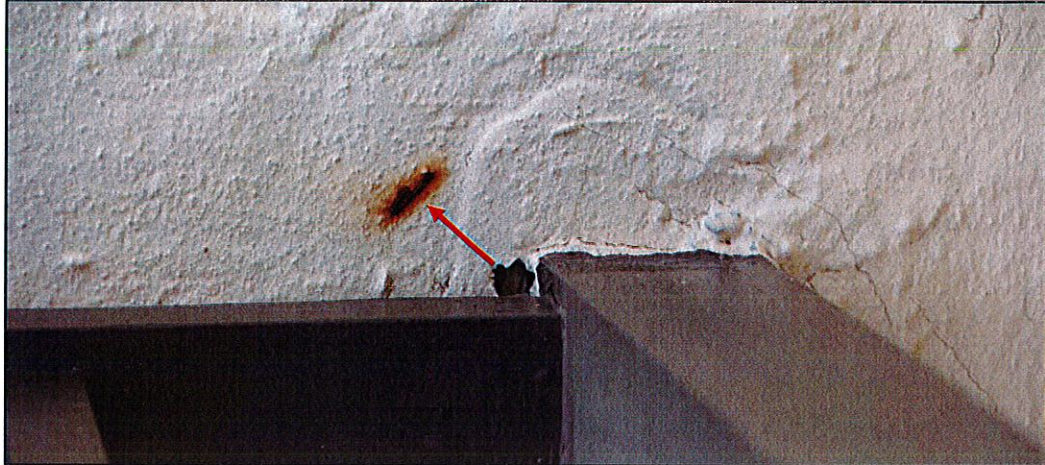
- Balcony ceiling and exterior edges with exposed and corroded metals and corroded steel elements observed at numerous units. This condition refers to metals used in the slab during construction, and also metals installed after construction (see **Photo #9**). Exposed corroded metals shall be removed by grinding metals to a depth of at least 1 inch, coating remains of metal elements in cavity, patching hole and finish or paint to match existing adjacent areas.

Photo #9. Close up view of embedded metals within concrete slabs. (Unit 501 balcony shown).

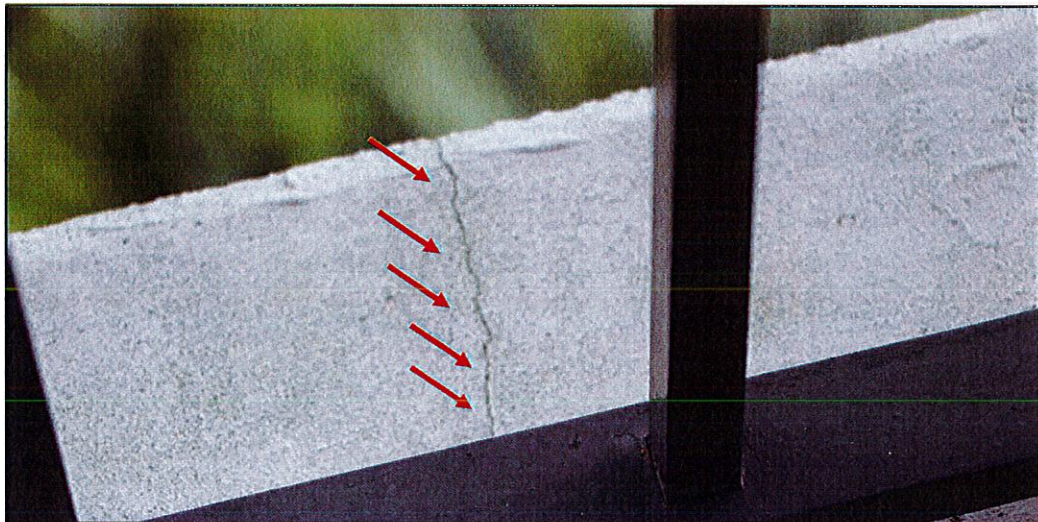
- View of floor slab with unsealed penetrations and floor cracks. Unsealed penetrations allow rainwater to penetrate and usually leads to corrosion of member reinforcement and spalling of concrete (Long term). Unsealed penetrations shall be filled with epoxy materials. The majority of the cracks observed are hairline cracks and do not represent a structural concern, however if not repaired they can cause future damage to the structure. Cracks shall be routed, sealed and surfaces finished with waterproofing membrane. (See **Photo #10**).

Photo #10. View slab cracks with visible corrosion stains and damages to stucco finishes (Unit 506 balcony shown).
