January 31, 2023

Board of Directors  
The Marina at the Bluffs Condominium Association, Inc.  
1550 Marina Isle Way  
Jupiter, FL 33477

**Re: Milestone Inspection Report – Phase One.  
Building 19.  
1901 Marina Isle Way, Jupiter, FL 33477**

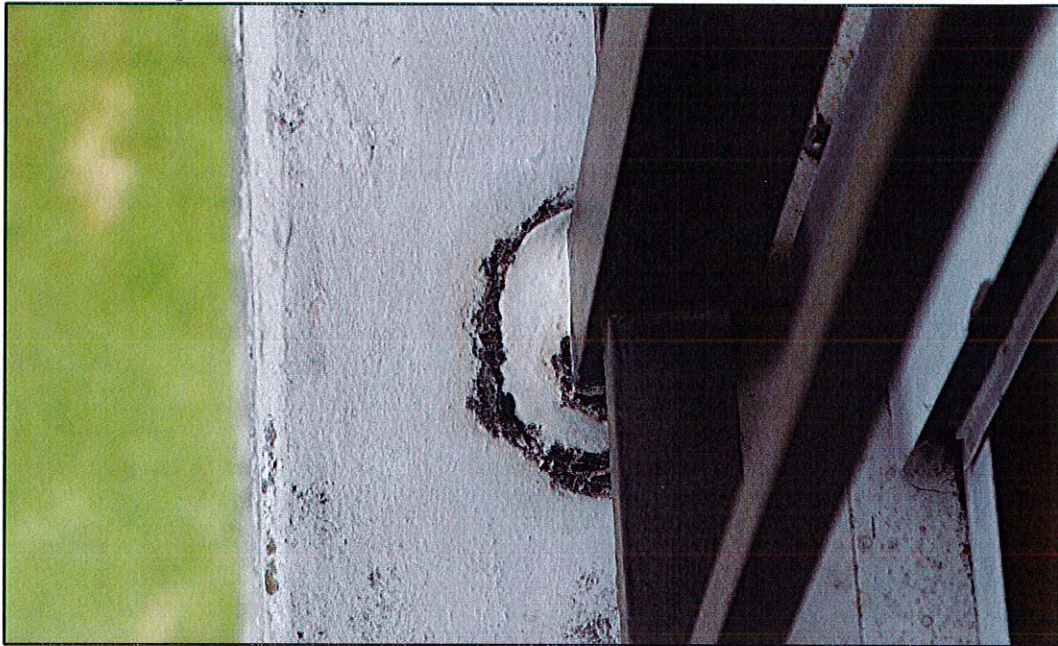
- Balcony guardrail vertical posts with visible separation and/or gaps between the concrete wall of the concrete pocket and the post (see **Photos #1 and #2**). Also, moisture was observed ponding in low spots around the post base. This condition indicates moisture has penetrated the base of the post and could cause damage to the concrete and corrosion of the reinforcement in the slab. Further evidence of moisture within the railing post base can be observed at locations with vegetation and/or organic growth. Also, at several locations, the degree of deterioration of the post base grout allows unwanted lateral movement of the guardrail system top member or top rail.

Photo #1. View of post base deteriorated grout and metal post with signs of corrosion damage (unit 502 balcony).

Since the existing guardrail system is not “current” code compliant, the guardrail system cannot be removed or un-installed from the current location. If the guardrail is removed, a new current code compliant system shall be installed in its place. For that reason, we recommend the following remedial actions:

- At locations where concrete/grout cracks, delamination, and/or spalling is identified, remove all grout to expose the embedded portion of railing post and remove adjoining cracked, delaminated and/or spalled concrete.
- Remove all grout, corrosion, scale, slurry, and other bond-inhibiting material from exposed railing post by thorough wire-brushing or high-pressure water blasting.
- Install weep hole at post base above finishes.
- Replace removed concrete non-shrink non-metallic grout around the post.
- Prime railing posts to a minimum of 1-inch above the finish concrete surface to provide adequate grout-to-aluminum isolation.
- Seal around post base with sealant.
- Plaster finish and paint the repair area to match the surroundings.

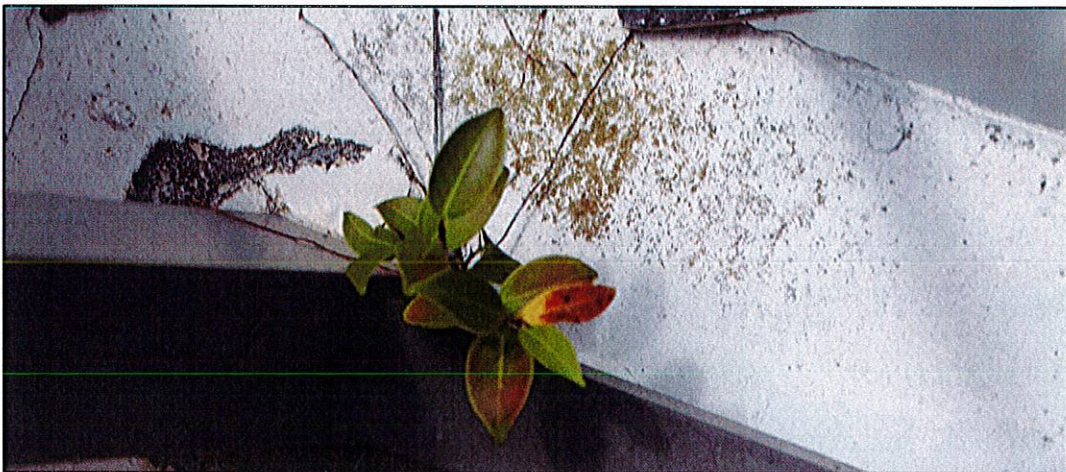
Photo #2. View of post base deteriorated grout and signs of organic growth (unit 406 balcony).

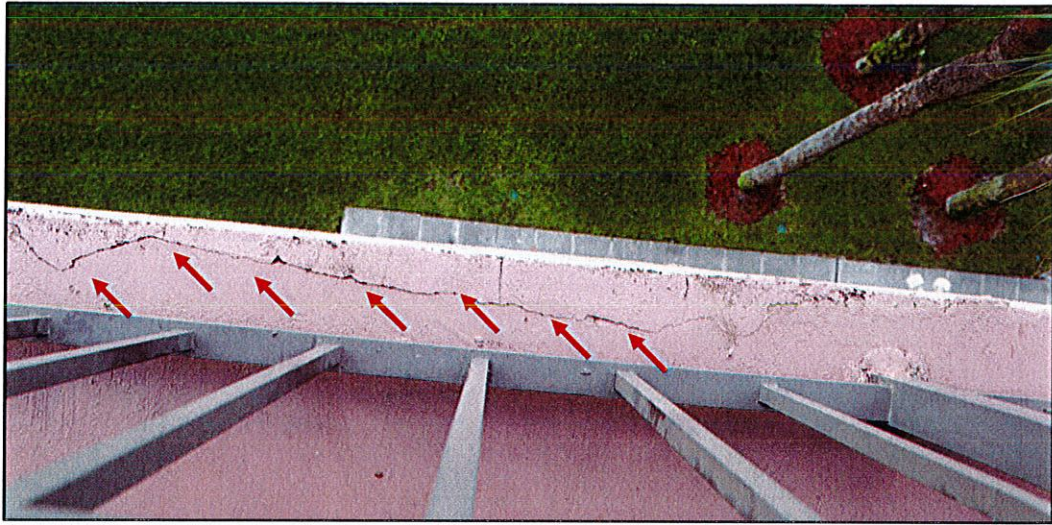
- Balcony floors and exterior edges with imminent concrete spalls. This condition can also be caused by insufficient rebar concrete coverage and by superficial cracks that allow moisture intrusion. Corrosion present at reinforcing steel produces expansion of the diameter of the bar which leads to displacement of surface materials, in this case, concrete (See **Photo #3**). Due to the uncertainty of this condition, it is not possible to predict if or when the finishes will fall. We recommend removing the deficient portions of the finishes or concrete elements from the slab edges or ceilings to prevent pieces of debris from falling down and hurting residents.

**Photo #3.** View of imminent spalling of concrete slab edge observed at edge of floor slab (Unit 505 balcony shown).

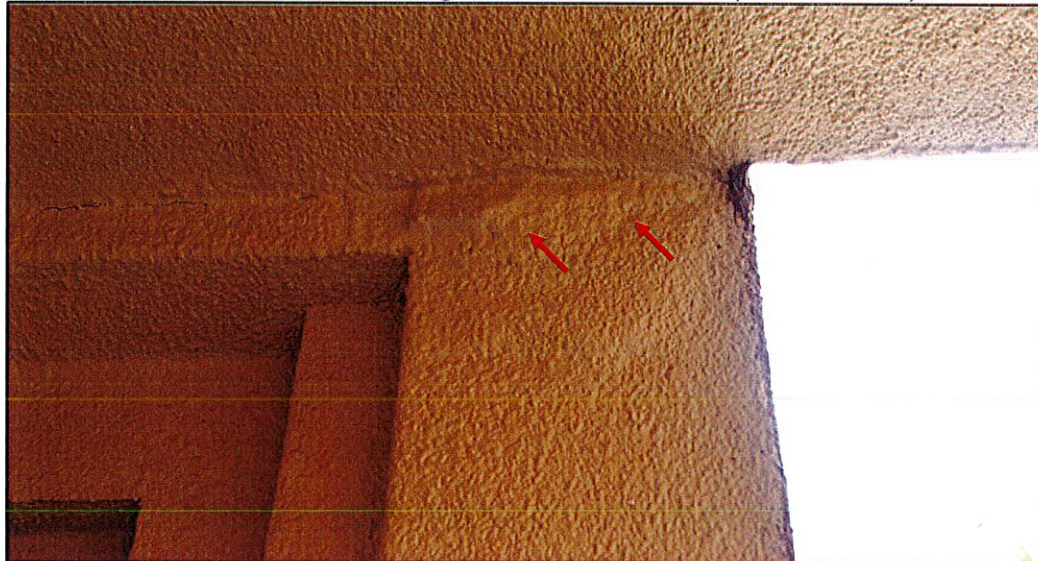
- Balcony ceiling and exterior edges with exposed and corroded reinforcement bars. This condition can be caused by insufficient rebar concrete coverage and by superficial cracks that allow moisture intrusion. Corrosion present at reinforcing steel produces expansion of the diameter of the bar (exfoliation) which leads to displacement (jacking) of surface finishes, such as stucco. This condition can be observed prior to stucco/concrete finishes failure, in the form of bulging of the exterior finishes (see **Photo #4**) and after finishes have been removed or displaced by the expansion of the reinforcing bar due to corrosion (see **Photo #5**).

**Photo #4.** View of deteriorated ceiling stucco finishes, signs of concrete slab spalling due to corroded reinforcing, condition observed at ceiling of unit 305 front corridor.

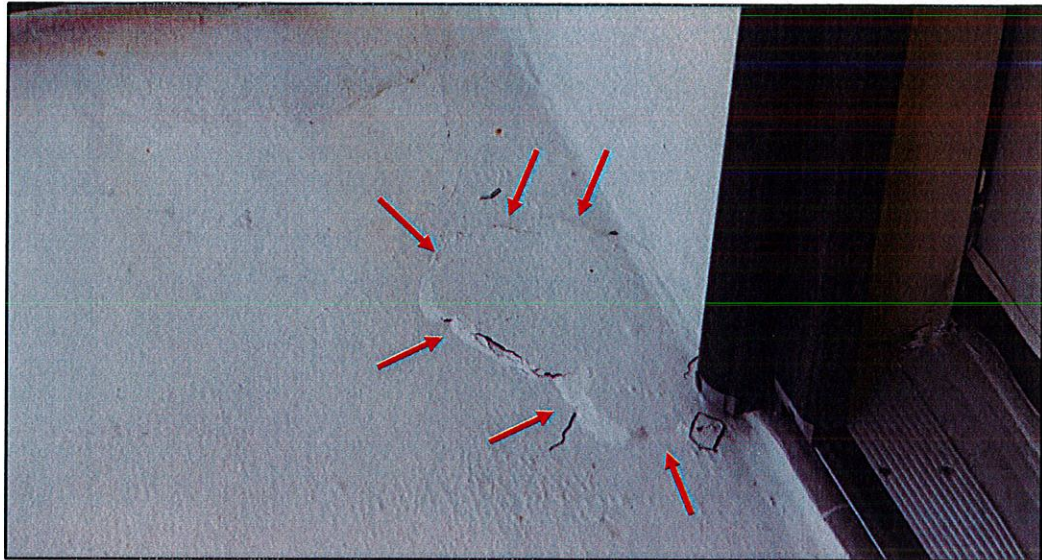
**Photo #5.** View of exterior stucco finishes with localized bulging (Unit 301 front corridor).

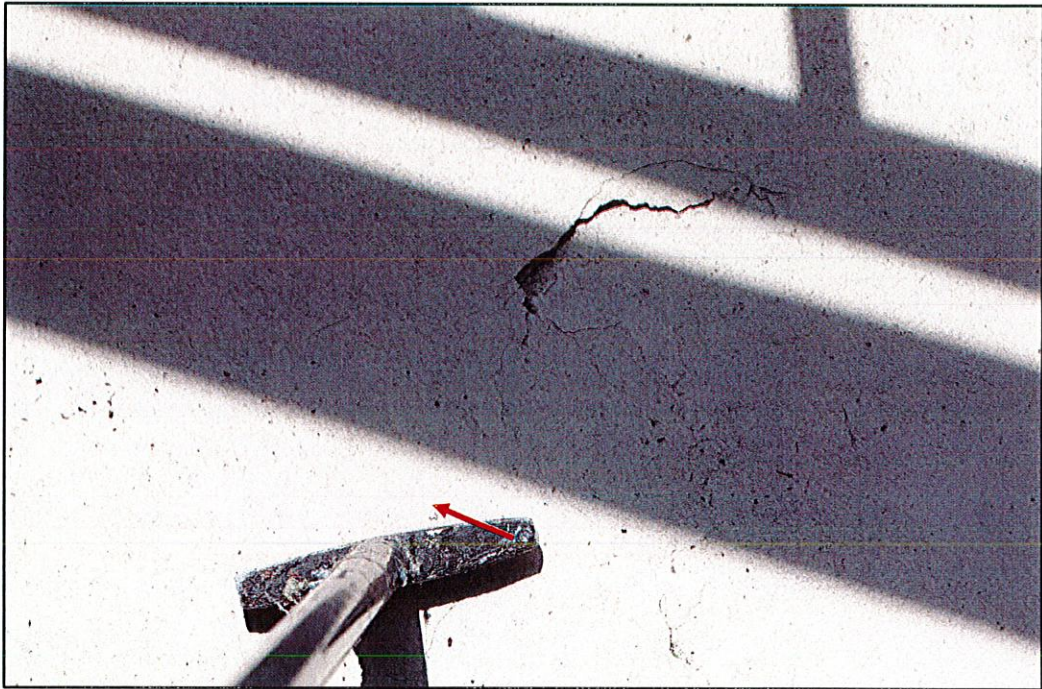
- In certain instances, this condition can be concealed by finishes that have not yet failed or have been covered by previous repairs. This condition requires additional invasive evaluations to clearly define the limits of the deficiency (see **Photo #6**).

**Photo #6.** View of deteriorated floor finishes, signs of concrete slab spalling due to corroded reinforcing, condition observed at floor (Top of slab) of unit 304 balcony.

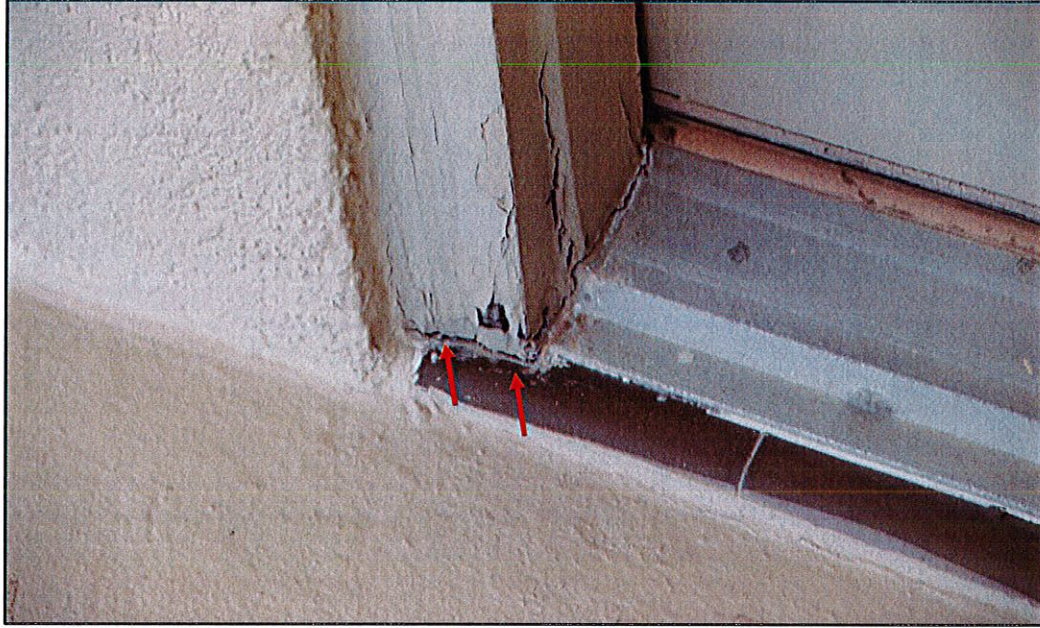
- Exterior sealants around door and window observed with signs of deterioration (cohesion failure). This condition can allow wind driven rain to enter the building envelope and cause damage to the concrete elements as well as damage to interior finishes, personal property and create environmental contamination such as mold and mildew. Sealant shall be removed and replaced preferably with a paintable and UV resistant silicone or hybrid sealant material (See **Photo #7**).

**Photo #7.** View of deteriorated sealant around the front door of unit 503.

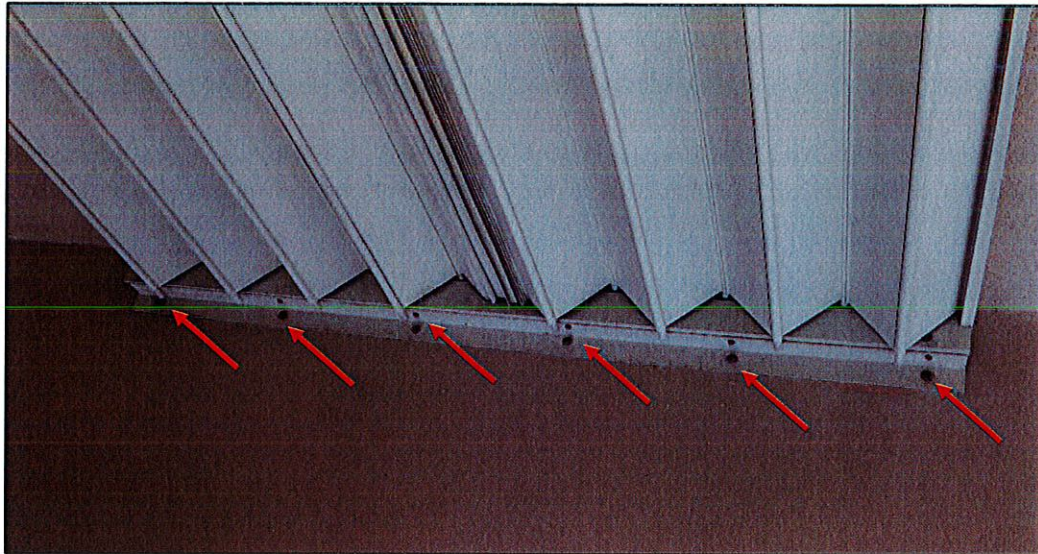
- Anchors for hurricane shutters observed with severe deterioration in the form of corrosion. This condition will compromise the structural integrity of the shutters under severe wind events. Expansion of the anchor due to severe corrosion will damage the concrete and can allow moisture to enter and damage reinforcing bars within the slab. Corroded anchors shall be replaced with corrosion resistant anchors

**Photo #8.** View of deteriorated metal anchors for the hurricane shutters. Observed at several units (Unit 504 shown).

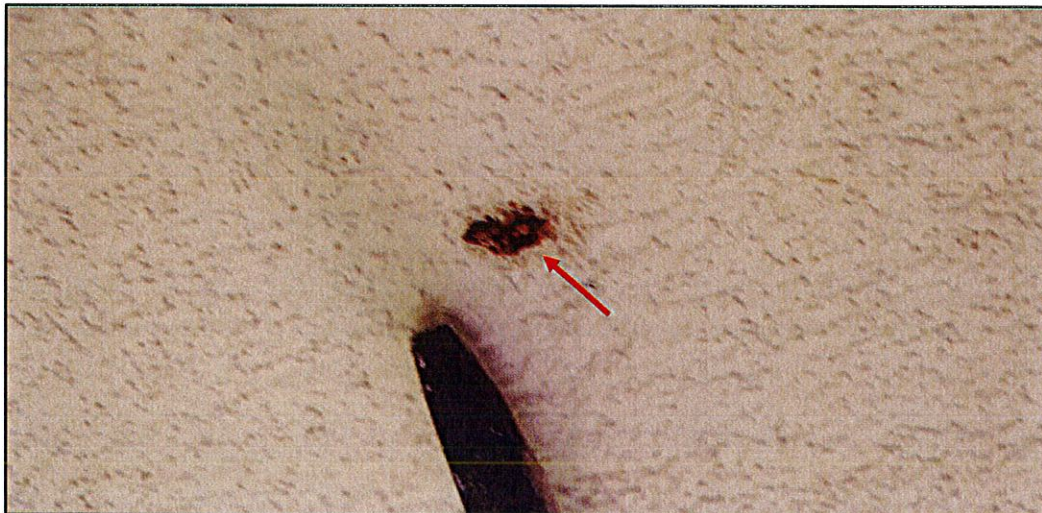
- Balcony ceiling and exterior edges with exposed and corroded metals and corroded steel elements observed at numerous units. This condition refers to metals used in the slab during construction, and also metals installed after construction (see **Photo #9**). Exposed corroded metals shall be removed by grinding metals to a depth of at least 1 inch, coating remains of metal elements in cavity, patching hole and finish or paint to match existing adjacent areas.

**Photo #9.** Close up view of embedded metals within concrete slabs. (Unit 402 balcony shown).

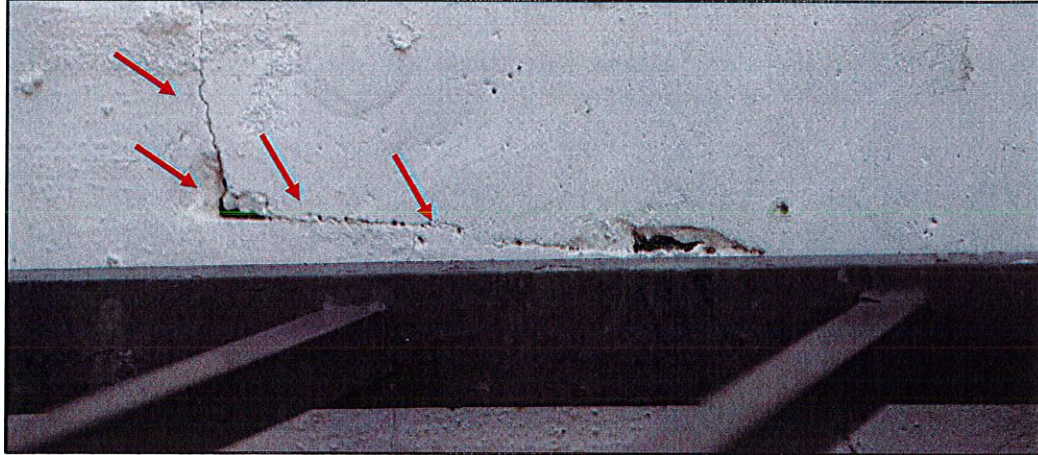
- View of floor slab with unsealed penetrations and floor cracks. Unsealed penetrations allow rainwater to penetrate and usually leads to corrosion of member reinforcement and spalling of concrete (Long term). Unsealed penetrations shall be filled with epoxy materials. The majority of the cracks observed are hairline cracks and do not represent a structural concern, however if

**Photo #10.** View slab cracks with visible corrosion stains and damages to stucco finishes (Unit 202 front corridor shown).

not repaired they can cause future damage to the structure. Cracks shall be routed, sealed and surfaces finished with waterproofing membrane. (See **Photos #10**).
