January 31, 2023

Board of Directors  
The Marina at the Bluffs Condominium Association, Inc.  
1550 Marina Isle Way  
Jupiter, FL 33477

**Re: Milestone Inspection Report – Phase One.  
Building 20.  
2001 Marina Isle Way, Jupiter, FL 33477**

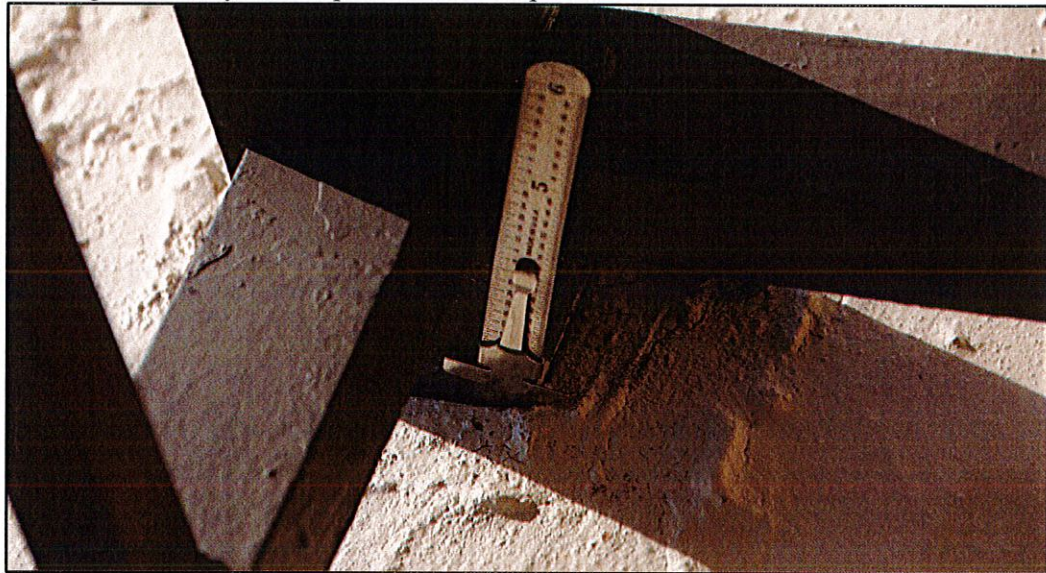
- Balcony guardrail vertical posts with visible separation and/or gaps between the concrete wall of the concrete pocket and the post (see **Photo #1 and #2**). In several locations, a metal ruler was able to be inserted to depths of up to 3 inches. Moisture was observed at the end of the ruler upon removal from the gap. Also, moisture was observed ponding in low spots around the post base. This condition indicates moisture has penetrated the base of the post and could cause damage to the concrete and corrosion of the reinforcement in the slab. Further evidence of moisture within the railing post base can be observed at locations with vegetation and/or organic growth (See **Photos #3 and #4**). Also, at several locations, the degree of deterioration of the post base grout allows unwanted lateral movement of the guardrail system top member or top rail.

**Photo #1.** View of post base deteriorated grout and metal post with signs of corrosion damage (unit 501 front corridor).

- At locations where concrete/grout cracks, delamination, and/or spalling is identified, remove all grout to expose the embedded portion of railing post and remove adjoining cracked, delaminated and/or spalled concrete.
- Remove all grout, corrosion, scale, slurry, and other bond-inhibiting material from exposed railing post by thorough wire-brushing or high-pressure water blasting.
- Install weep hole at post base above finishes.
- Replace removed concrete non-shrink non-metallic grout around the post.
- Prime railing posts to a minimum of 1-inch above the finish concrete surface to provide adequate grout-to-aluminum isolation.
- Seal around post base with sealant.
- Plaster finish and paint the repair area to match the surroundings.

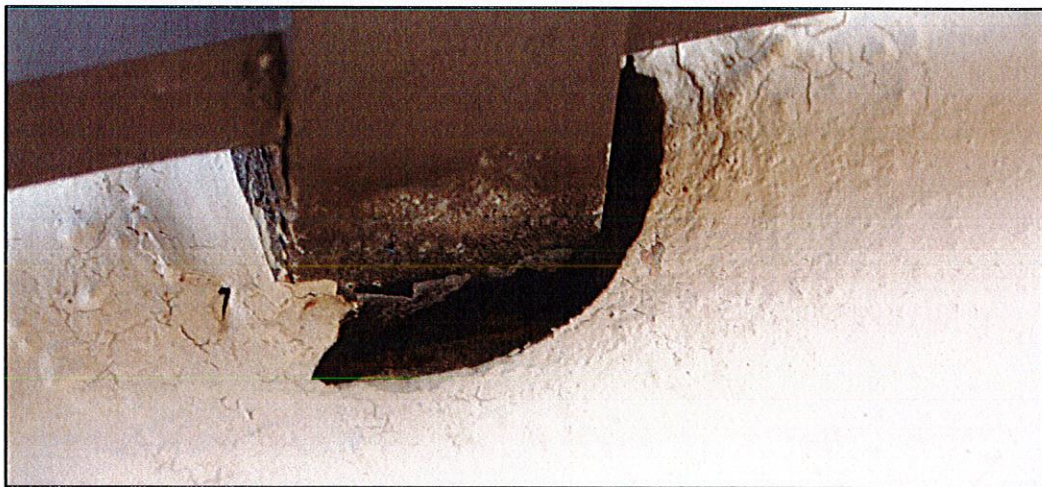
**Photo #2.** View of post base deteriorated grout and metal post with signs of corrosion damage (unit 402 front corridor).

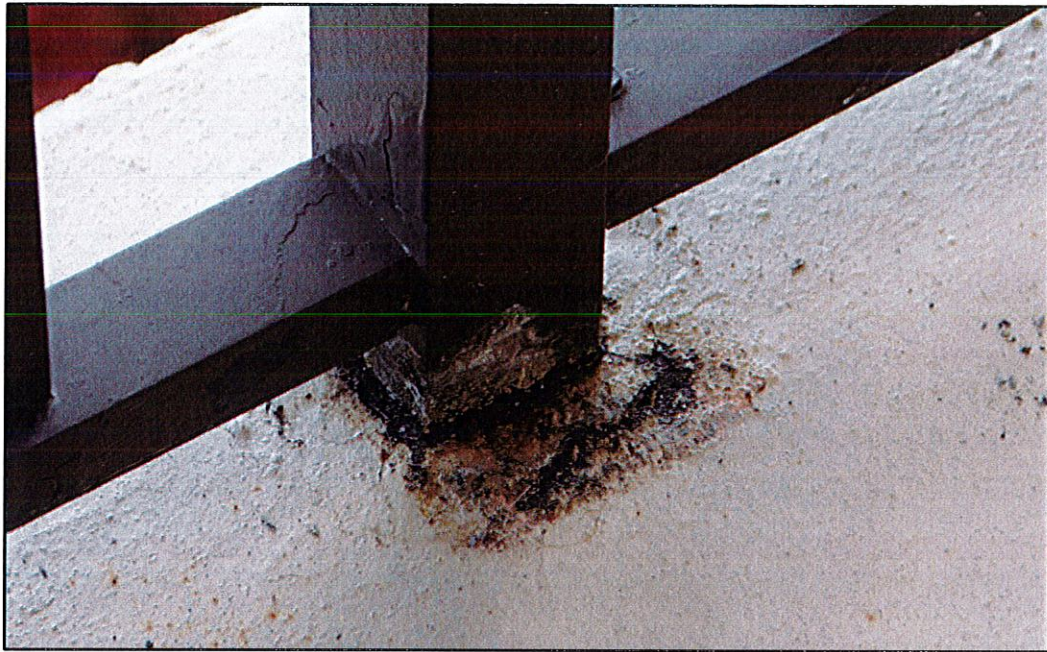
Photo #3. View of post base deteriorated grout and signs of organic growth (unit 202 front corridor).

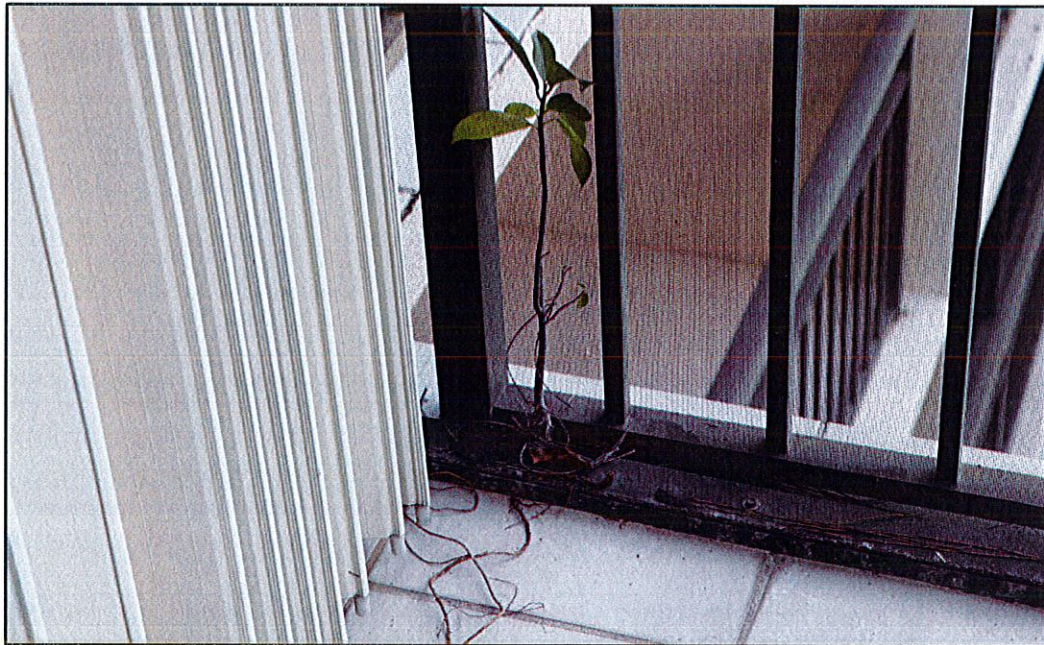
Photo #4. View of post base deteriorated grout and vegetation growth (unit 405 rear balcony).

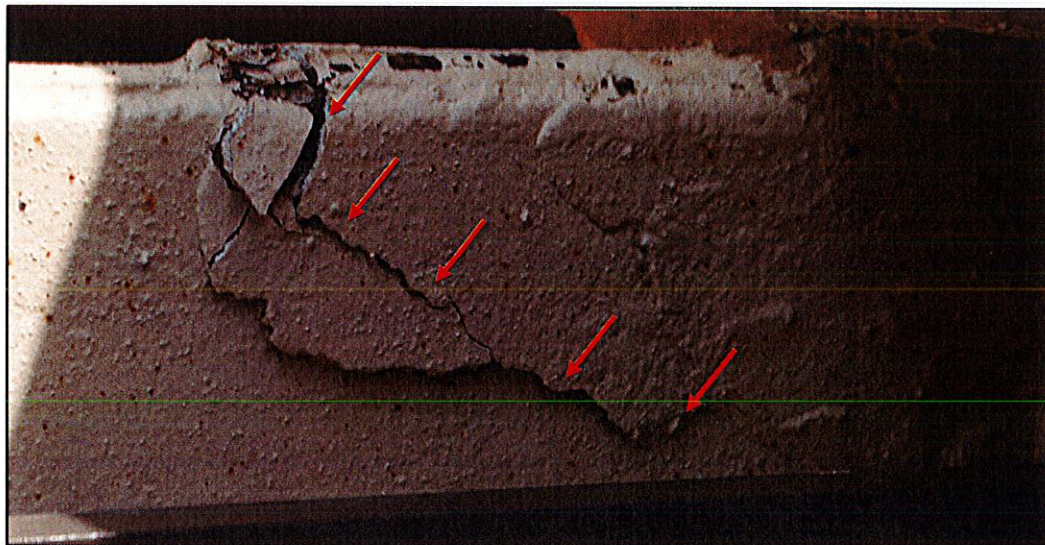
- Balcony floors and exterior edges with imminent concrete spalls. This condition can also be caused by insufficient rebar concrete coverage and by superficial cracks that allow moisture intrusion. Corrosion present at reinforcing steel produces expansion of the diameter of the bar which leads to displacement of surface materials, in this case, concrete (See **Photos #5 and #6**). Due to the uncertainty of this condition, it is not possible to predict if or when the finishes will fall. We recommend removing the deficient portions of the finishes or concrete elements from the slab edges or ceilings to prevent pieces of debris from falling down and hurting residents.

**Photo #5.** View of imminent spalling of concrete slab edge observed at floor of unit 503 front corridor.

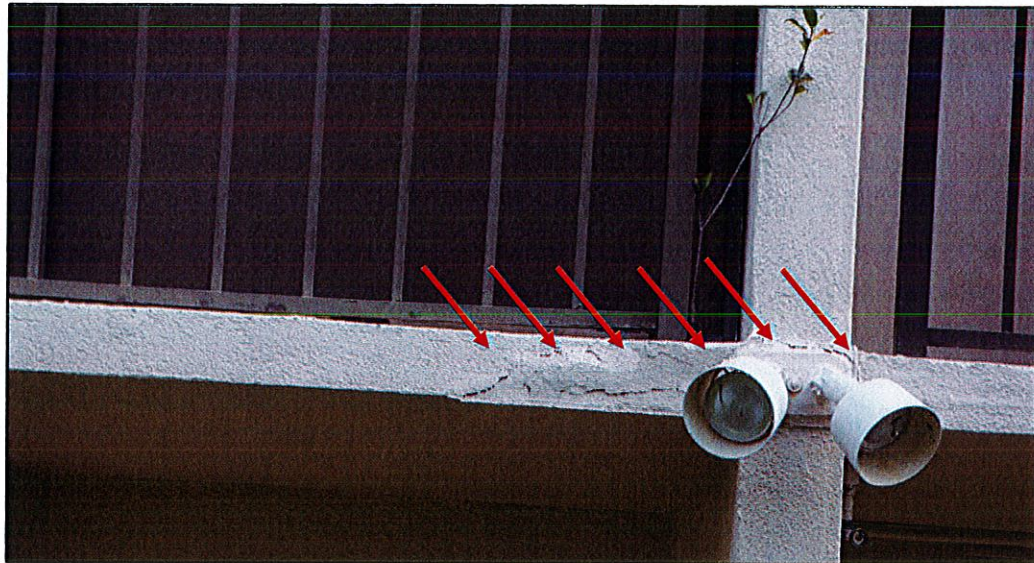
**Photo #6.** View of imminent spalling of concrete slab edge observed at edge of floor slab (Between units 103 and 104 balcony).

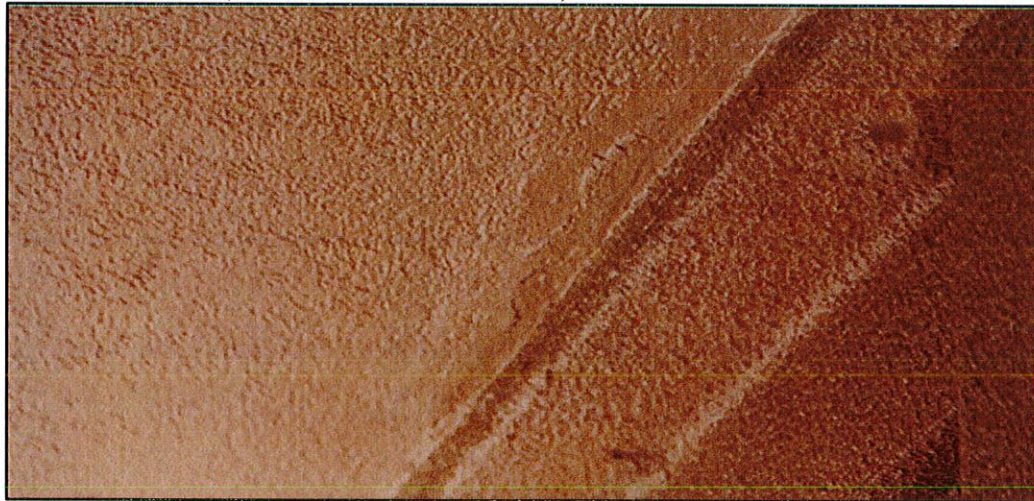
- Balcony ceiling and exterior edges with exposed and corroded reinforcement bars. This condition can be caused by insufficient rebar concrete coverage and by superficial cracks that allow moisture intrusion. Corrosion present at reinforcing steel produces expansion of the diameter of the bar (exfoliation) which leads to displacement (jacking) of surface finishes, such as stucco. This condition can be observed prior to stucco/concrete finishes failure, in the form of bulging of the exterior finishes (see **Photos #7, #8 and #9**).

**Photo #7.** View of deteriorated ceiling stucco finishes, signs of concrete slab spalling due to corroded reinforcing, condition observed at ceiling in front of stairs between units 105 and 106.

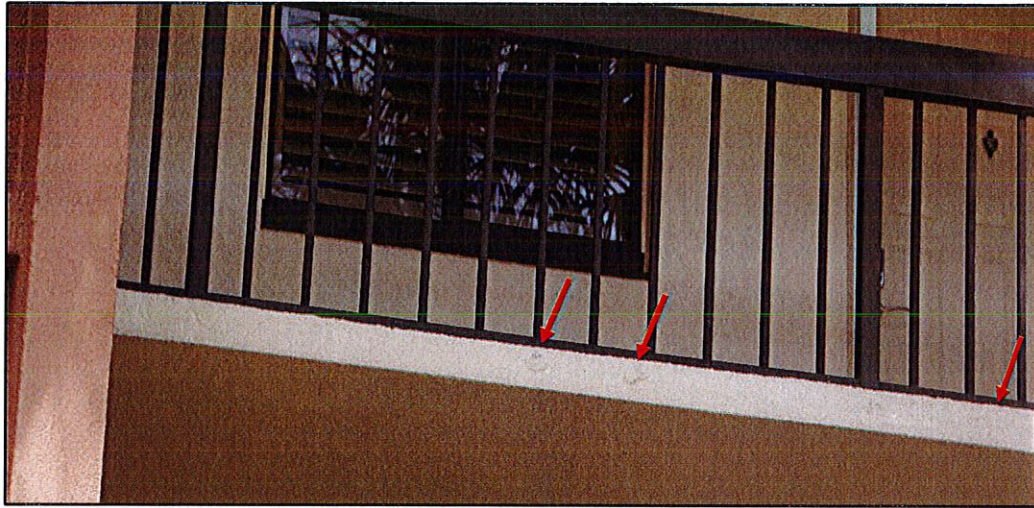
Photo #8. View of exterior stucco finishes with localized bulging (Ceiling of unit 206 front corridor).

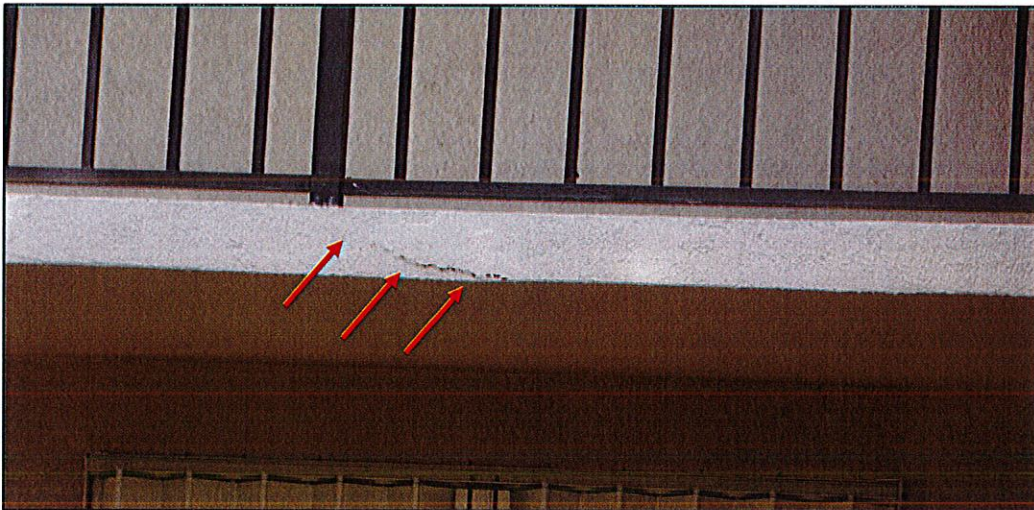
Photo #9. View of bulging stucco finishes observed at ceiling of unit 205 (front corridor).

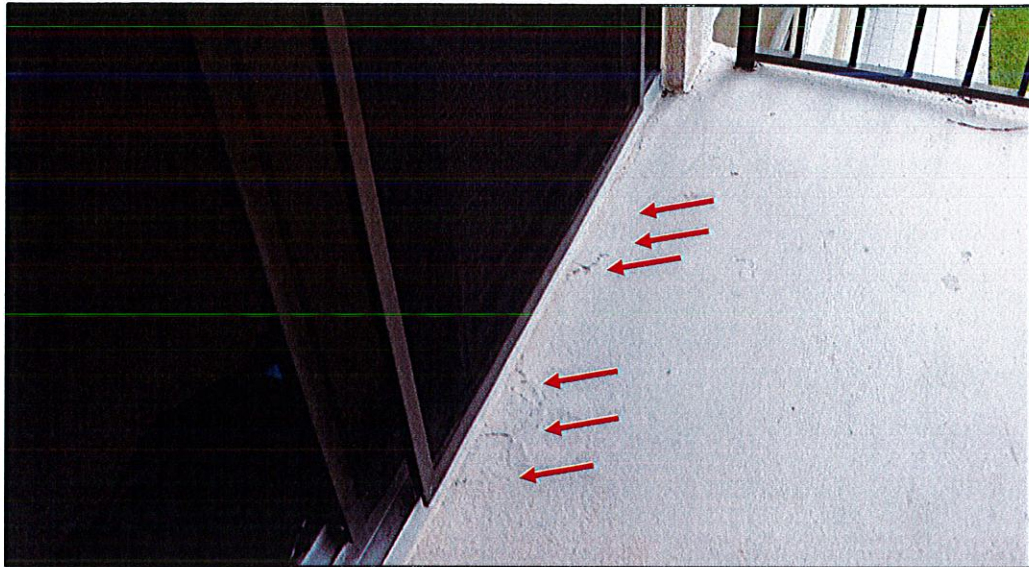
- In certain instances, this condition can be concealed by finishes that have not yet failed or have been covered by previous repairs. This condition requires additional invasive evaluations to clearly define the limits of the deficiency (see **Photos #10 & #11**).

**Photo #10.** View of deteriorated floor finishes, signs of concrete slab spalling due to corroded reinforcing, condition observed at floor (Top of slab) of unit 305 balcony.

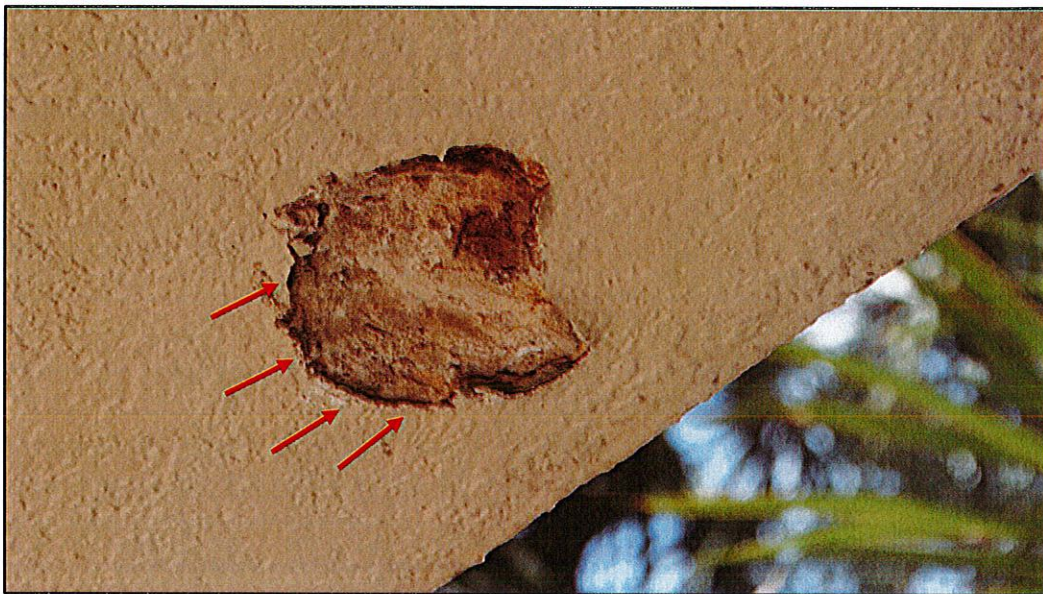
**Photo #11.** View of deteriorated ceiling finishes, signs of concrete slab spalling and moisture intrusion, location of failed finishes matches with the location of the railing vertical post above (Ceiling of unit 104 front corridor)

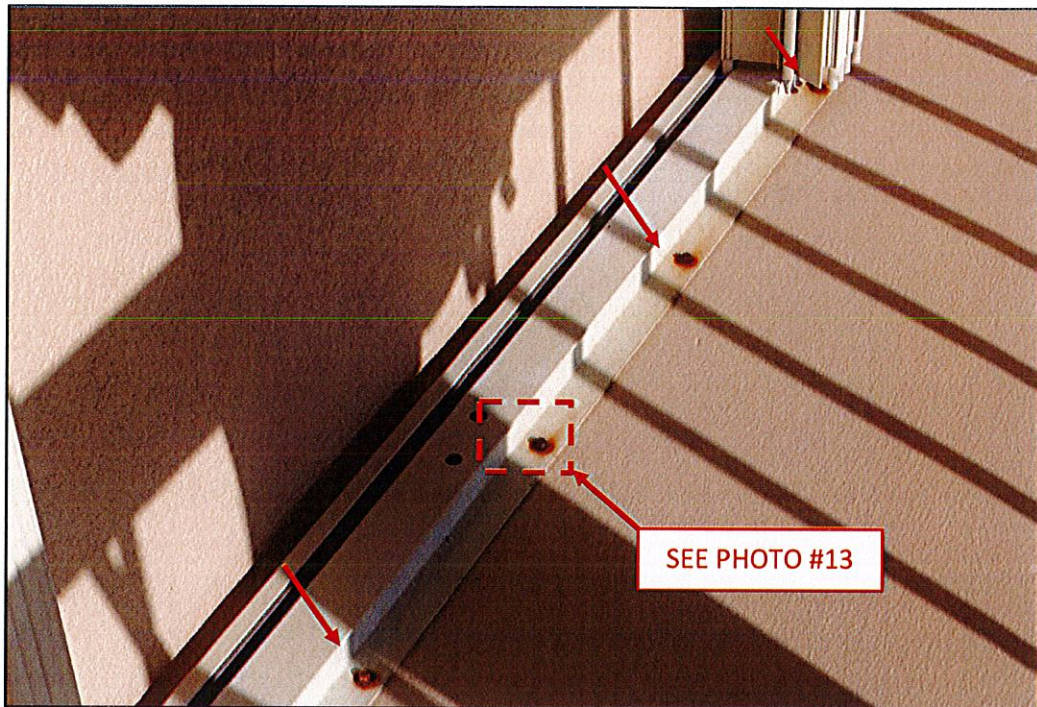
- Anchors for hurricane shutters observed with severe deterioration in the form of corrosion. This condition will compromise the structural integrity of the shutters under severe wind events. Expansion of the anchor due to severe corrosion will damage the concrete and can allow moisture to enter and damage reinforcing bars within the slab. Corroded anchors shall be replaced with corrosion resistant anchors

Photo #12. View of deteriorated metal anchors for the hurricane shutters. Observed at several units (Unit 504 shown).

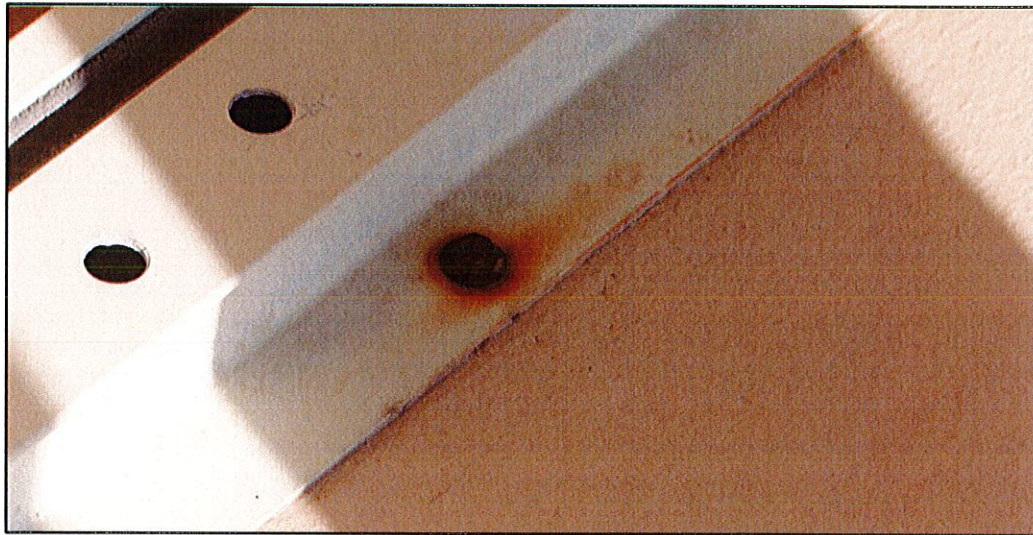
Photo #13. Close up view of deteriorated metal anchors for the hurricane shutters. (Unit 504 shown).

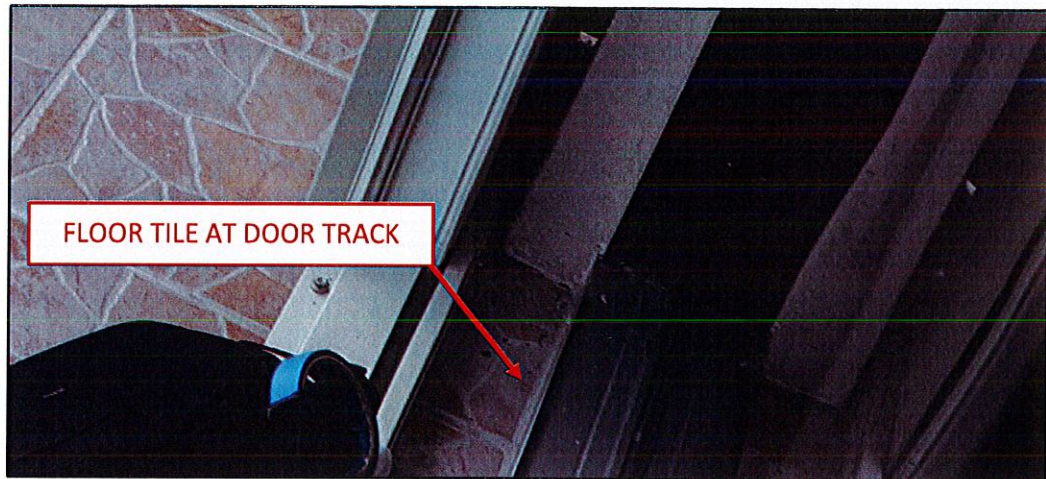
- Balcony units with floor finishes (i.e. tile) installed higher than the window and sliding glass door frames and tracks. At many of the locations, water accumulates with no way to drain out. This condition can potentially allow wind-driven water to deposit along the recessed tracks and penetrate the interior of the unit through cracks, unsealed joints or frame anchors (see **Photo #14**). This condition shall be remediated by removing finishes or providing proper drainage weep holes.

Photo #14. View of floor finishes installed above the sliding glass doors. (Unit 403 balcony shown).

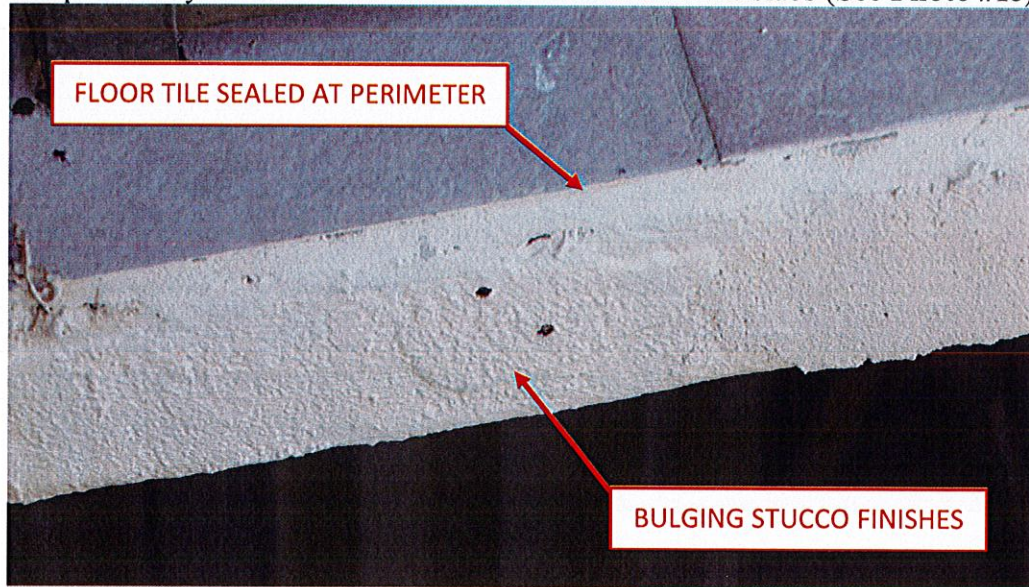
- Also, it was observed, at private balcony units with floor finishes (i.e. tile) installed up to the edge of the slab and the edge of the tile perimeter completely sealed preventing water that enters through grout lines or cracks to escape. In many cases water accumulates with no way to drain out damaging the finishes and potentially the concrete and reinforcement within the slabs (See **Photo #15**).

Photo #15. View of floor finishes (tile) with edges sealed (Unit 505 balcony shown).

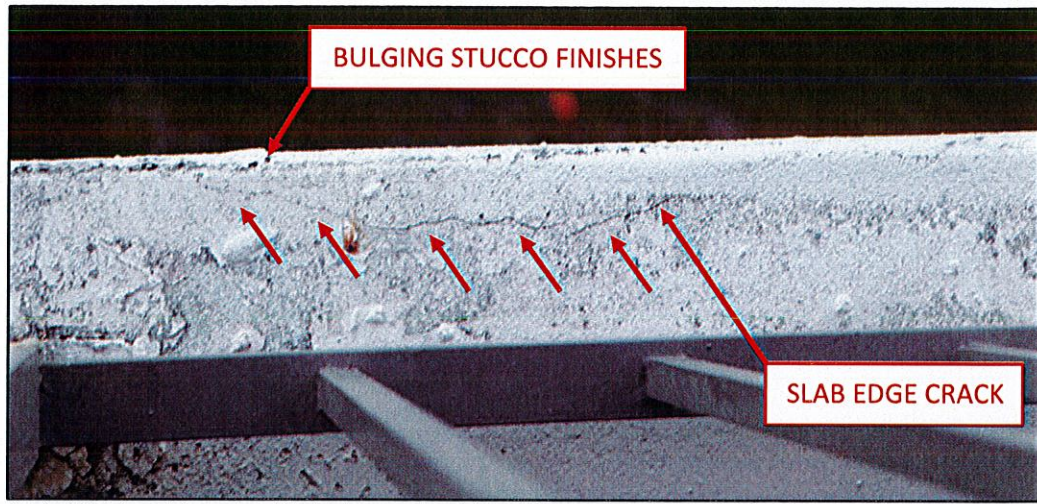
- Floor slab with unsealed penetrations and floor cracks. Unsealed penetrations allow rainwater to penetrate and usually leads to corrosion of member reinforcement and spalling of concrete (Long term). Unsealed penetrations shall be filled with epoxy materials. The majority of the cracks observed are hairline cracks and do not represent a structural concern, however if not repaired they can cause future damage to the structure. Cracks shall be routed, sealed and surfaces finished with waterproofing membrane. (See **Photos #16 through 20**).

Photo #16. View slab cracks with visible corrosion stains and damages to stucco finishes (Unit 502 balcony shown).

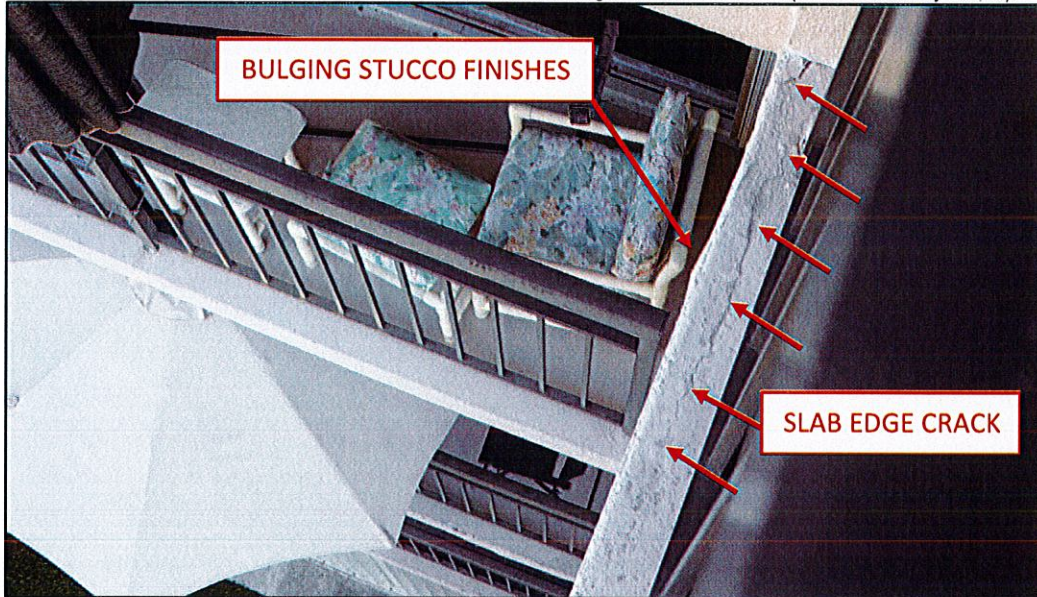
Photo #17. View slab cracks with visible corrosion stains and damage to stucco finishes (Unit 504 balcony shown).

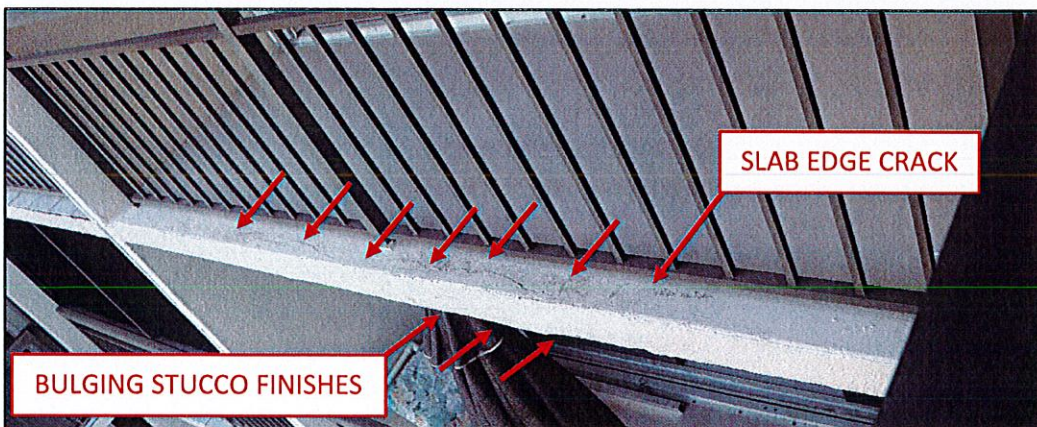
Photo #18. View slab cracks with visible corrosion stains and damage to stucco finishes (Unit 504 balcony shown).

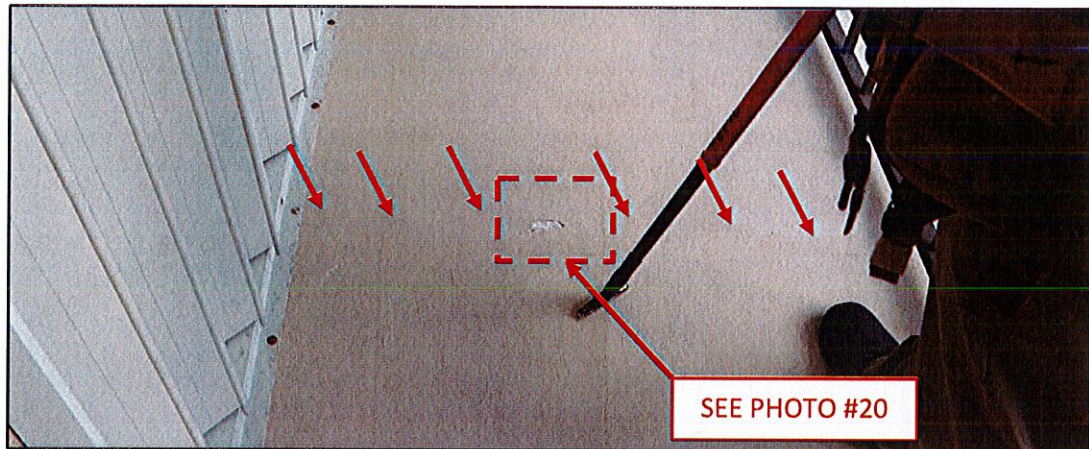
Photo #19. View of slab with visible cracks (Unit 204 front corridor shown).

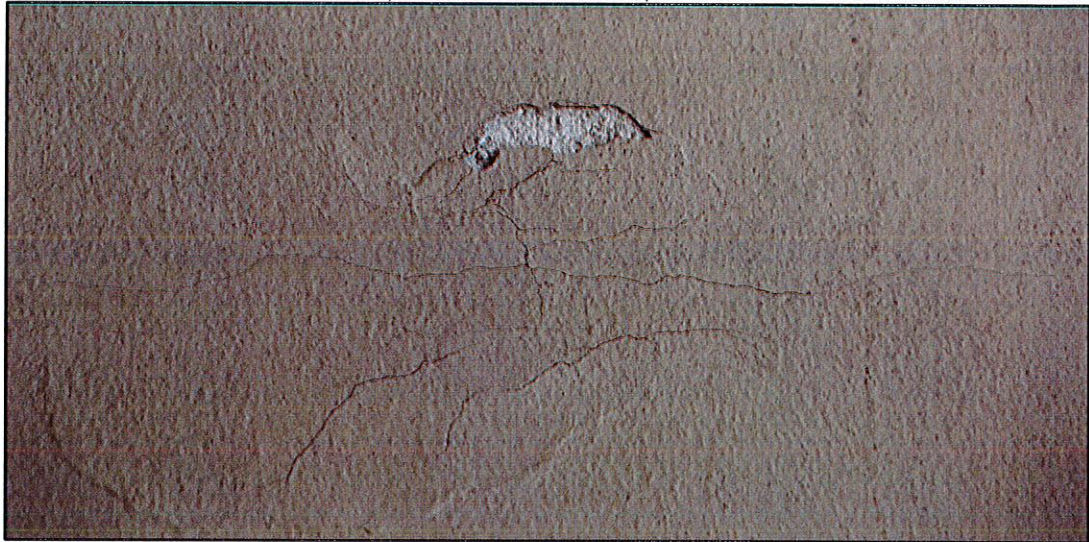
Photo #20. Close up view of slab crack and finished spalling exposing concrete below (Unit 204 front corridor shown).
