January 31, 2023.

Board of Directors  
The Marina at the Bluffs Condominium Association, Inc.  
1550 Marina Isle Way  
Jupiter, FL 33477

**Re: Milestone Inspection Report – Phase One.  
Building 21.  
2101 Marina Isle Way, Jupiter, FL 33477**

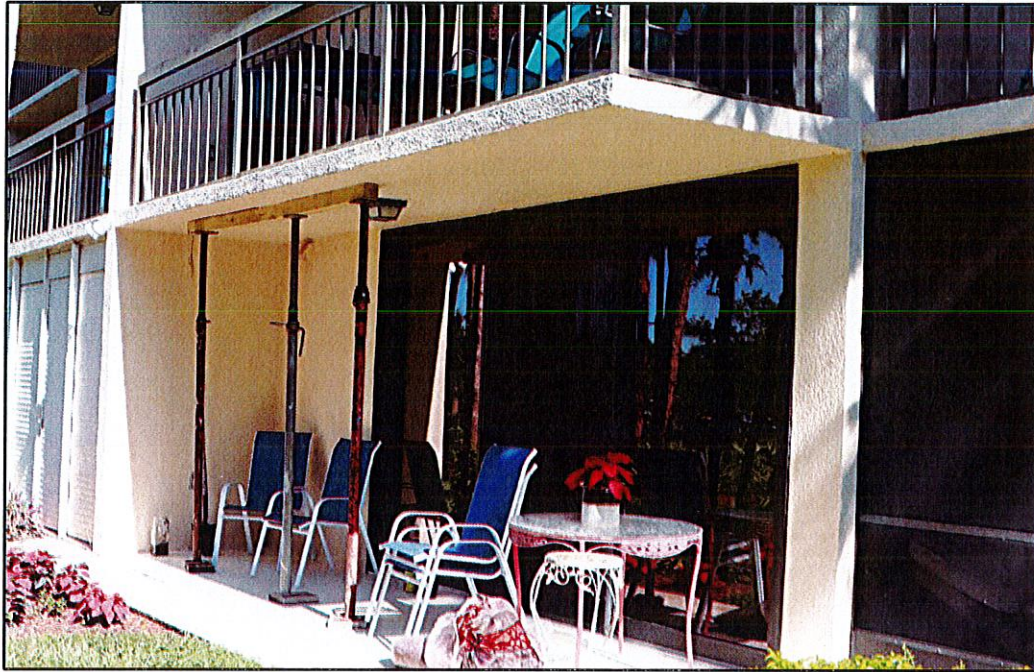
- It was observed at the balcony slab of unit 201 several superficial cracks parallel to the edge of the slab (long side). Also it appeared that the slab was deflecting when multiple people walked near the edge of the cantilevered portion. In a abundance of caution, the balcony was temporarily and remains shored to date (see **Photo #1**).

Photo #1. View of temporary post shores at balcony of unit 201.

- Additional investigation is required as part of the “Milestone Inspection” phase 2, which will be conducted at a later date (within the next 90 days). Epic has requested the Association to provide existing plans for the building to perform the necessary review and analysis of the existing field condition discussed above.

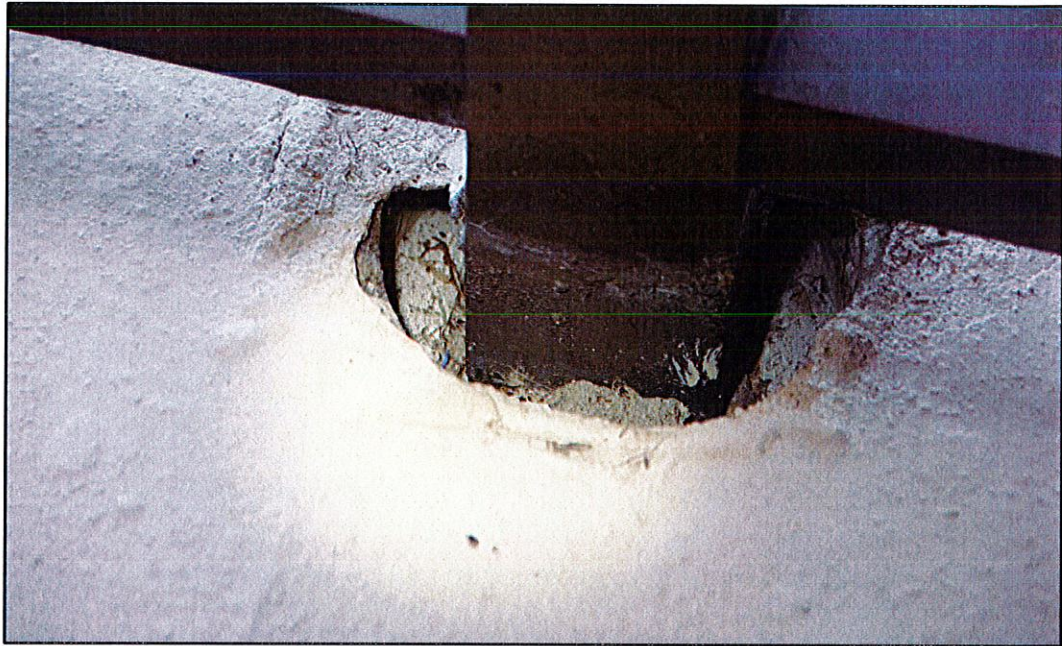
- Balcony guardrail vertical posts with visible separation and/or gaps between the concrete wall of the concrete pocket and the post (see **Photo #2**). In several locations, a metal ruler was able to be inserted to depths of up to 2 inches. Moisture was observed at the end of the ruler upon removal from the gap. Also, moisture was observed ponding in low spots around the post base. This condition indicates moisture has penetrated the base of the post and could cause damage to the concrete and corrosion of the reinforcement in the slab. Further evidence of moisture within the railing post base can be observed at locations with vegetation and/or organic growth (See **Photo #3**). Also, at several locations, the degree of deterioration of the post base grout allows unwanted lateral movement of the guardrail system top member or top rail.

Photo #2. View of post base missing grout (unit 205 front corridor).

Since the existing guardrail system is not “current” code compliant, the guardrail system cannot be removed or un-installed from the current location. If the guardrail is removed, a new current code compliant system shall be installed in its place. For that reason, we recommend the following remedial actions:

- At locations where concrete/grout cracks, delamination, and/or spalling is identified, remove all grout to expose the embedded portion of railing post and remove adjoining cracked, delaminated and/or spalled concrete.
- Remove all grout, corrosion, scale, slurry, and other bond-inhibiting material from exposed railing post by thorough wire-brushing or high-pressure water blasting.

- Install weep hole at post base above finishes.
- Replace removed concrete non-shrink non-metallic grout around the post.
- Prime railing posts to a minimum of 1-inch above the finish concrete surface to provide adequate grout-to-aluminum isolation.
- Seal around post base with sealant.
- Plaster finish and paint the repair area to match the surroundings.

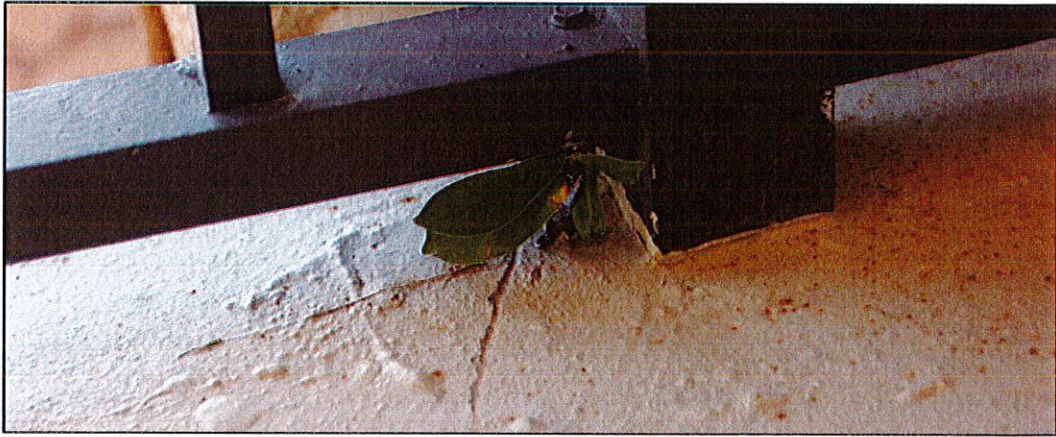
Photo #3. View of post base with vegetation growth (unit 304 front corridor).

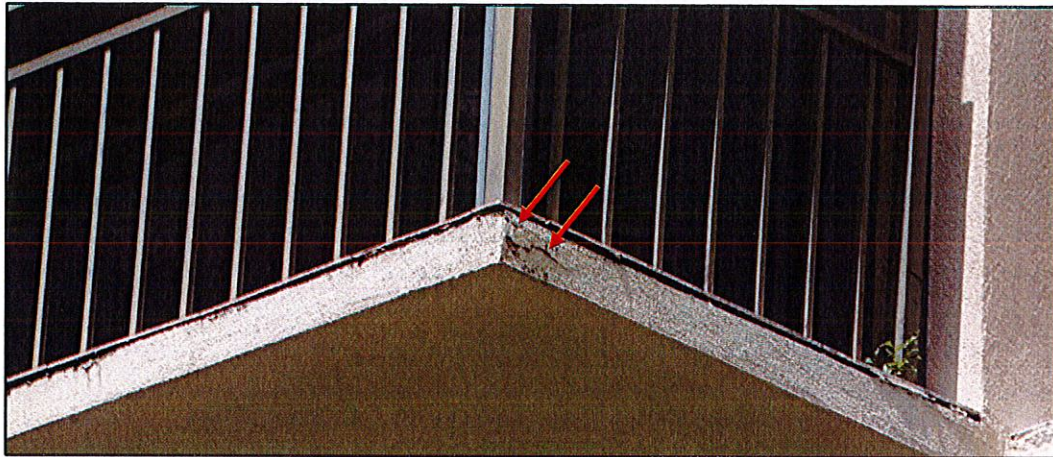
- Balcony floors and exterior edges with imminent concrete spalls. This condition can also be caused by insufficient rebar concrete coverage and by superficial cracks that allow moisture intrusion. Corrosion present at reinforcing steel produces expansion of the diameter of the bar which leads to displacement of surface materials, in this case, concrete (See **Photos #4 and #5**). Due to the uncertainty of this condition, it is not possible to predict if or when the finishes will fall. We recommend removing the deficient portions of the finishes or concrete elements from the slab edges or ceilings to prevent pieces of debris from falling down and hurting residents.

Photo #4. View of imminent spalling of concrete slab edge observed at floor of unit 301 balcony.

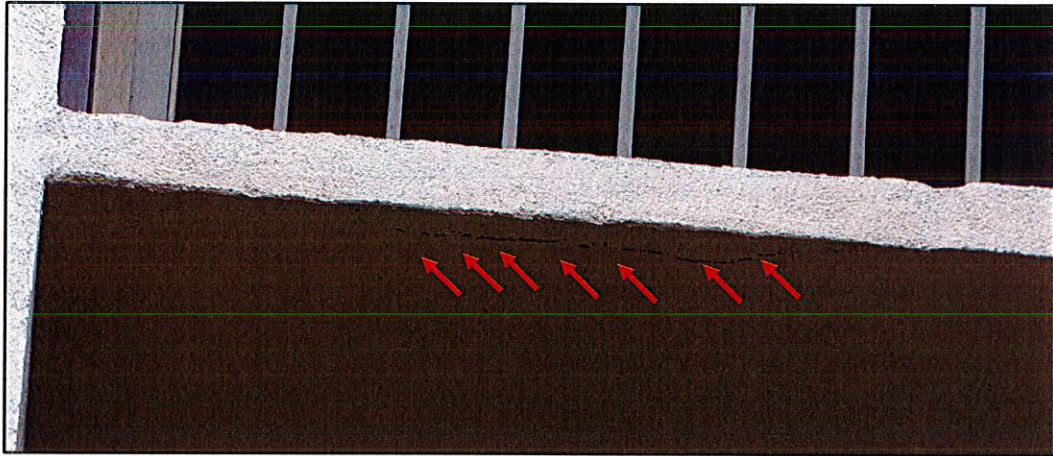
Photo #5. View of imminent spalling of concrete slab edge observed at edge of floor slab (Unit 402 balcony shown).

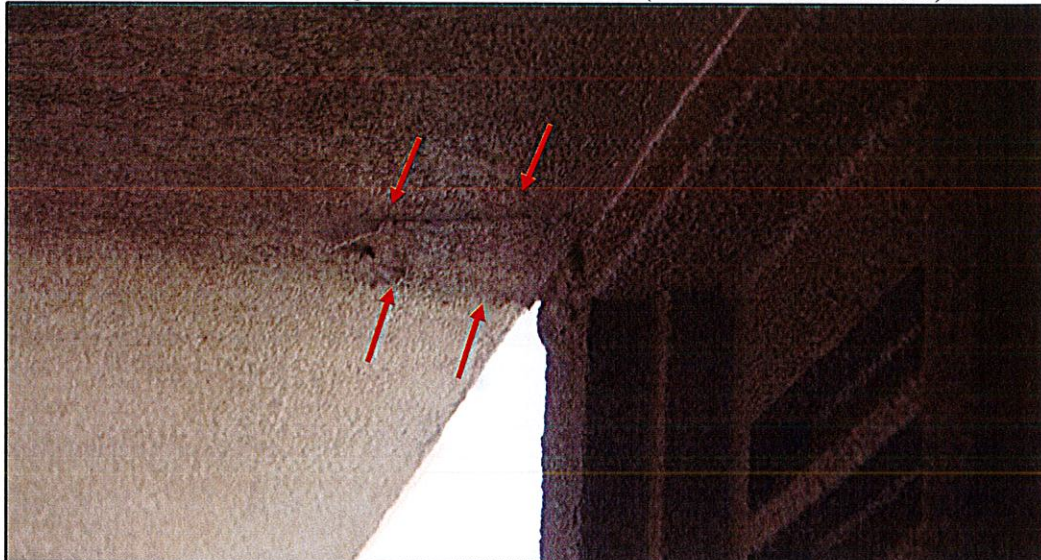
- Balcony ceiling and exterior edges with exposed and corroded reinforcement bars. This condition can be caused by insufficient rebar concrete coverage and by superficial cracks that allow moisture intrusion. Corrosion present at reinforcing steel produces expansion of the diameter of the bar (exfoliation) which leads to displacement (jacking) of surface finishes, such as stucco. This condition can be observed prior to stucco/concrete finishes failure, in the form of bulging of the exterior finishes and after finishes have been removed or displaced by the expansion of the reinforcing bar due to corrosion (see **Photos #6 and #7**).

Photo #6. View of deteriorated ceiling stucco finishes, signs of concrete slab spalling due to corroded reinforcing, condition observed at ceiling of unit 402 front corridor.

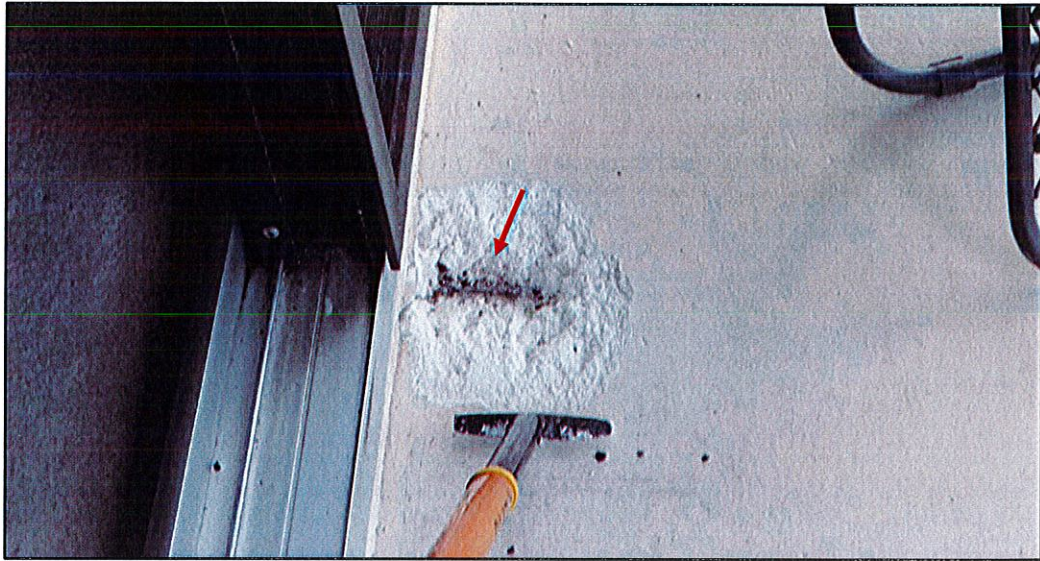
**Photo #7.** View of spalled concrete due to rebar corrosion (Unit 405 balcony shown).

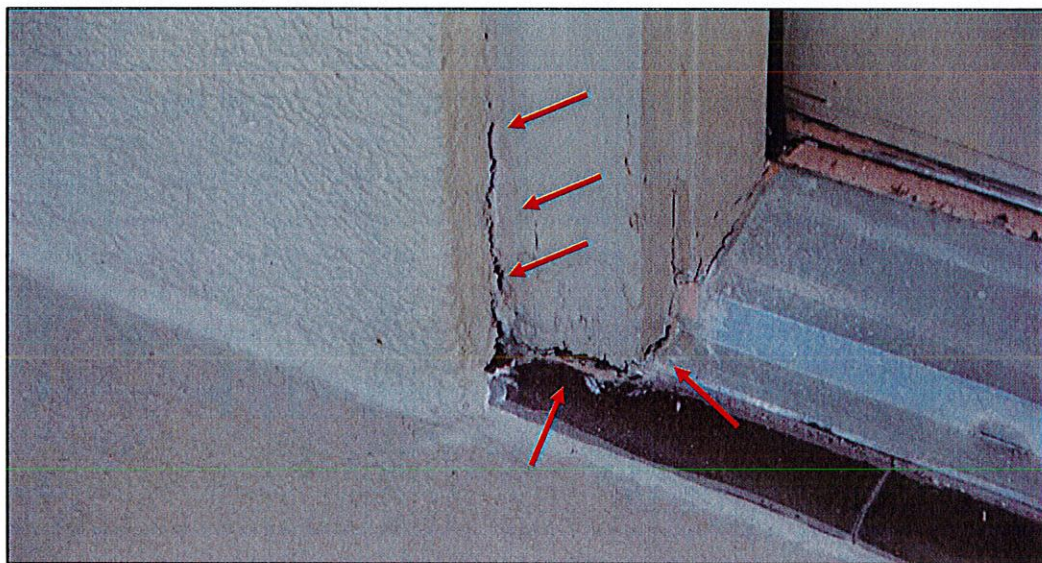
- In certain instances, this condition can be concealed by finishes that have not yet failed or have been covered by previous repairs. This condition requires additional invasive evaluations to clearly define the limits of the deficiency.
- Exterior sealants around door and window observed with signs of deterioration (cohesion failure). This condition can allow wind driven rain to enter the building envelope and cause damage to the concrete elements as well as damage to interior finishes, personal property and create environmental contamination such as mold and mildew. Sealant shall be removed and replaced preferably with a paintable and UV resistant silicone or hybrid sealant material (See **Photo #8**).

**Photo #8.** View of deteriorated sealant around the front door of unit 402.

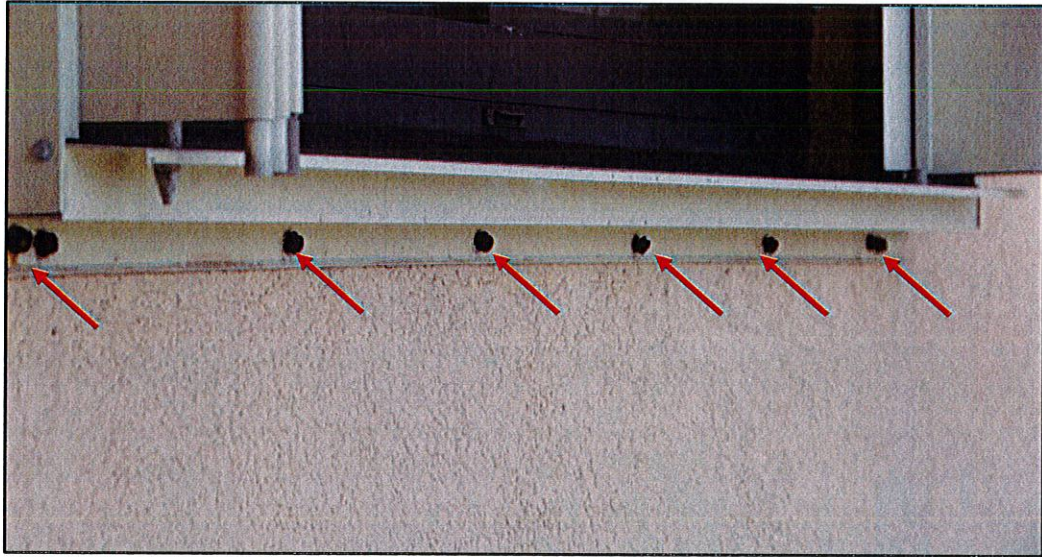
- Anchors for hurricane shutters observed with severe deterioration in the form of corrosion. This condition will compromise the structural integrity of the shutters under severe wind events. Expansion of the anchor due to severe corrosion will damage the concrete and can allow moisture to enter and damage reinforcing bars within the slab (see **Photo #9**). Corroded anchors shall be replaced with corrosion resistant anchors.

**Photo #9.** View of deteriorated metal anchors for the hurricane shutters. Observed at several units (Unit 506 shown).

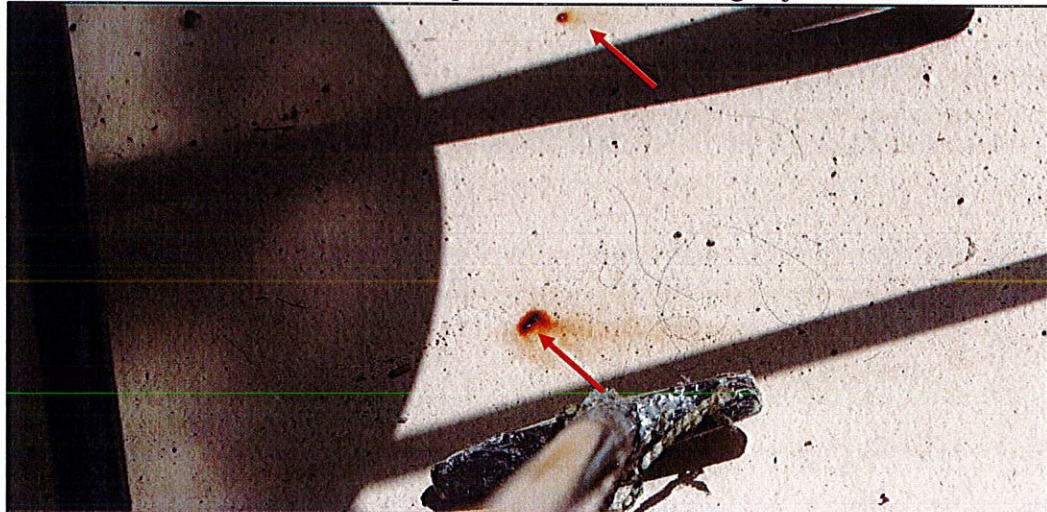
- Balcony ceiling and exterior edges with exposed and corroded metals and corroded steel elements observed at numerous units. This condition refers to metals used in the slab during construction, and also metals installed after construction (see **Photo #10**). Exposed corroded metals shall be removed by grinding metals to a depth of at least 1 inch, coating remains of metal elements in cavity, patching hole and finish or paint to match existing adjacent areas.

**Photo #10.** Close up view of embedded metals within concrete slabs. (Unit 205 balcony shown).

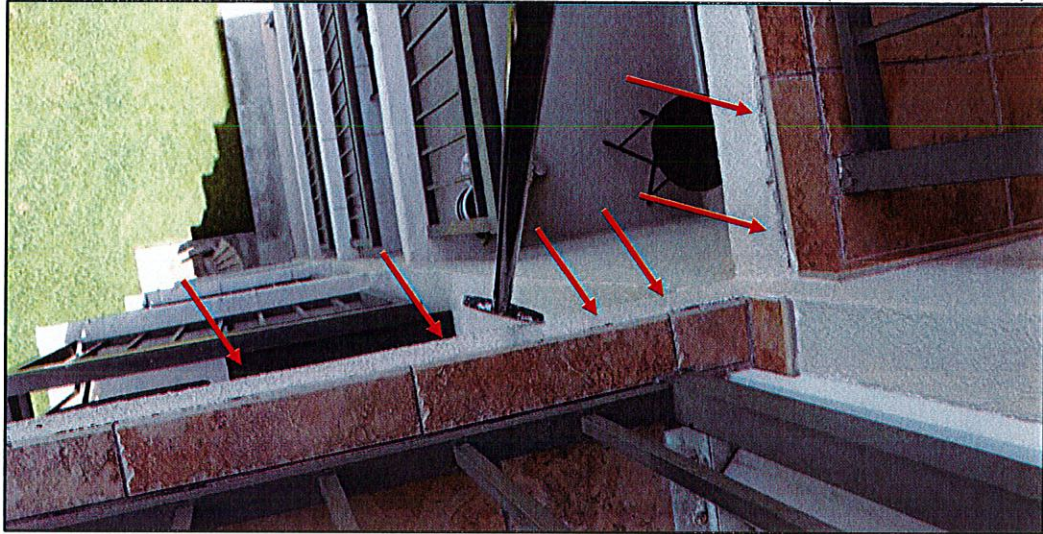
- Also, it was observed, at private balcony units with floor finishes (i.e. tile) installed up to the edge of the slab and the edge of the tile perimeter completely sealed preventing water that enters through grout lines or cracks to escape. In many cases water accumulates with no way to drain out damaging the finishes and potentially the concrete and reinforcement within the slabs (See **Photo #11**).

Photo #11. View of floor finishes (tile) with edges sealed (Unit 503 balcony shown).
