January 31, 2023

Board of Directors  
The Marina at the Bluffs Condominium Association, Inc.  
1550 Marina Isle Way  
Jupiter, FL 33477

**Re: Milestone Inspection Report – Phase One.  
Building 22.  
2201 Marina Isle Way, Jupiter, FL 33477**

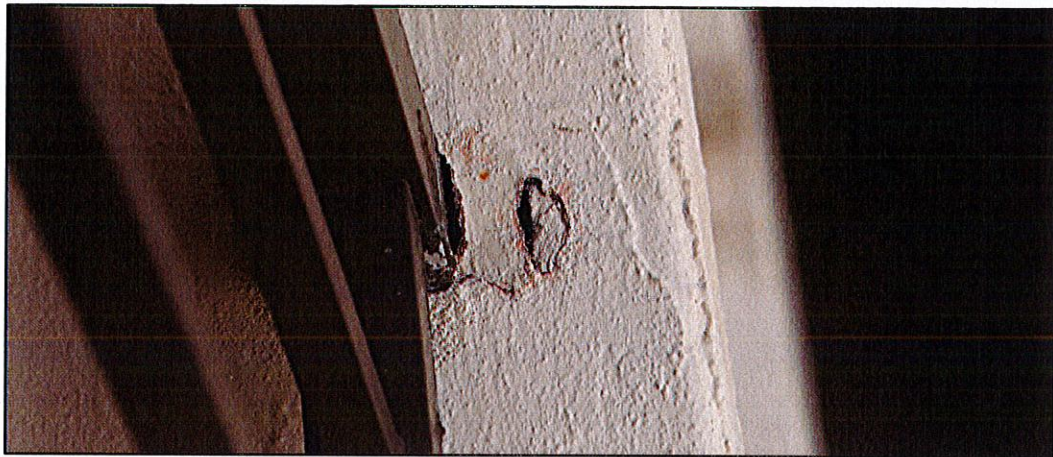
- Balcony guardrail vertical posts with visible separation and/or gaps between the concrete wall of the concrete pocket and the post (see **Photo #1**). Also, moisture was observed ponding in low spots around the post base. This condition indicates moisture has penetrated the base of the post and could cause damage to the concrete and corrosion of the reinforcement in the slab. Further evidence of moisture within the railing post base can be observed at locations with vegetation and/or organic growth (See **Photos #2 through #4**). Also, at several locations, the degree of deterioration of the post base grout allows unwanted lateral movement of the guardrail system top member or top rail.

**Photo #1.** View of post base deteriorated grout and metal post with signs of corrosion damage (unit 502 front corridor).

Since the existing guardrail system is not “current” code compliant, the guardrail system cannot be removed or un-installed from the current location. If the guardrail is removed, a new current code compliant system shall be installed in its place. For that reason, we recommend the following remedial actions:

- At locations where concrete/grout cracks, delamination, and/or spalling is identified, remove all grout to expose the embedded portion of railing post and remove adjoining cracked, delaminated and/or spalled concrete.

- Remove all grout, corrosion, scale, slurry, and other bond-inhibiting material from exposed railing post by thorough wire-brushing or high-pressure water blasting.
- Install weep hole at post base above finishes.
- Replace removed concrete non-shrink non-metallic grout around the post.
- Prime railing posts to a minimum of 1-inch above the finish concrete surface to provide adequate grout-to-aluminum isolation.
- Seal around post base with sealant.
- Plaster finish and paint the repair area to match the surroundings.

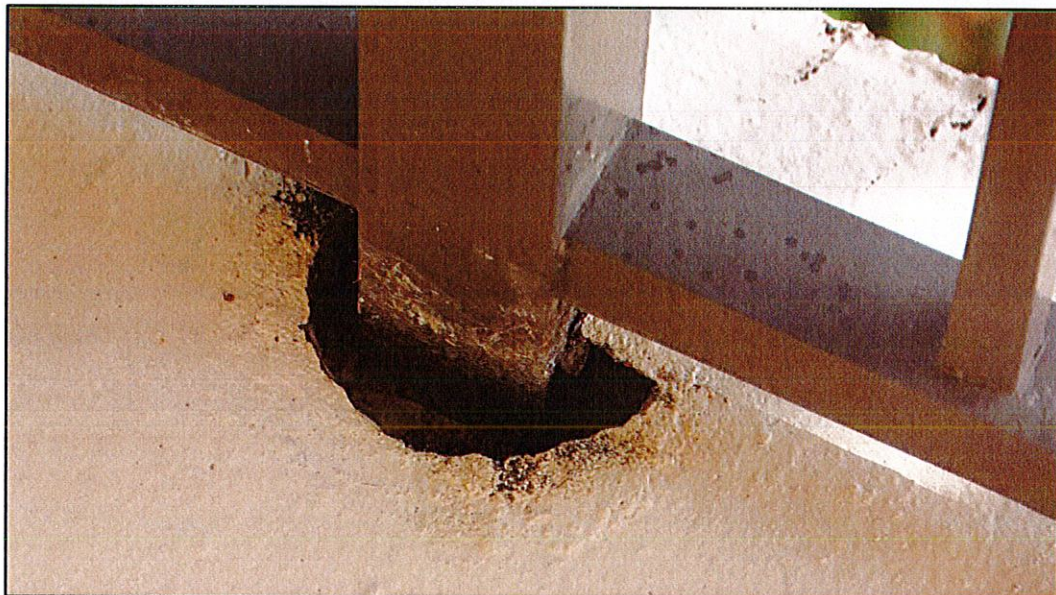
**Photo #2.** View of post base deteriorated grout and metal post with signs of corrosion damage (unit 305 front corridor).

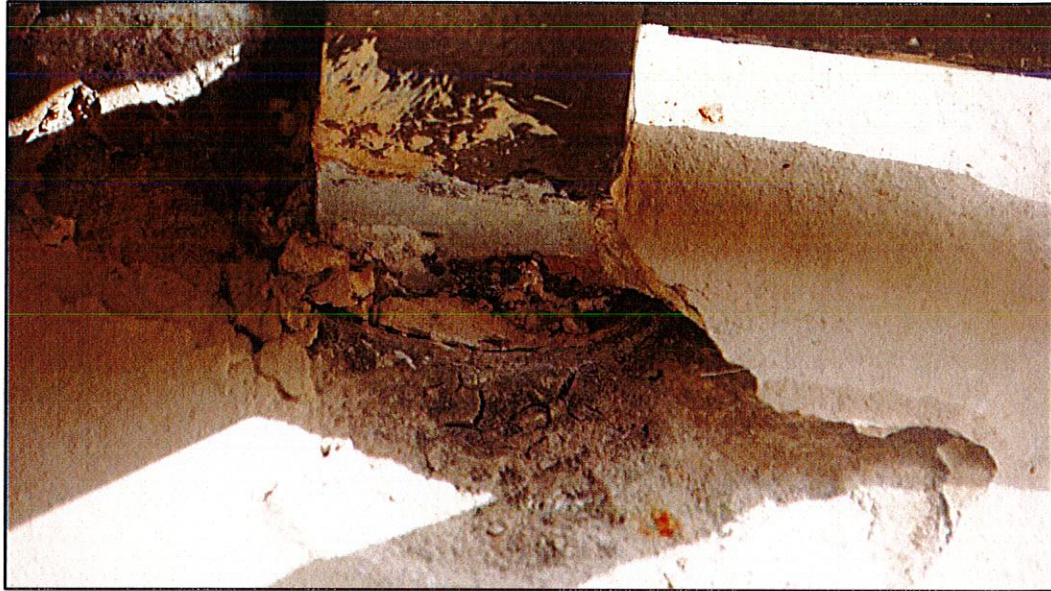
Photo #3. View of post base deteriorated grout and signs of organic growth (unit 203 front corridor).

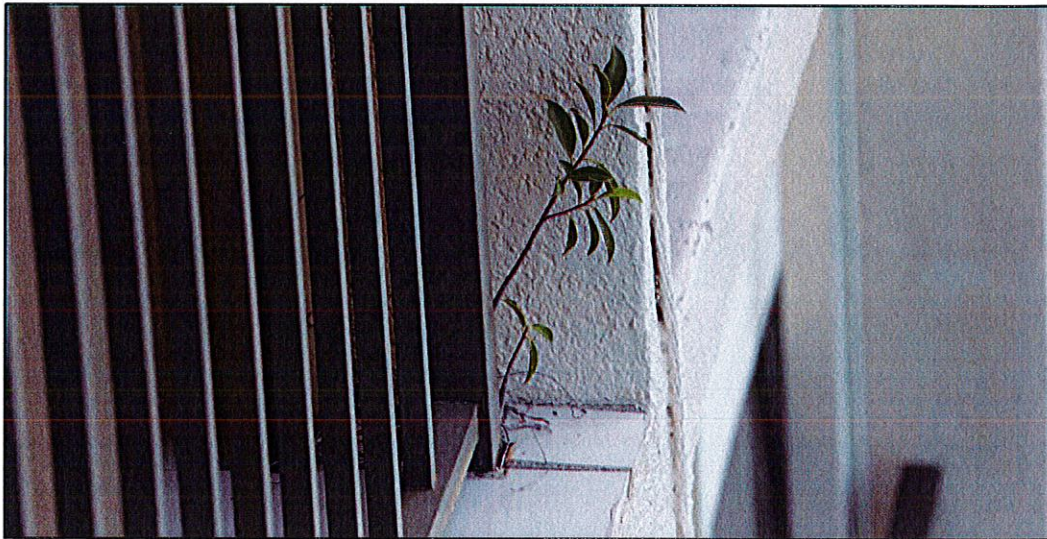
Photo #4. View of post base deteriorated grout and vegetation growth (unit 503 rear balcony).

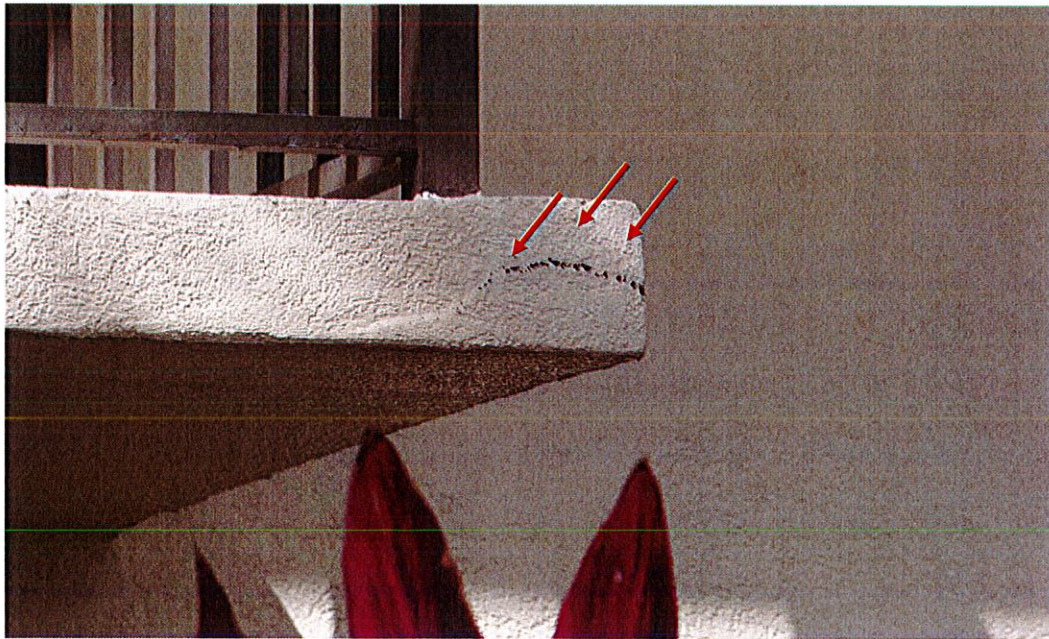
- Balcony floors and exterior edges with imminent concrete spalls. This condition can also be caused by insufficient rebar concrete coverage and by superficial cracks that allow moisture intrusion. Corrosion present at reinforcing steel produces expansion of the diameter of the bar which leads to displacement of surface materials, in this case, concrete (See **Photos #5 and #6**). Due to the uncertainty of this condition, it is not possible to predict if or when the finishes will fall. We recommend removing the deficient portions of the finishes or concrete elements from the slab edges or ceilings to prevent pieces of debris from falling down and hurting residents.

Photo #5. View of imminent spalling of concrete slab edge observed at ceiling of unit 106 balcony.

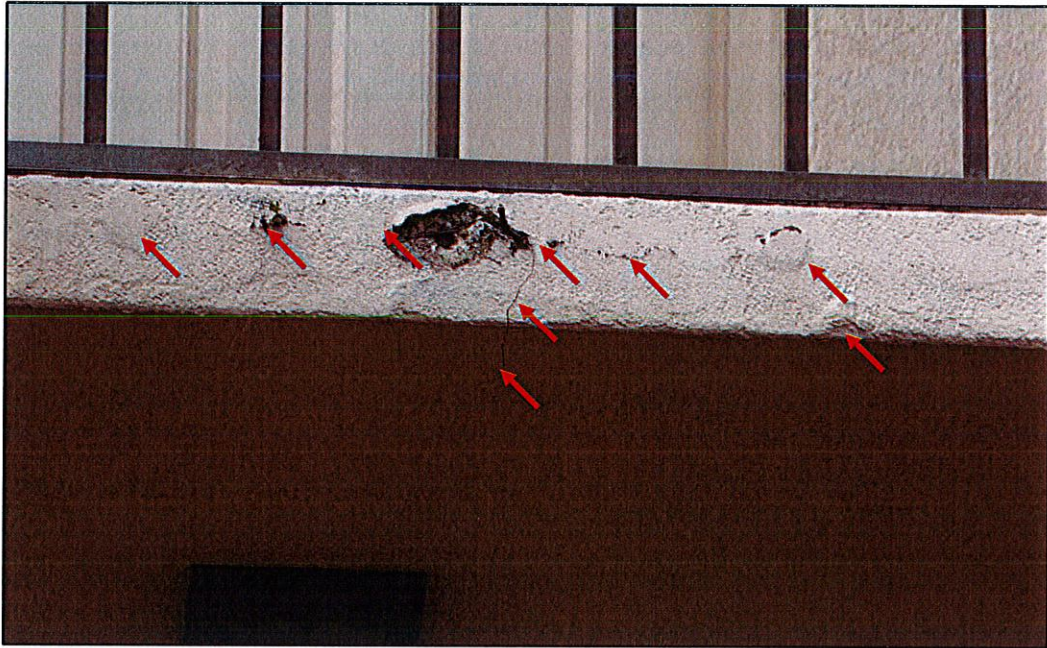
Photo #6. View of imminent spalling of concrete slab observed at edge of slab (unit 303 front corridor).

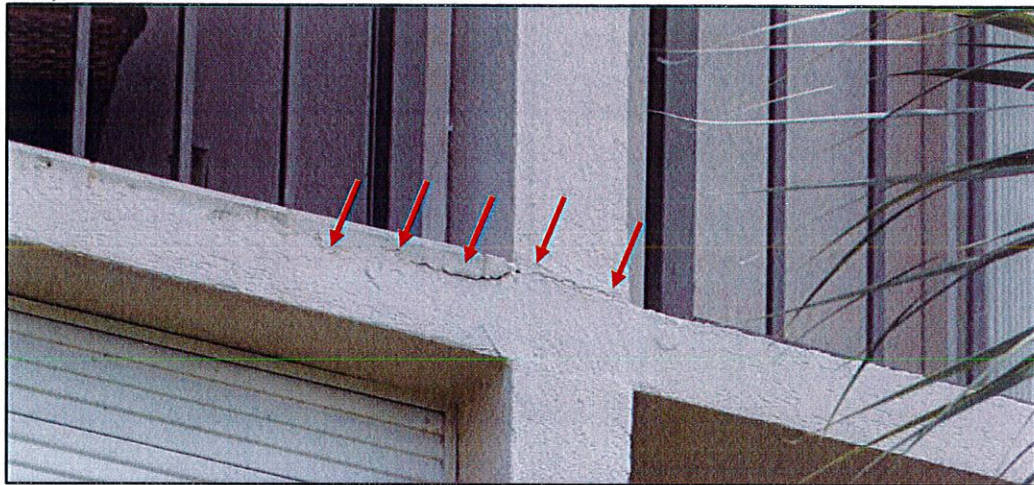
- Balcony ceiling and exterior edges with exposed and corroded reinforcement bars. This condition can be caused by insufficient rebar concrete coverage and by superficial cracks that allow moisture intrusion. Corrosion present at reinforcing steel produces expansion of the diameter of the bar (exfoliation) which leads to displacement (jacking) of surface finishes, such as stucco. This condition can be observed prior to stucco/concrete finishes failure, in the form of bulging of the exterior finishes (see **Photos #7, #8, and #9**) and after finishes have been removed or displaced by the expansion of the reinforcing bar due to corrosion (see **Photo #10**).

Photo #7. View of deteriorated stucco finishes, signs of concrete slab spalling due to corroded reinforcing, condition observed at edge of slab at unit 402 balcony.

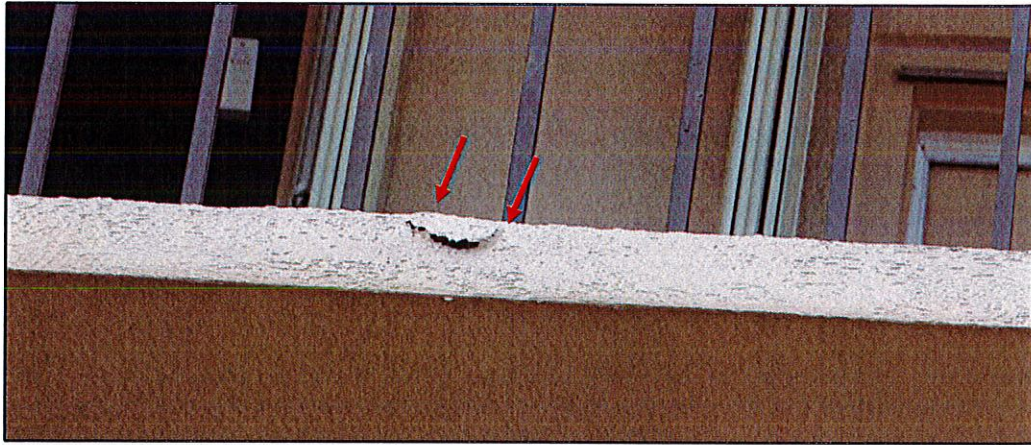
Photo #8. View of exterior stucco finishes with localized bulging (unit 504 front corridor).

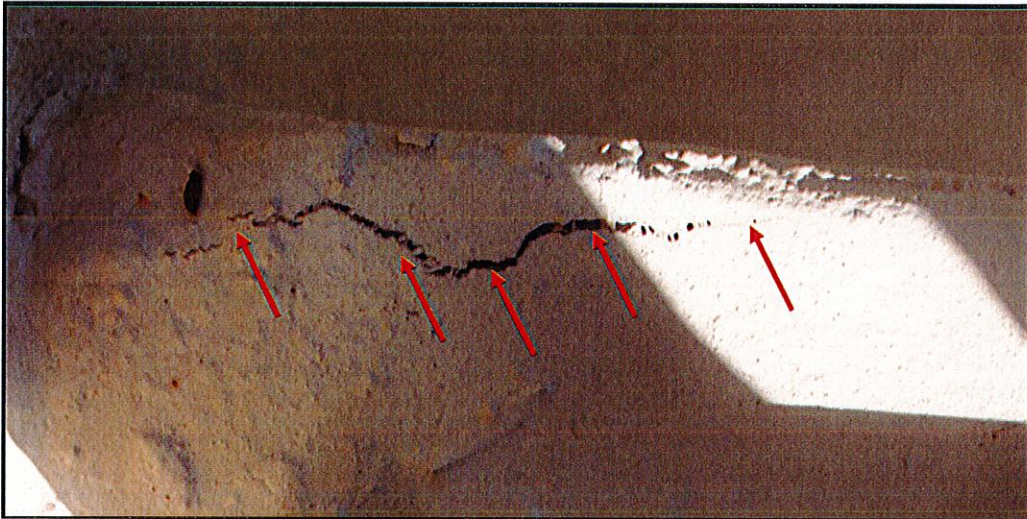
Photo #9. View of spalled concrete with exposed and corroded slab reinforcing bars observed at unit 406 front corridor.

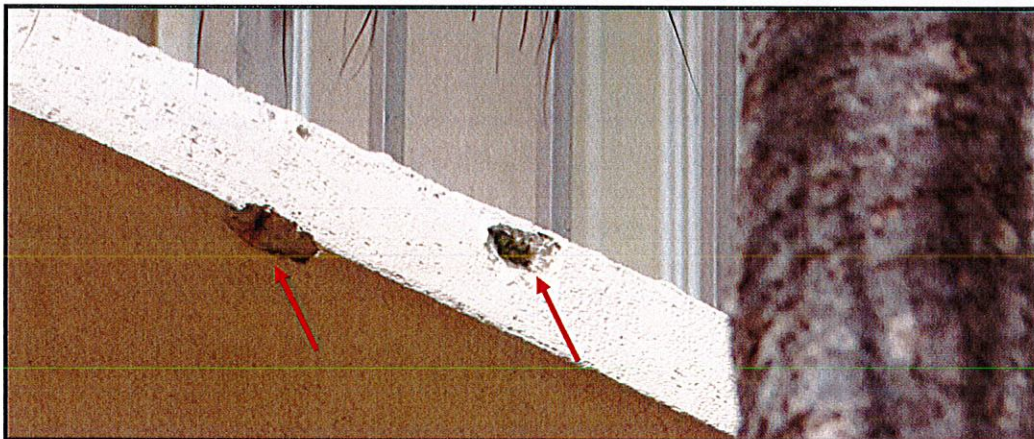
Photo #10. View of spalled concrete with exposed and corroded slab reinforcing bars observed at unit 405 front corridor.

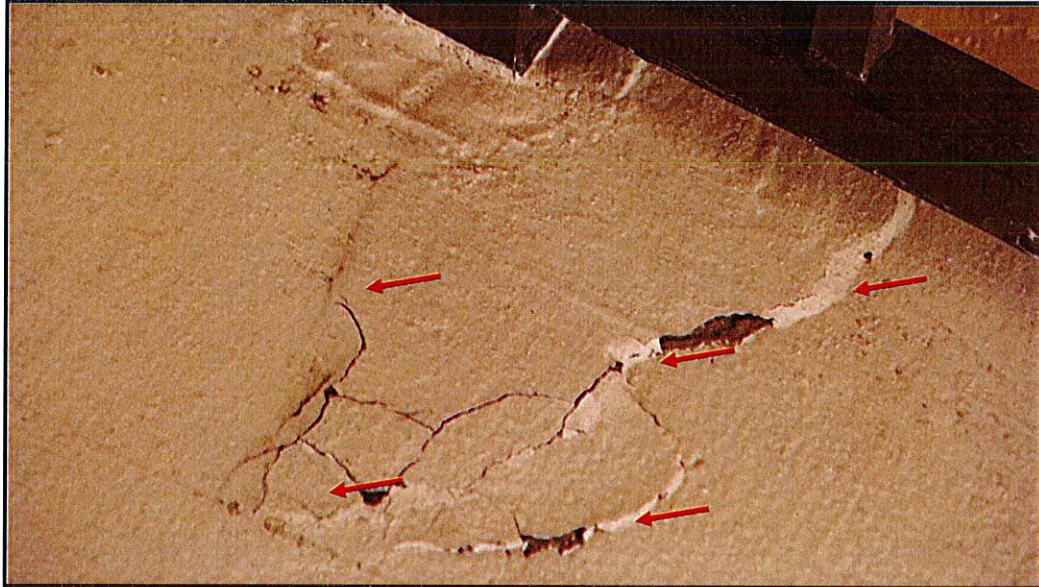
- In certain instances, this condition can be concealed by finishes that have not yet failed or have been covered by previous repairs. This condition requires additional invasive evaluations to clearly define the limits of the deficiency (see **Photo #11**).

**Photo #11.** View of deteriorated floor finishes, signs of concrete slab spalling due to corroded reinforcing, condition observed at floor (Top of slab) of unit 505 front corridor.

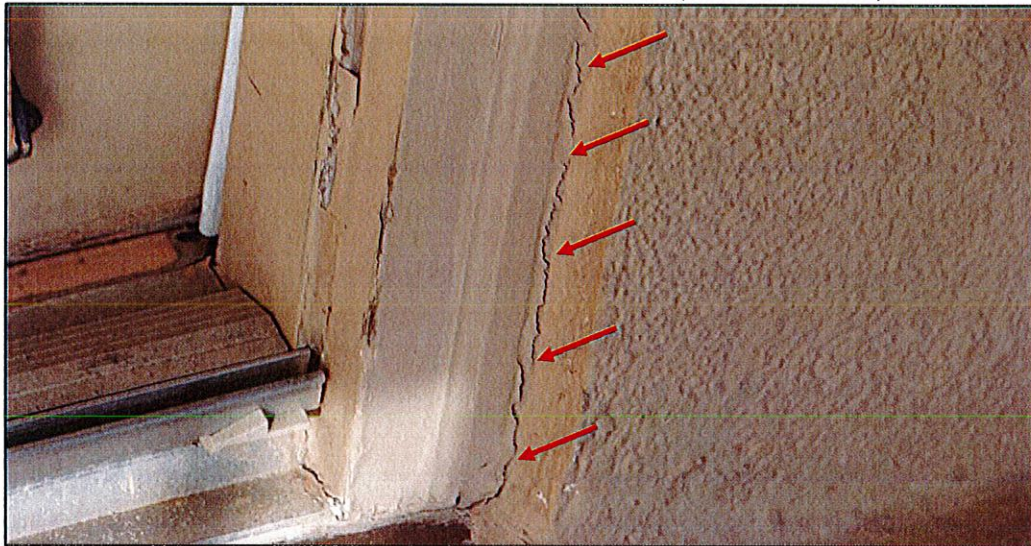
- Exterior sealants around door and window observed with signs of deterioration (cohesion failure). This condition can allow wind driven rain to enter the building envelope and cause damage to the concrete elements as well as damage to interior finishes, personal property and create environmental contamination such as mold and mildew. Sealant shall be removed and replaced preferably with a paintable and UV resistant silicone or hybrid sealant material (See **Photo #12**).

**Photo #12.** View of deteriorated sealant around the front door of unit 505.

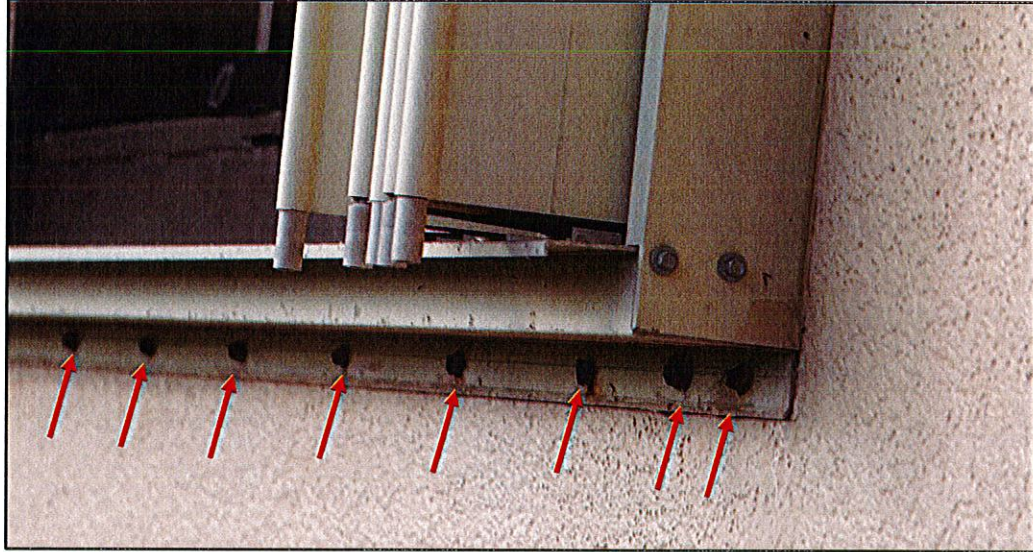
- Anchors for hurricane shutters observed with severe deterioration in the form of corrosion. This condition will compromise the structural integrity of the shutters under severe wind events. Expansion of the anchor due to severe corrosion will damage the concrete and can allow moisture to enter and damage reinforcing bars within the slab. Corroded anchors shall be replaced with corrosion resistant anchors

Photo #13. Close up view of deteriorated metal anchors for the hurricane shutters. (Unit 501 shown).

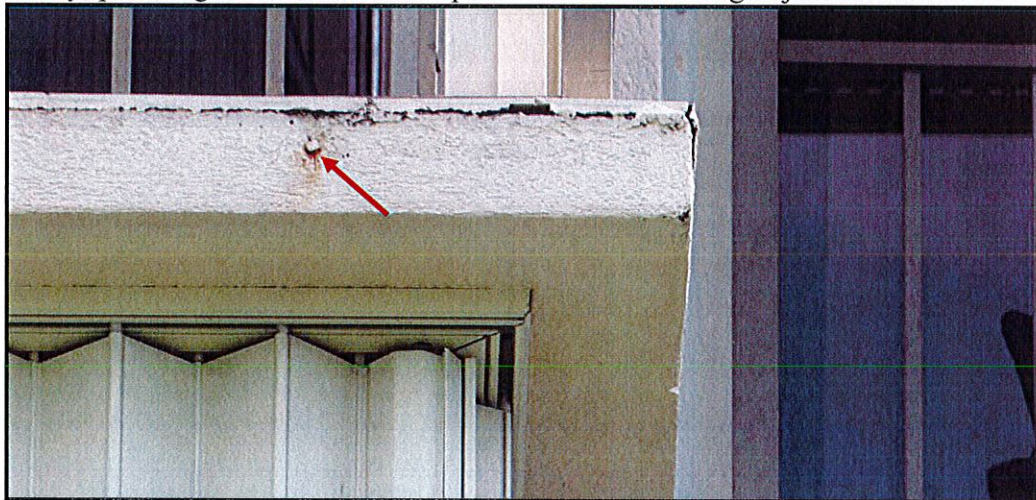
- Balcony ceiling and exterior edges with exposed and corroded metals and corroded steel elements observed at numerous units. This condition refers to metals used in the slab during construction, and also metals installed after construction (see **Photo #14**). Exposed corroded metals shall be removed by grinding metals to a depth of at least 1 inch, coating remains of metal elements in cavity, patching hole and finish or paint to match existing adjacent areas.

Photo #14. Close up view of embedded metals within concrete slabs. (Unit 403 balcony shown).

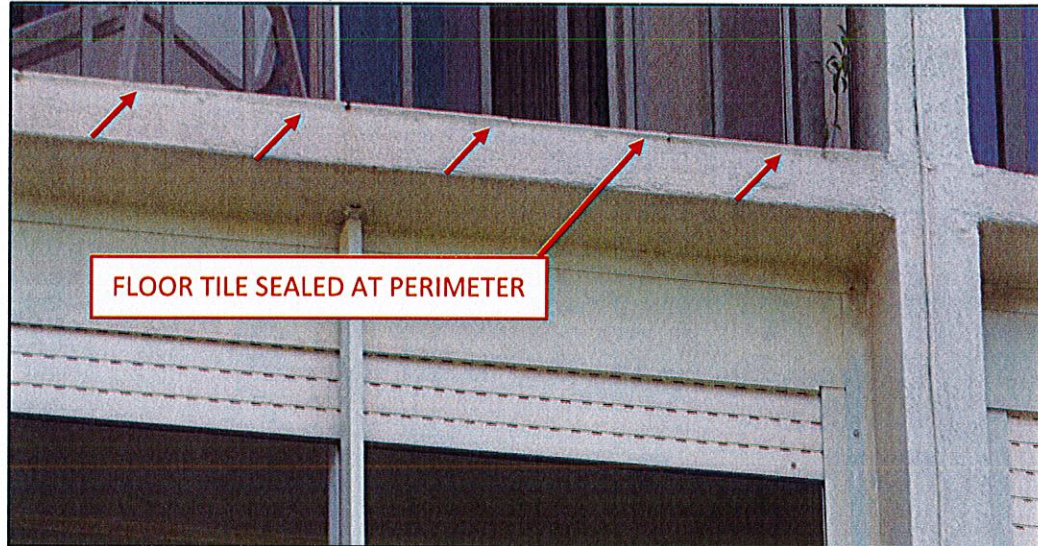
- Balcony units with floor finishes (i.e. tile), it was observed, at private balcony units with floor finishes (i.e. tile) installed up to the edge of the slab and the edge of the tile perimeter completely sealed preventing water that enters through grout lines or cracks to escape. In many cases water accumulates with no way to drain out damaging the finishes and potentially the concrete and reinforcement within the slabs (See **Photo #15**).

Photo #15. View of floor finishes (tile) with edges sealed (Unit 503 balcony shown).

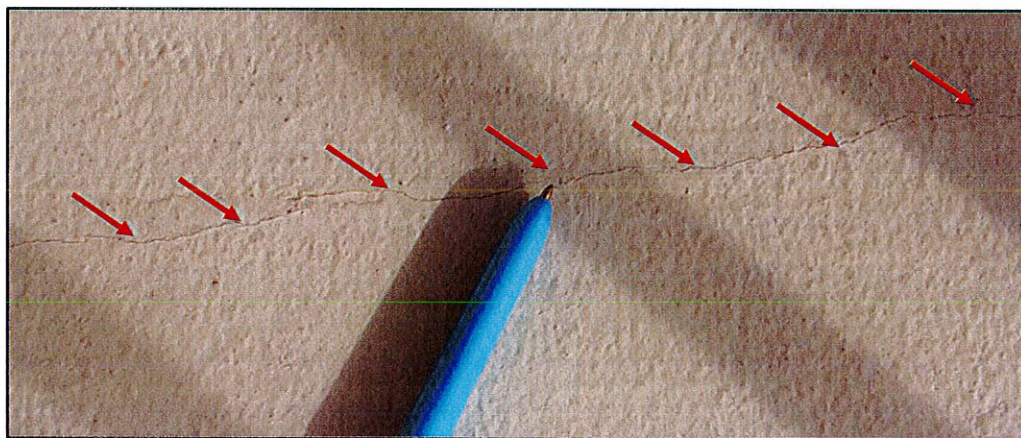
- Exterior floor slab with unsealed penetrations and floor cracks. Unsealed penetrations allow rainwater to penetrate and usually leads to corrosion of member reinforcement and spalling of concrete (Long term). Unsealed penetrations shall be filled with epoxy materials. The majority of the cracks observed are hairline cracks and do not represent a structural concern, however if not repaired they can cause future damage to the structure. Cracks shall be routed, sealed and surfaces finished with waterproofing membrane. (See **Photo #16**).

Photo #16. View of slab cracks with visible damage to stucco finishes (unit 504 front corridor shown).
