January 31, 2023.

Board of Directors  
The Marina at the Bluffs Condominium Association, Inc.  
1550 Marina Isle Way  
Jupiter, FL 33477

**Re: Milestone Inspection Report – Phase One.  
Building 23.  
2301 Marina Isle Way, Jupiter, FL 33477**

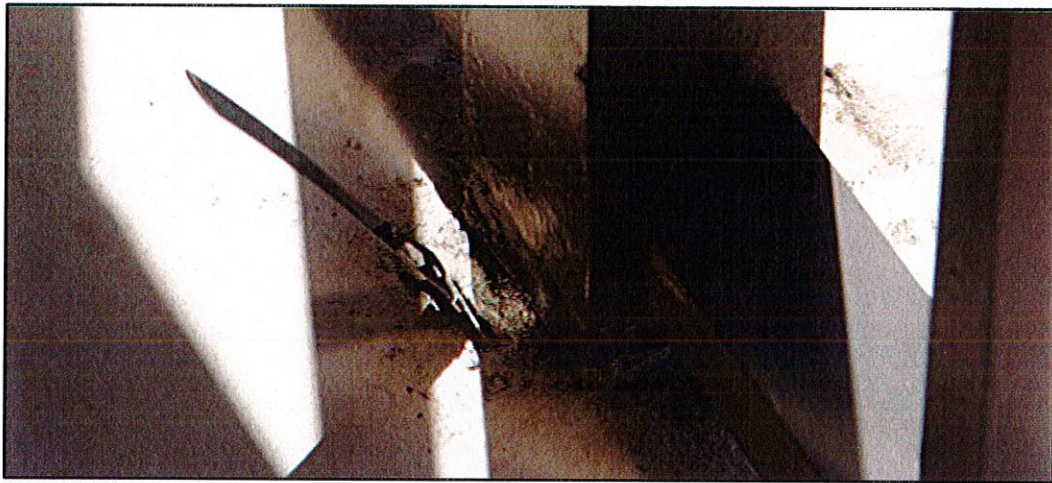
- Balcony guardrail vertical posts with visible separation and/or gaps between the concrete wall of the concrete pocket and the post (see **Photo #1**). Also, moisture was observed ponding in low spots around the post base. This condition indicates moisture has penetrated the base of the post and could cause damage to the concrete and corrosion of the reinforcement in the slab. Further evidence of moisture within the railing post base can be observed at locations with vegetation and/or organic growth (See **Photos #2 through #4**). Also, at several locations, the degree of deterioration of the post base grout allows unwanted lateral movement of the guardrail system top member or toprail.

**Photo #1.** View of post base deteriorated grout and metal post with signs of corrosion damage (unit 404 front corridor).

- At locations where concrete/grout cracks, delamination, and/or spalling is identified, remove all grout to expose the embedded portion of railing post and remove adjoining cracked, delaminated and/or spalled concrete.
- Remove all grout, corrosion, scale, slurry, and other bond-inhibiting material from exposed railing post by thorough wire-brushing or high-pressure water blasting.
- Install weep hole at post base above finishes.
- Replace removed concrete non-shrink non-metallic grout around the post.
- Prime railing posts to a minimum of 1-inch above the finish concrete surface to provide adequate grout-to-aluminum isolation.
- Seal around post base with sealant.
- Plaster finish and paint the repair area to match the surroundings.

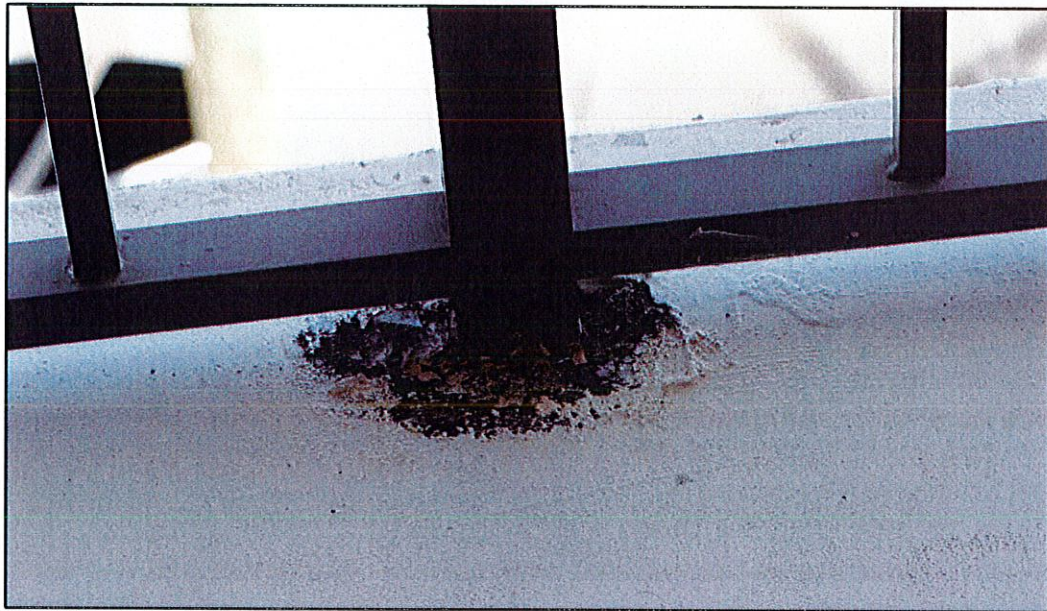
**Photo #2.** View of post base deteriorated grout and metal post with signs of corrosion damage (unit 402 balcony).

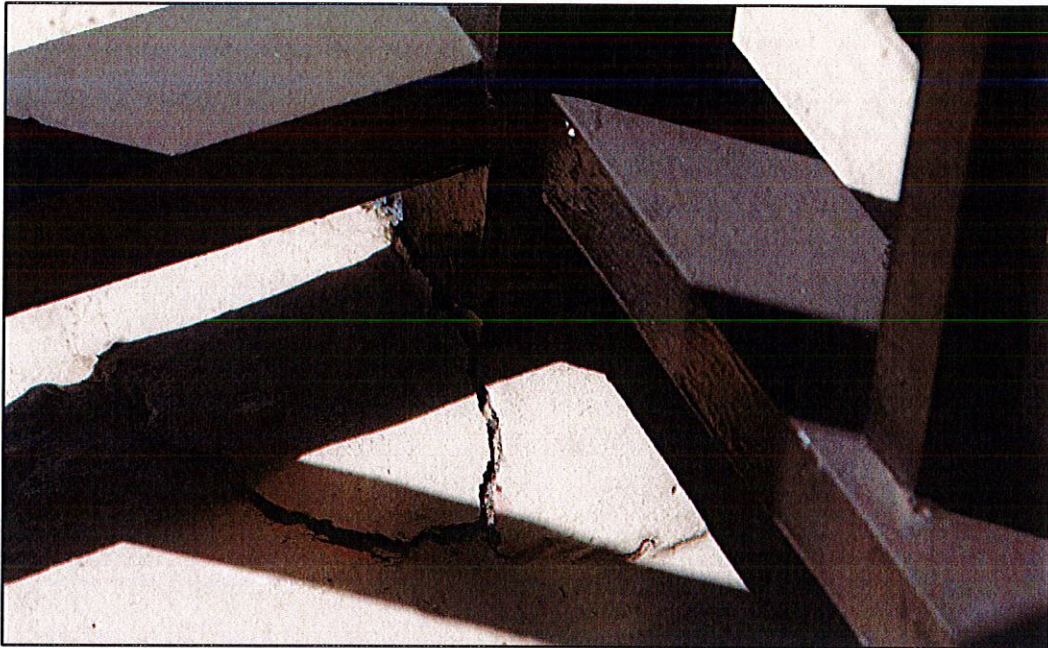
Photo #3. View of post base deteriorated grout and signs of organic growth (unit 201 front corridor).

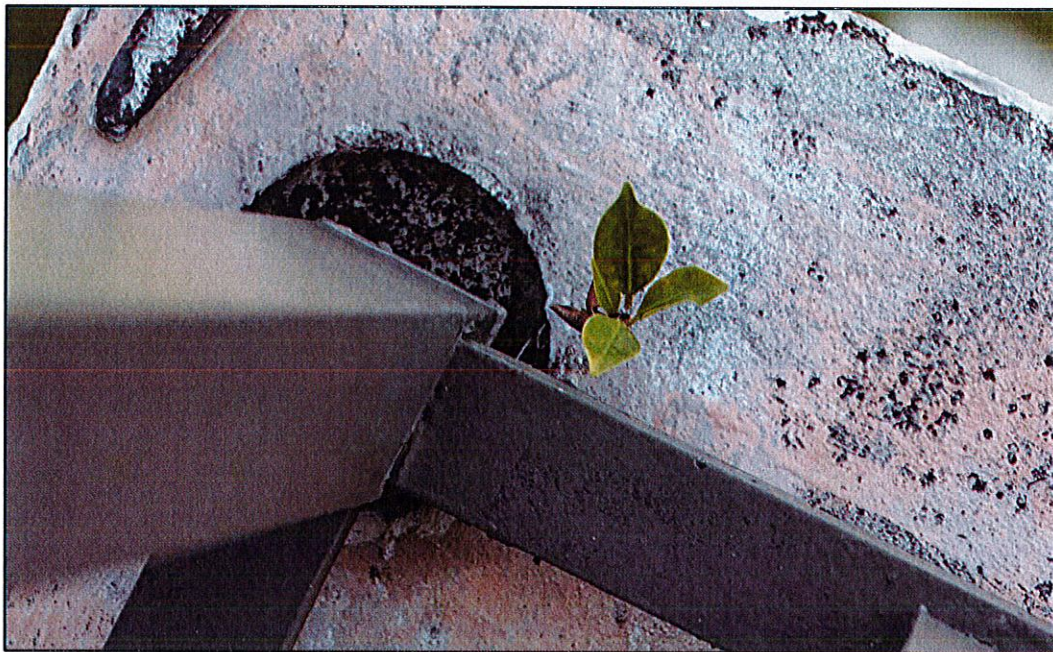
Photo #4. View of post base deteriorated grout and vegetation growth (unit 503 rear balcony).

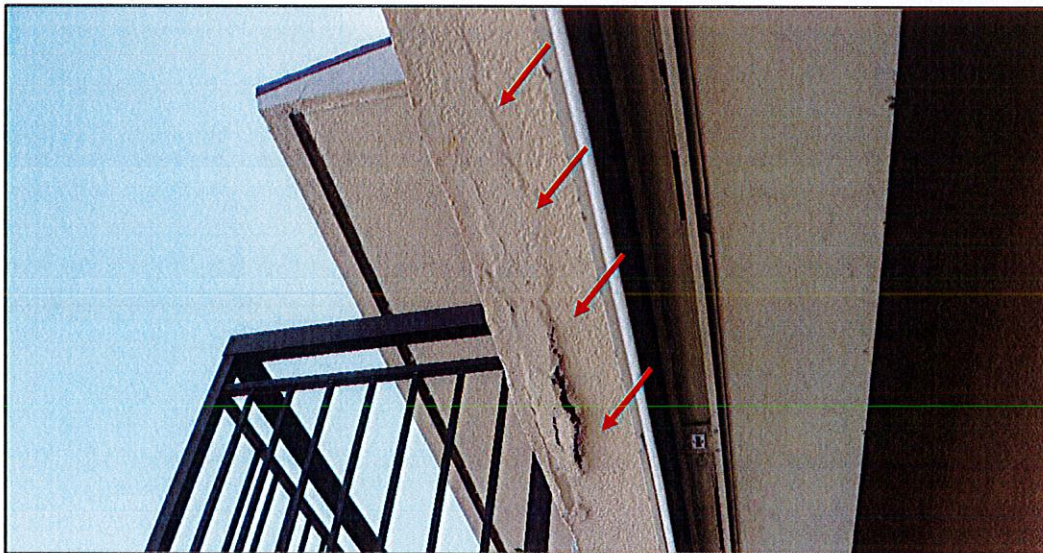
- Balcony floors and exterior edges with imminent concrete spalls. This condition can also be caused by insufficient rebar concrete coverage and by superficial cracks that allow moisture intrusion. Corrosion present at reinforcing steel produces expansion of the diameter of the bar which leads to displacement of surface materials, in this case, concrete (See **Photos #5, #6 and #7**). Due to the uncertainty of this condition, it is not possible to predict if or when the finishes will fall. We recommend removing the deficient portions of the finishes or concrete elements from the slab edges or ceilings to prevent pieces of debris from falling down and hurting residents.

Photo #5. View of imminent spalling of concrete slab edge observed at ceiling of unit 403 balcony.

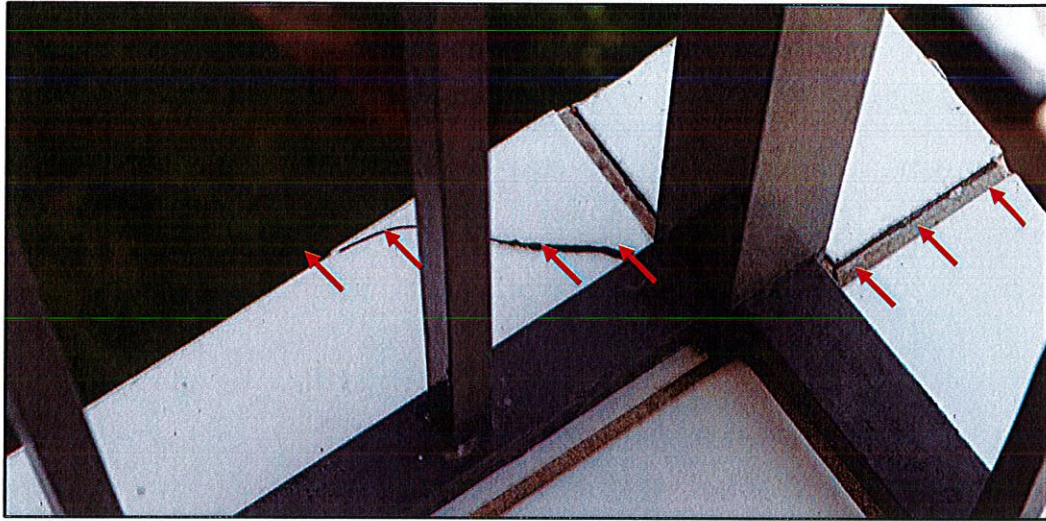
Photo #6. View of imminent spalling of concrete slab edge observed at edge of floor slab (unit 401 balcony shown).

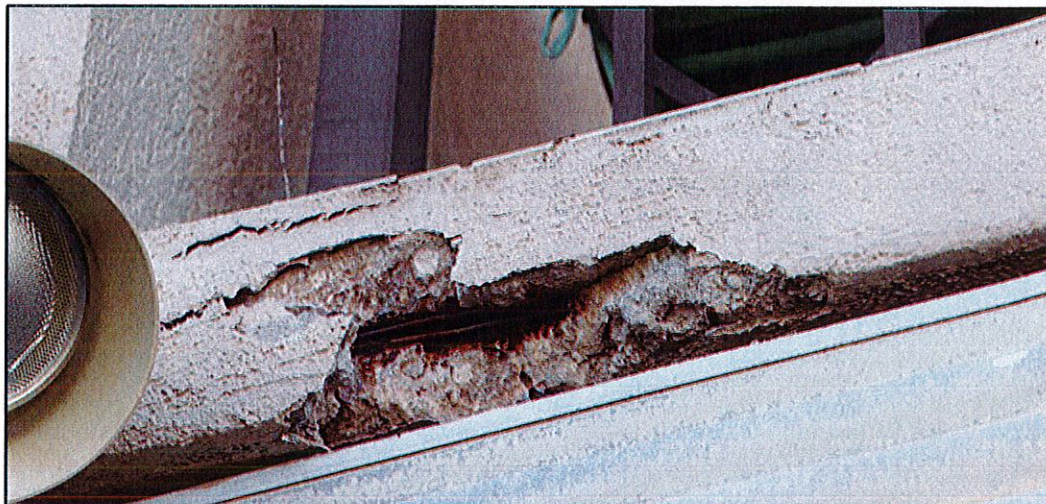
Photo #7. View of imminent spalling of concrete slab edge with corroded reinforcing bars observed at edge of floor (unit 103 balcony shown).

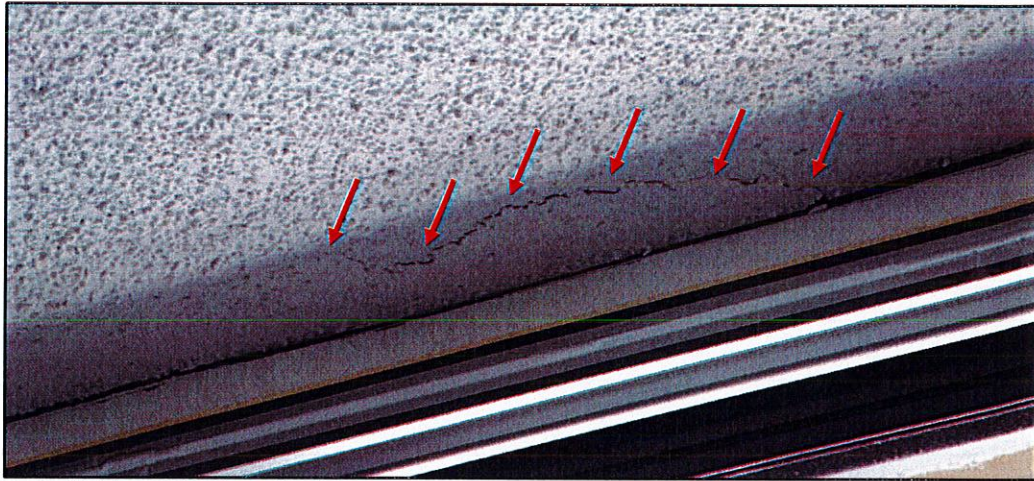
Photo #8. View of deteriorated ceiling stucco finishes, signs of concrete slab spalling due to corroded reinforcing, condition observed at interior ceiling of unit 404 balcony.

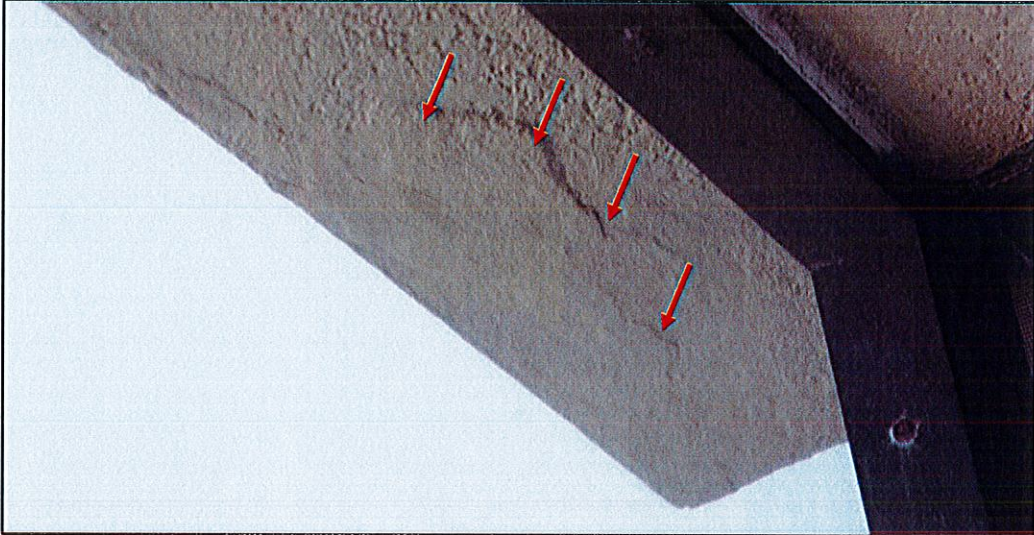
Photo #9. View of exterior stucco finishes with localized bulging (unit 404 balcony shown).

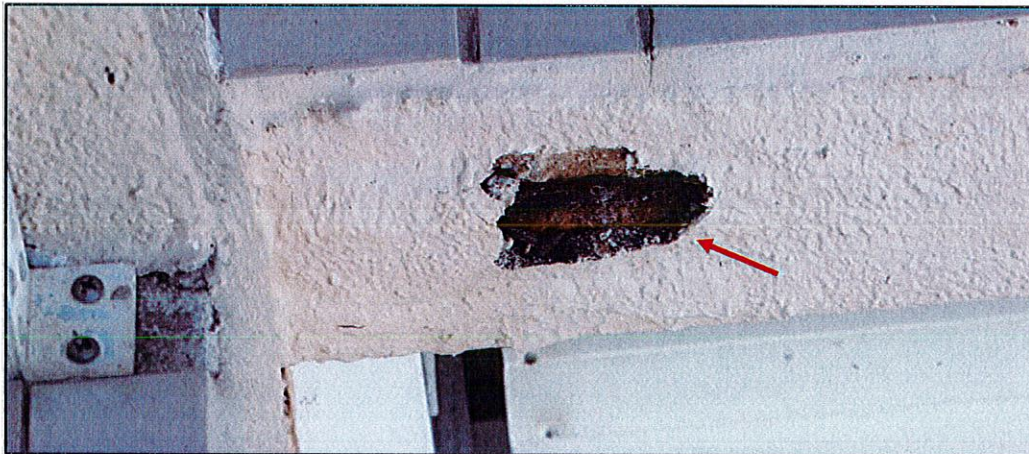
- Balcony ceiling and exterior edges with exposed and corroded reinforcement bars. This condition can be caused by insufficient rebar concrete coverage and by superficial cracks that allow moisture intrusion. Corrosion present at reinforcing steel produces expansion of the diameter of the bar (exfoliation) which leads to displacement (jacking) of surface finishes, such as stucco. This condition can be observed prior to stucco/concrete finishes failure, in the form of bulging of the exterior finishes (see **Photos #8 and #9**) and after finishes have been removed or displaced by the expansion of the reinforcing bar due to corrosion (see **Photo #10**).

Photo #10. View of spalled concrete with exposed and corroded slab reinforcing bars observed at unit 201 balcony.

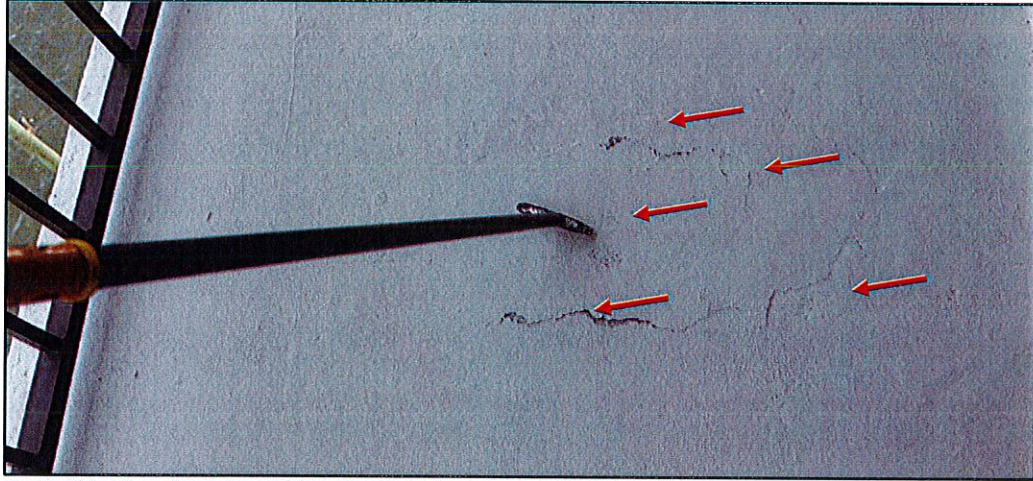
- In certain instances, this condition can be concealed by finishes that have not yet failed or have been covered by previous repairs. This condition requires additional invasive evaluations to clearly define the limits of the deficiency (see **Photo #11**).

**Photo #11.** View of deteriorated floor finishes, signs of concrete slab spalling due to corroded reinforcing, condition observed at floor (Top of slab) of unit 506 balcony.

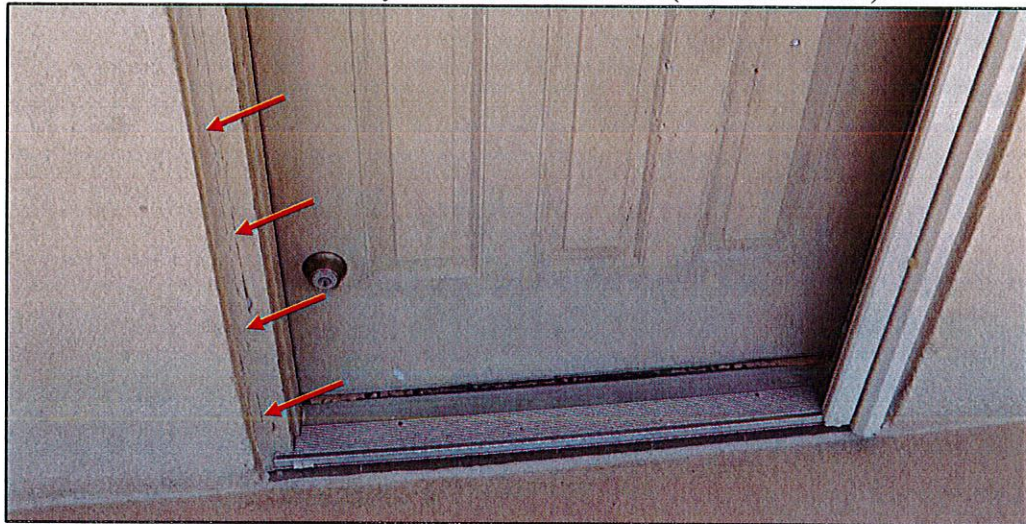
- Exterior sealants around door and window observed with signs of deterioration (cohesion failure). This condition can allow wind driven rain to enter the building envelope and cause damage to the concrete elements as well as damage to interior finishes, personal property and create environmental contamination such as mold and mildew. Sealant shall be removed and replaced preferably with a paintable and UV resistant silicone or hybrid sealant material (See **Photo #12**).

**Photo #12.** View of deteriorated sealant around the front door of unit 304.

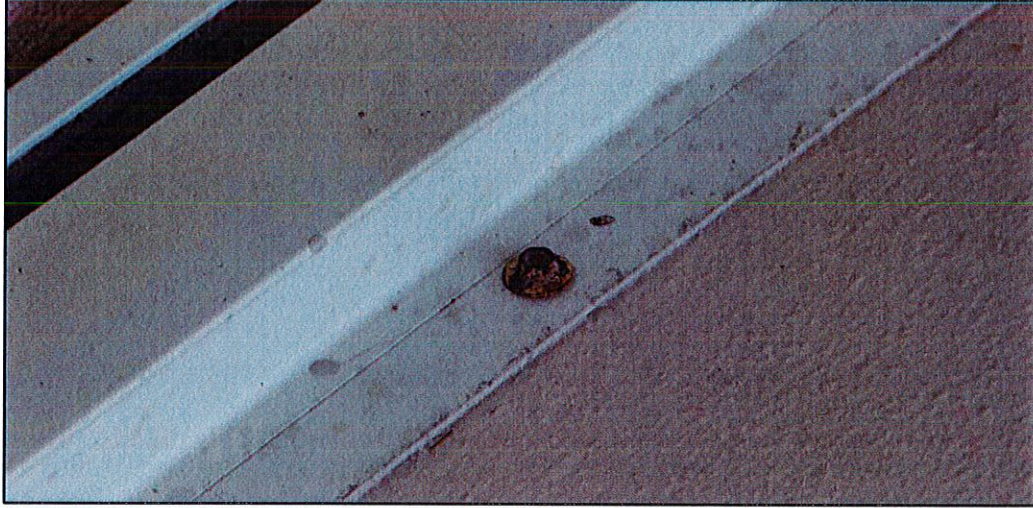
- Anchors for hurricane shutters observed with severe deterioration in the form of corrosion. This condition will compromise the structural integrity of the shutters under severe wind events. Expansion of the anchor due to severe corrosion will

damage the concrete and can allow moisture to enter and damage reinforcing bars within the slab. Corroded anchors shall be replaced with corrosion resistant anchors

**Photo #13.** Close up view of deteriorated metal anchors for the hurricane shutters. (Unit 505 shown).

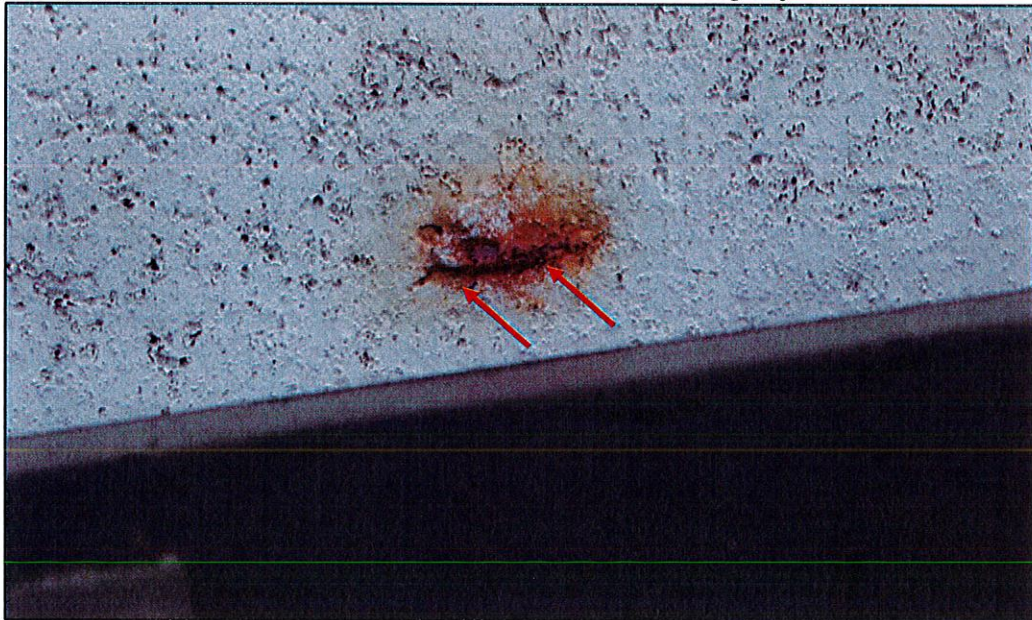
- Balcony ceiling and exterior edges with exposed and corroded metals and corroded steel elements observed at numerous units. This condition refers to metals used in the slab during construction, and also metals installed after construction (see **Photo #14**). Exposed corroded metals shall be removed by grinding metals to a depth of at least 1 inch, coating remains of metal elements in cavity, patching hole and finish or paint to match existing adjacent areas.

**Photo #14.** Close up view of embedded metals within concrete slabs. (Unit 506 balcony shown).

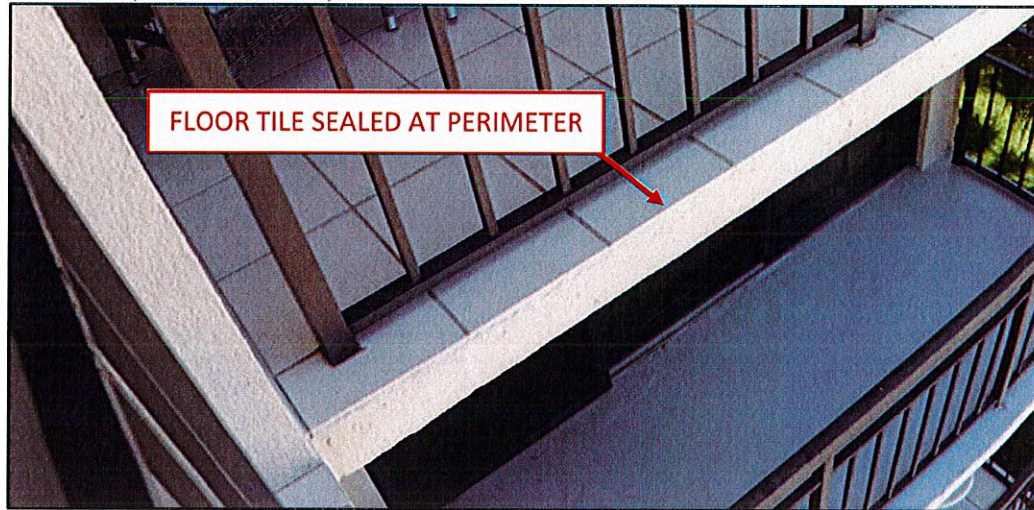
- Balcony units with floor finishes (i.e. tile), it was observed, at private balcony units with floor finishes (i.e. tile) installed up to the edge of the slab and the edge of the tile perimeter completely sealed preventing water that enters through grout lines or cracks to escape. In many cases water accumulates with no way to drain out damaging the finishes and potentially the concrete and reinforcement within the slabs (See **Photo #15**).

Photo #15. View of floor finishes (tile) with edges sealed (Unit 401 balcony shown).

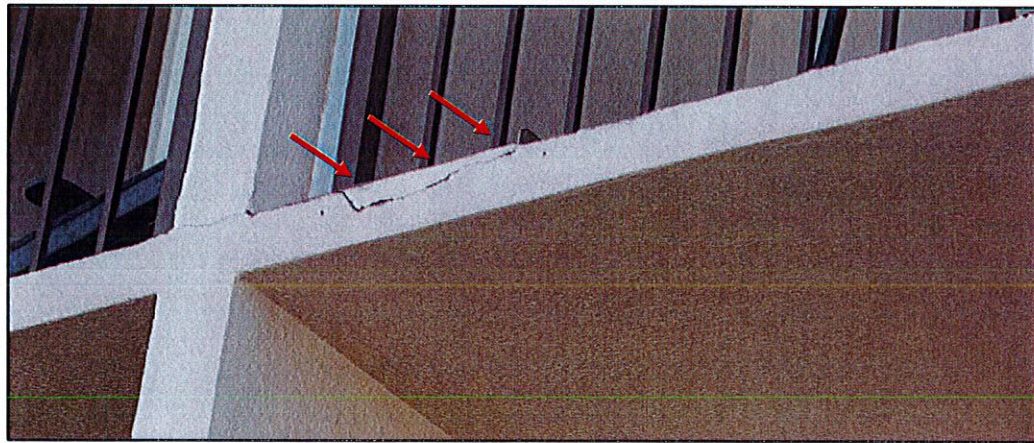
- Exterior floor slab with unsealed penetrations and floor cracks. Unsealed penetrations allow rainwater to penetrate and usually leads to corrosion of member reinforcement and spalling of concrete (Long term). Unsealed penetrations shall be filled with epoxy materials. The majority of the cracks observed are hairline cracks and do not represent a structural concern, however if not repaired they can cause future damage to the structure. Cracks shall be routed, sealed and surfaces finished with waterproofing membrane. (See **Photo #16**).

Photo #16. View of slab cracks with visible damage to stucco finishes (Unit 303 balcony shown).
