January 31, 2023.

Board of Directors  
The Marina at the Bluffs Condominium Association, Inc.  
1550 Marina Isle Way  
Jupiter, FL 33477

**Re: Milestone Inspection Report – Phase One.  
Building 24.  
2401 Marina Isle Way, Jupiter, FL 33477**

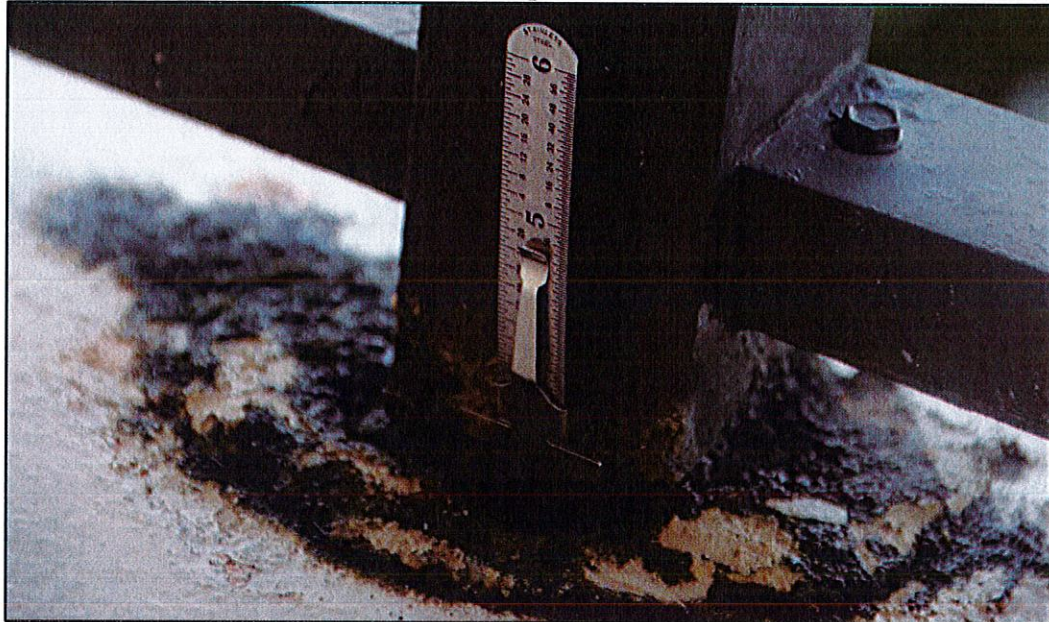
- Balcony guardrail vertical posts with visible separation and/or gaps between the concrete wall of the concrete pocket and the post (see **Photo #1**). In several locations, a metal ruler was able to be inserted to depths of up to 3 inches. Moisture was observed at the end of the ruler upon removal from the gap. Also, moisture was observed ponding in low spots around the post base. This condition indicates moisture has penetrated the base of the post and could cause damage to the concrete and corrosion of the reinforcement in the slab. Further evidence of moisture within the railing post base can be observed at locations with vegetation and/or organic growth (See **Photos #2 through #4**). Also, at several locations, the degree of deterioration of the post base grout allows unwanted lateral movement of the guardrail system top member or toprail.

**Photo #1.** View of post base deteriorated grout and metal post with signs of corrosion damage (unit 202 front corridor).

- At locations where concrete/grout cracks, delamination, and/or spalling is identified, remove all grout to expose the embedded portion of railing post and remove adjoining cracked, delaminated and/or spalled concrete.

- Remove all grout, corrosion, scale, slurry, and other bond-inhibiting material from exposed railing post by thorough wire-brushing or high-pressure water blasting.
- Install weep hole at post base above finishes.
- Replace removed concrete non-shrink non-metallic grout around the post.
- Prime railing posts to a minimum of 1-inch above the finish concrete surface to provide adequate grout-to-aluminum isolation.
- Seal around post base with sealant.
- Plaster finish and paint the repair area to match the surroundings.

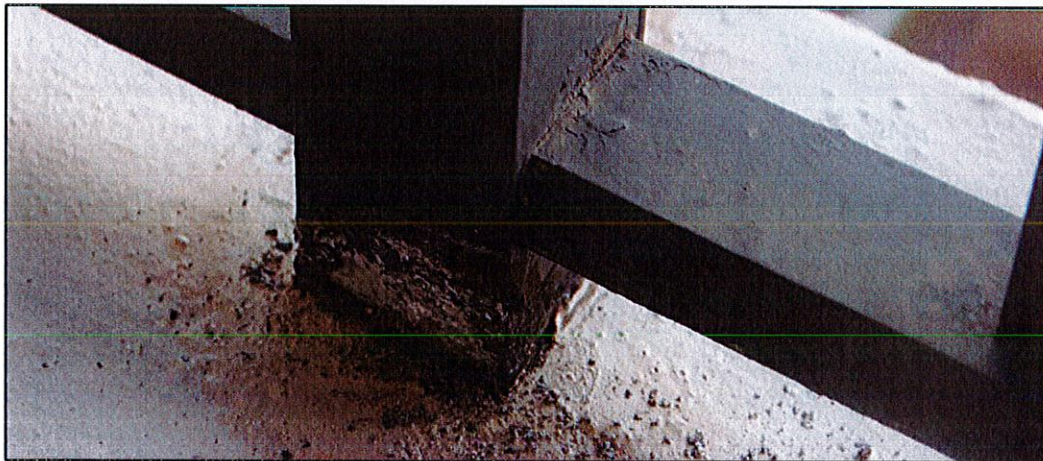
**Photo #2.** View of post base deteriorated grout and metal post with signs of corrosion damage (unit 304 front corridor).

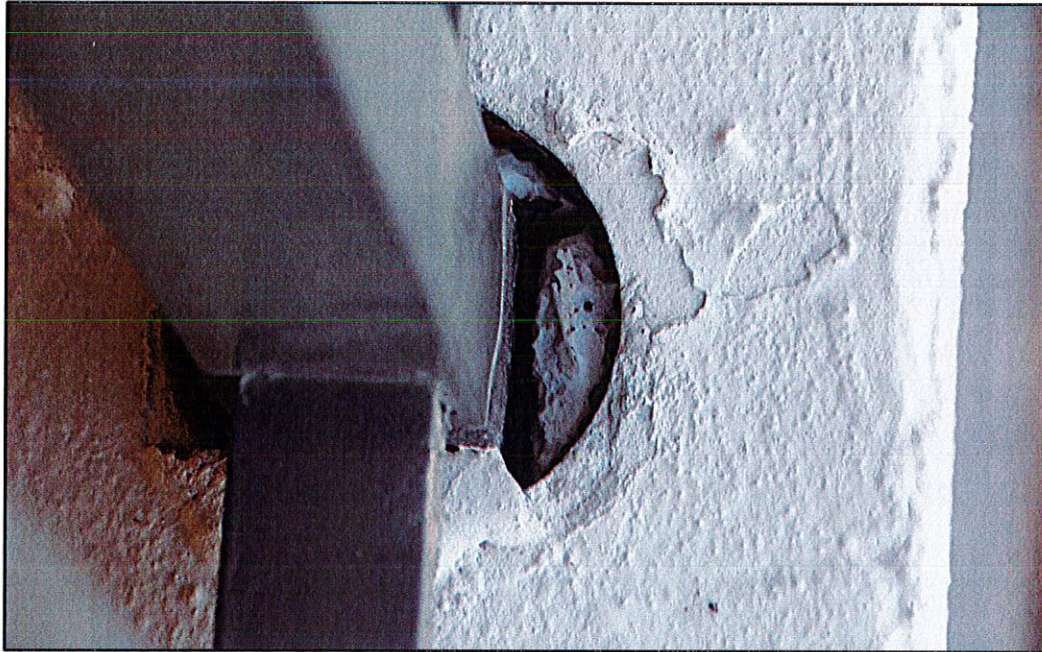
Photo #3. View of post base deteriorated grout and signs of organic growth (unit 505 balcony).

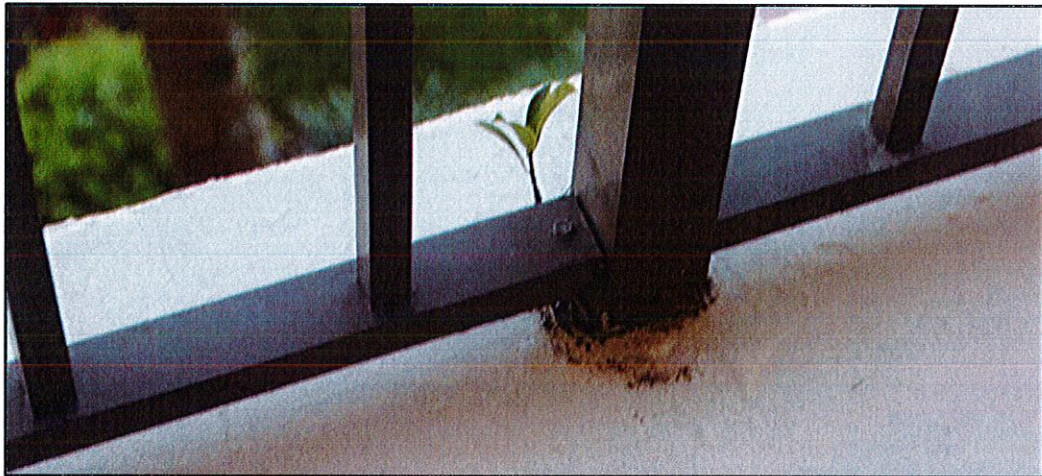
Photo #4. View of post base deteriorated grout and vegetation growth (unit 405 front corridor).

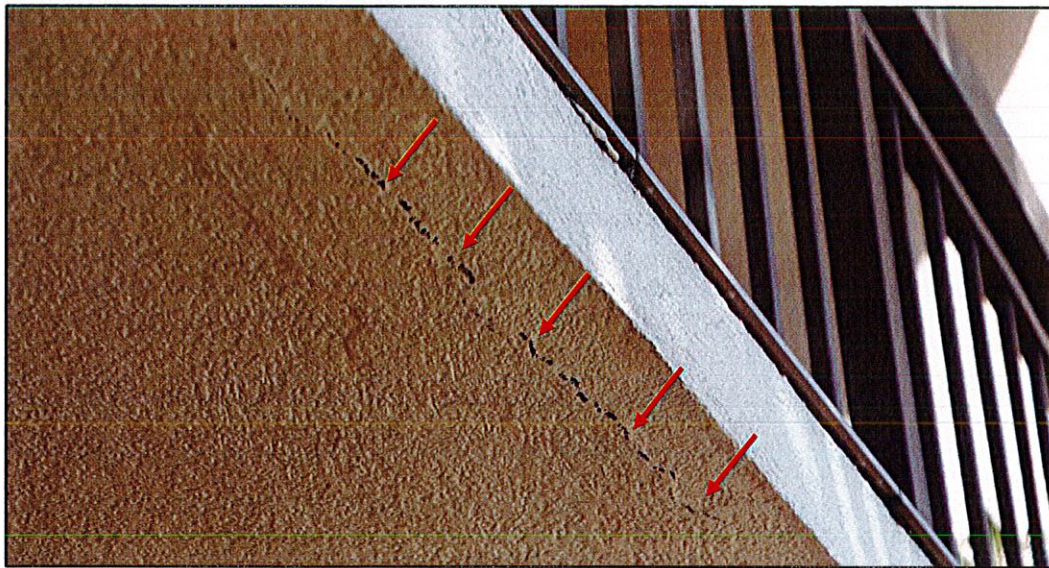
- Balcony floors and exterior edges with imminent concrete spalls. This condition can also be caused by insufficient rebar concrete coverage and by superficial cracks that allow moisture intrusion. Corrosion present at reinforcing steel produces expansion of the diameter of the bar which leads to displacement of surface materials, in this case, concrete (See **Photos #5 thru #8**). Due to the uncertainty of this condition, it is not possible to predict if or when the finishes will fall. We recommend removing the deficient portions of the finishes or concrete elements from the slab edges or ceilings to prevent pieces of debris from falling down and hurting residents.

Photo #5. View of imminent spalling of concrete slab edge observed at ceiling of unit 104 balcony.

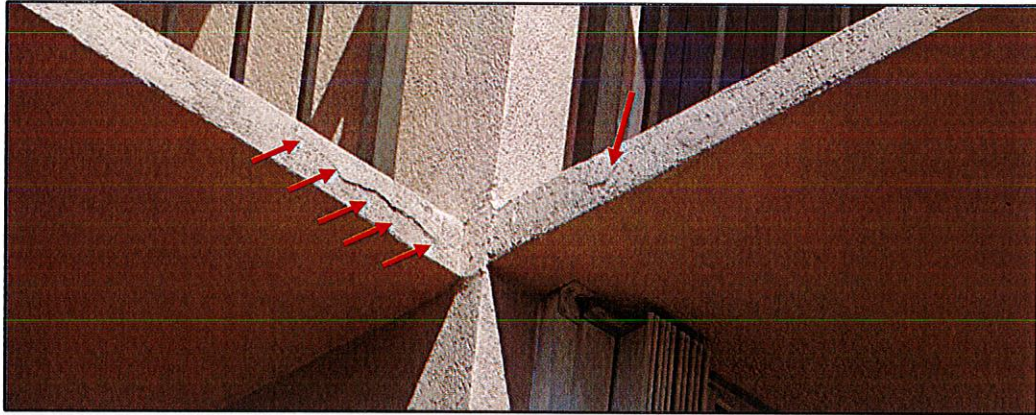
Photo #6. View of imminent spalling of concrete slab observed at balcony edge (Units 405 & 406 balcony shown).

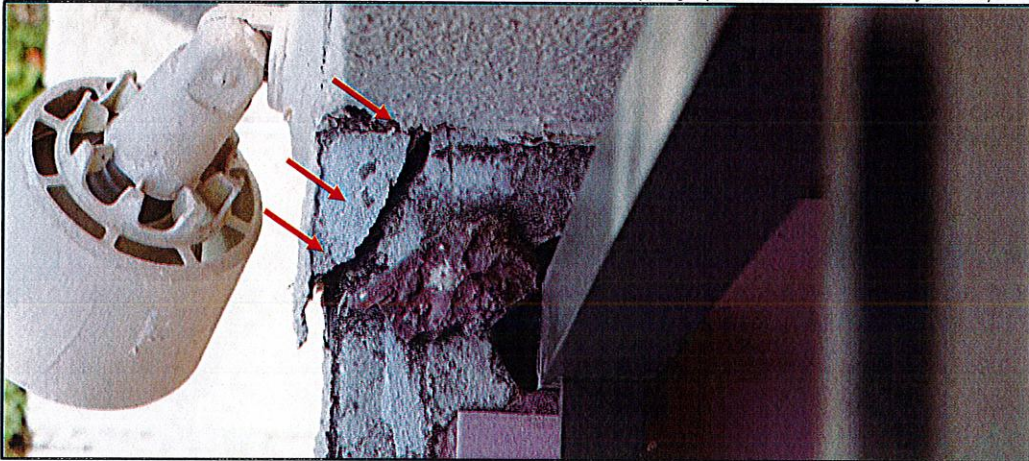
Photo #7. View of spalled concrete with observed at floor slab of unit 205 balcony.

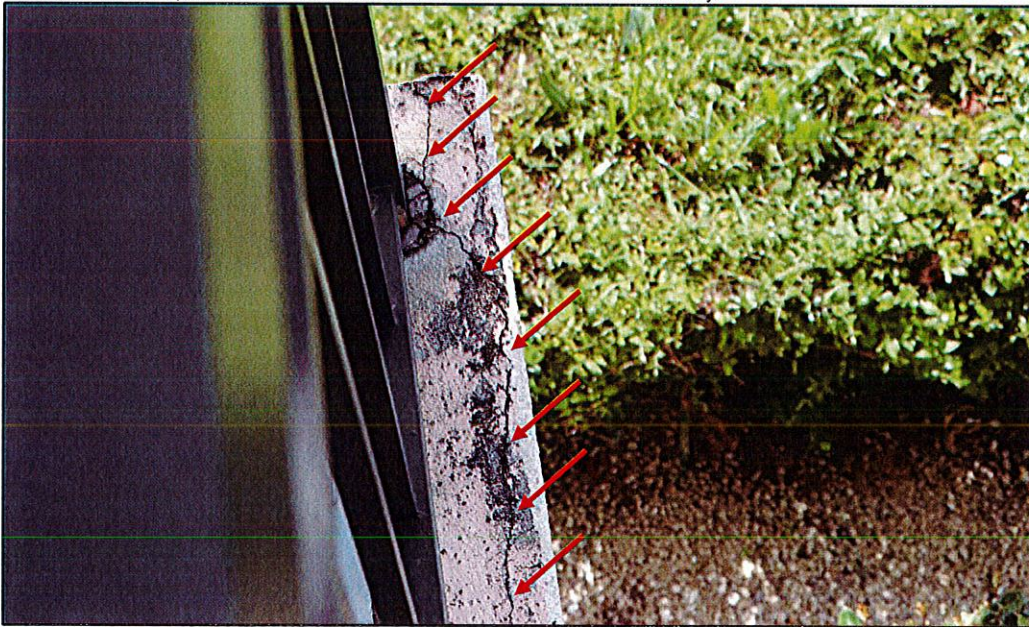
Photo #8. View of imminent spalling of concrete edge at floor slab of unit 206 balcony.

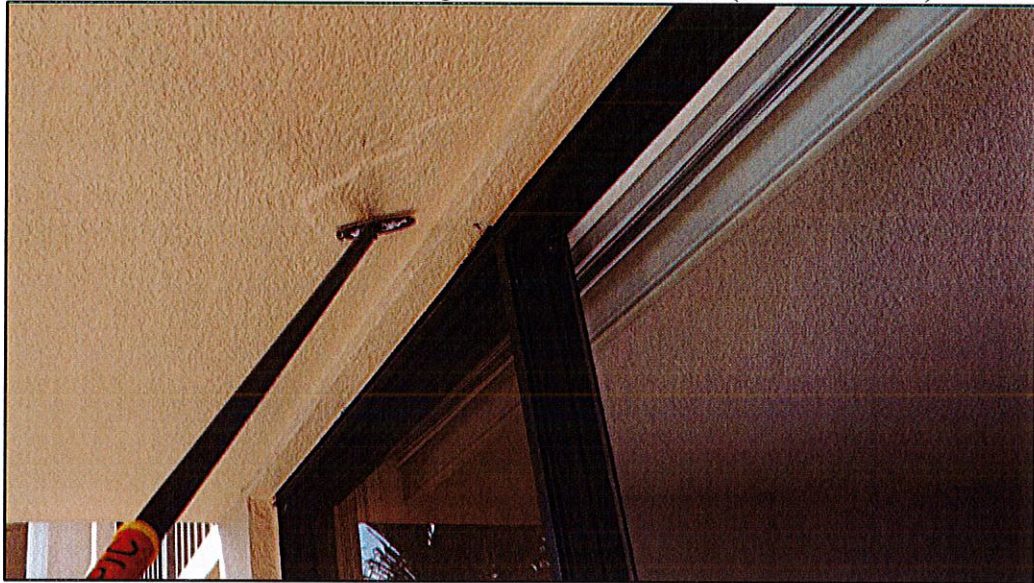
- Balcony ceiling and exterior edges with exposed and corroded reinforcement bars. This condition can be caused by insufficient rebar concrete coverage and by superficial cracks that allow moisture intrusion. Corrosion present at reinforcing steel produces expansion of the diameter of the bar (exfoliation) which leads to displacement (jacking) of surface finishes, such as stucco. This condition can be observed prior to stucco/concrete finishes failure, in the form of bulging of the exterior finishes (see **Photo #9**) and after finishes have been removed or displaced by the expansion of the reinforcing bar due to corrosion (see **Photo #10**).

**Photo #9.** View of deteriorated ceiling stucco finishes, signs of concrete slab spalling due to corroded reinforcing, condition observed at ceiling of unit 204 balcony.

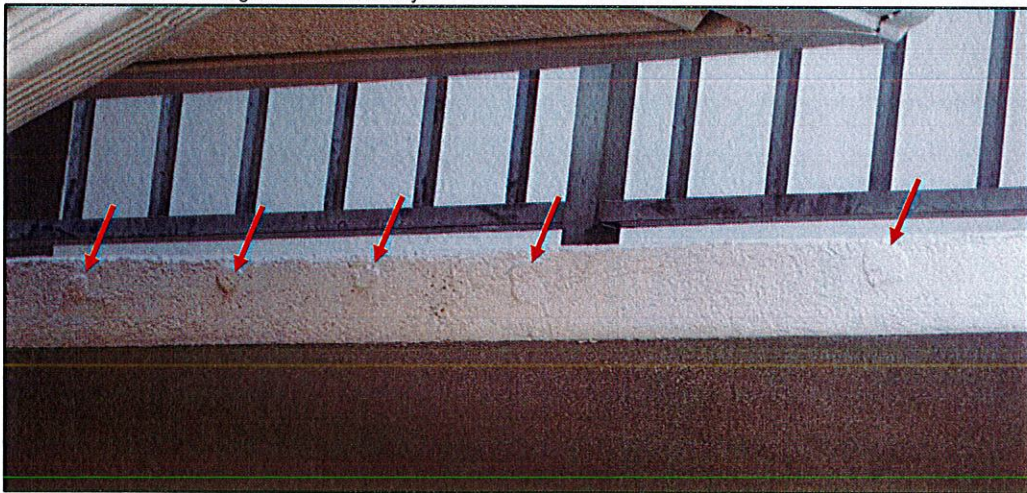
**Photo #10.** View of exterior stucco finishes with localized bulging, edge of slab, ceiling of unit 104 front corridor).

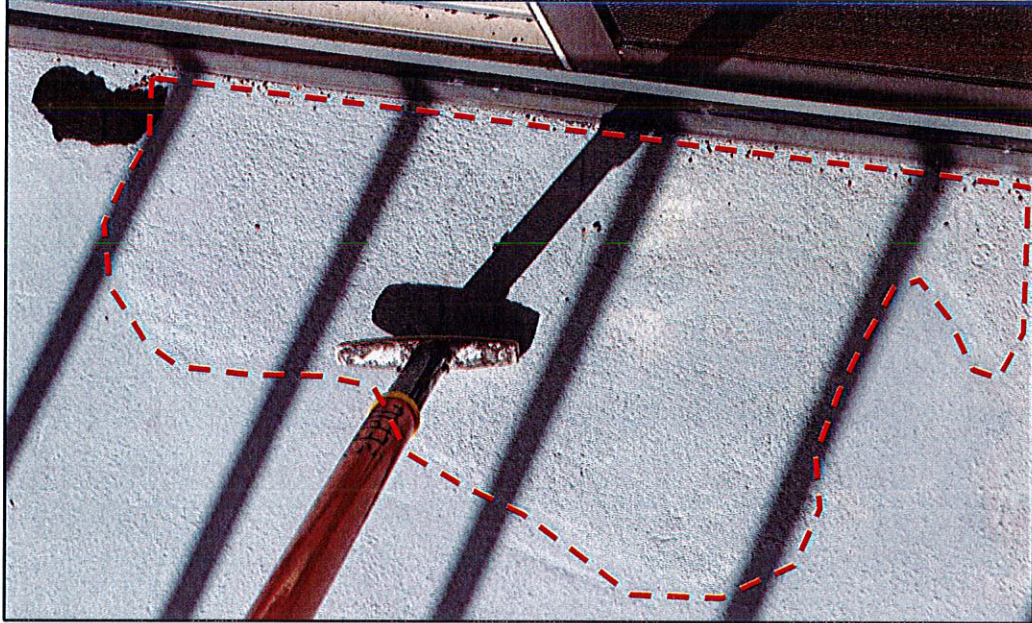
- In certain instances, this condition can be concealed by finishes that have not yet failed or have been covered by previous repairs. This condition requires

additional invasive evaluations to clearly define the limits of the deficiency (see **Photo #11**).

**Photo #11.** View of deteriorated floor finishes, signs of concrete slab spalling due to corroded reinforcing, condition observed at floor (Top of slab) of unit 506 balcony.

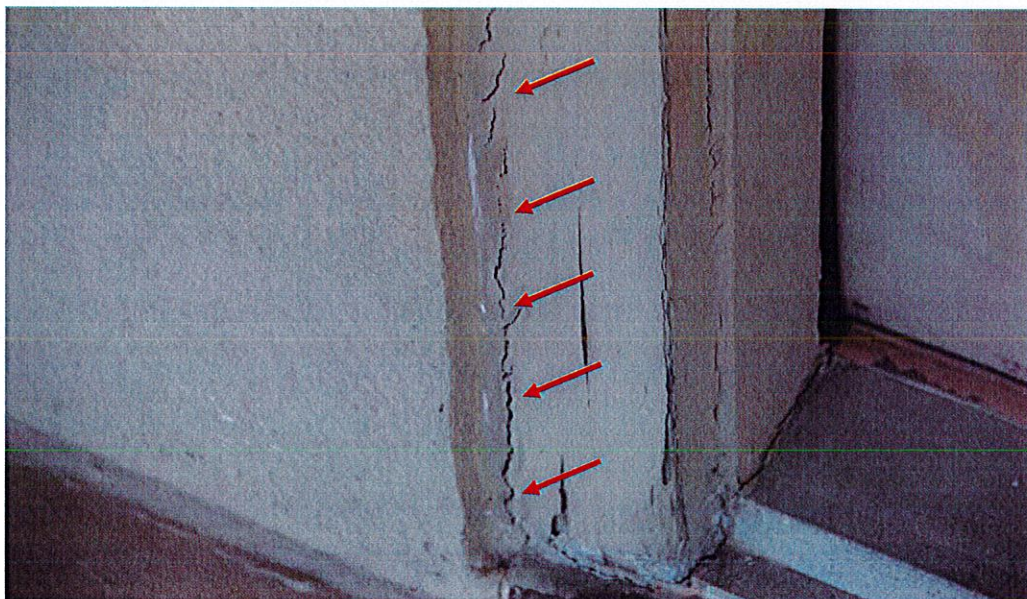
- Exterior sealants around door and window observed with signs of deterioration (cohesion failure). This condition can allow wind driven rain to enter the building envelope and cause damage to the concrete elements as well as damage to interior finishes, personal property and create environmental contamination such as mold and mildew. Sealant shall be removed and replaced preferably with a paintable and UV resistant silicone or hybrid sealant material (See **Photo #12**).

**Photo #12.** View of deteriorated sealant around the front door of unit 506.

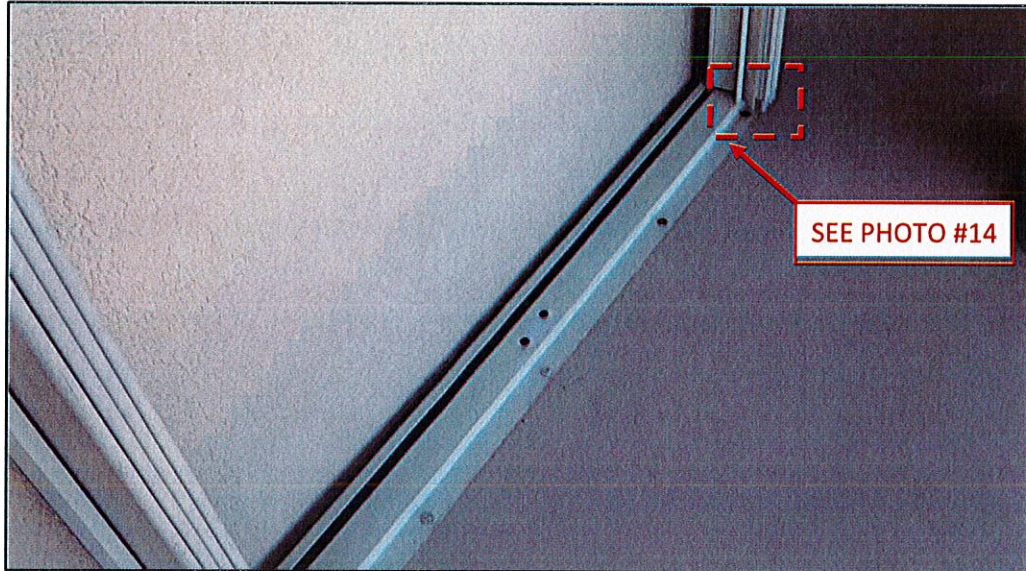
- Anchors for hurricane shutters observed with severe deterioration in the form of corrosion. This condition will compromise the structural integrity of the shutters under severe wind events. Expansion of the anchor due to severe corrosion will damage the concrete and can allow moisture to enter and damage reinforcing bars within the slab. Corroded anchors shall be replaced with corrosion resistant anchors

Photo #13. View of deteriorated metal anchors for the hurricane shutters. Observed at several units (Unit 403 shown).

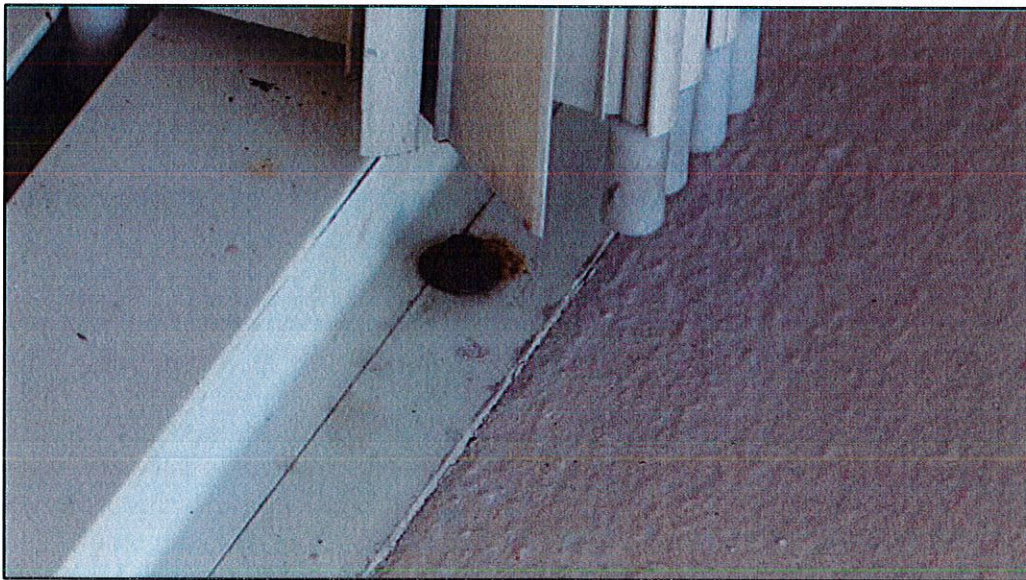
Photo #14. Close up view of deteriorated metal anchors for the hurricane shutters. (Unit 403 shown).

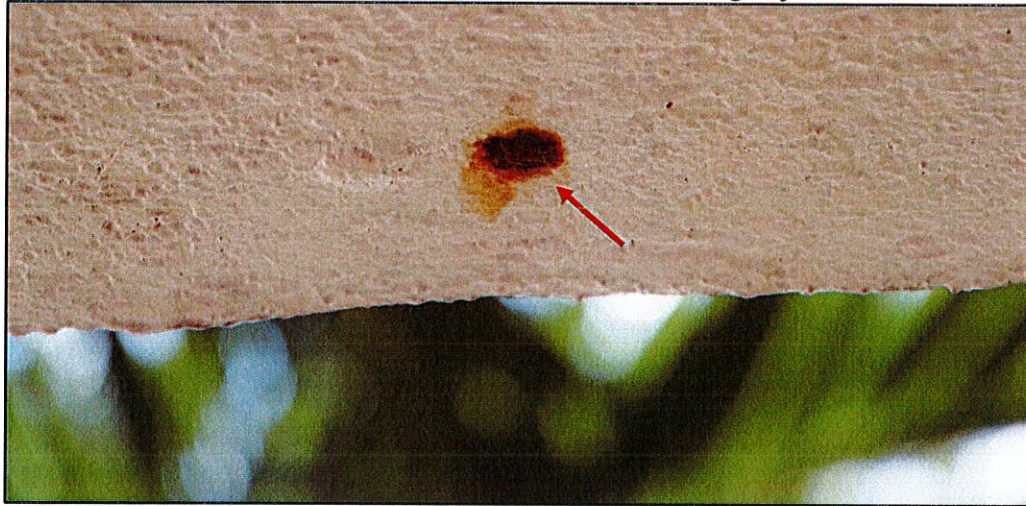
- Balcony ceiling and exterior edges with exposed and corroded metals and corroded steel elements observed at numerous units. This condition refers to metals used in the slab during construction, and also metals installed after

**Photo #15.** Close up view of embedded metals within concrete slabs. (Unit 104 ceiling balcony shown).

construction (see **Photo #15**). Exposed corroded metals shall be removed by grinding metals to a depth of at least 1 inch, coating remains of metal elements in cavity, patching hole and finish or paint to match existing adjacent areas.

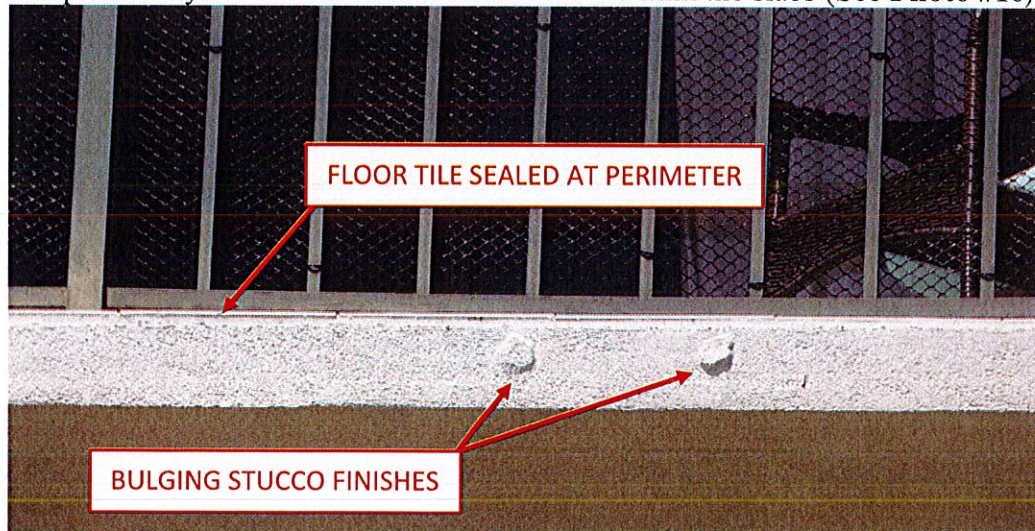
- Also, it was observed, at private balcony units with floor finishes (i.e. tile) installed up to the edge of the slab and the edge of the tile perimeter completely sealed preventing water that enters through grout lines or cracks to escape. In many cases water accumulates with no way to drain out damaging the finishes and potentially the concrete and reinforcement within the slabs (See **Photo #16**).

**Photo #16.** View of floor finishes (tile) with edges sealed (Unit 203 balcony shown).

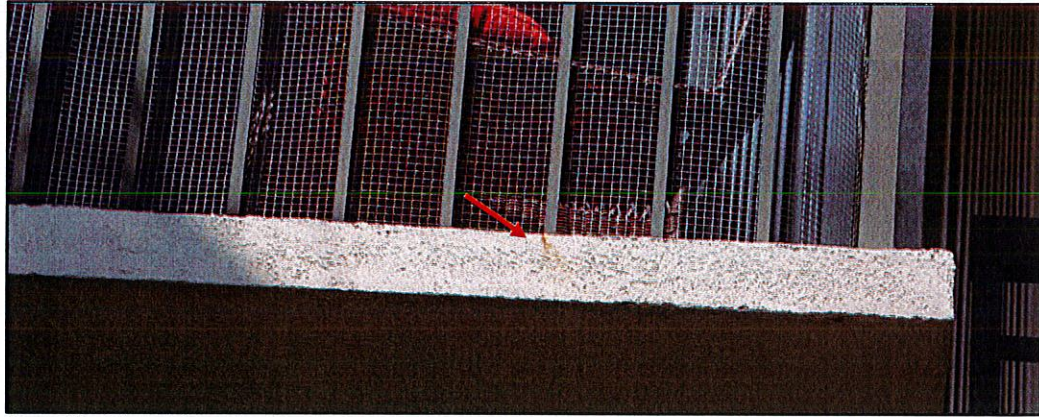
- View of floor slab with unsealed penetrations and floor cracks. Unsealed penetrations allow rainwater to penetrate and usually leads to corrosion of member reinforcement and spalling of concrete (Long term). Unsealed penetrations shall be filled with epoxy materials. The majority of the cracks observed are hairline cracks and do not represent a structural concern, however if

Photo #17. View slab cracks with visible corrosion stains and damages to stucco finishes (Unit 405 balcony shown).

not repaired they can cause future damage to the structure. Cracks shall be routed, sealed and surfaces finished with waterproofing membrane. (See **Photos #17, 18 and 19**).

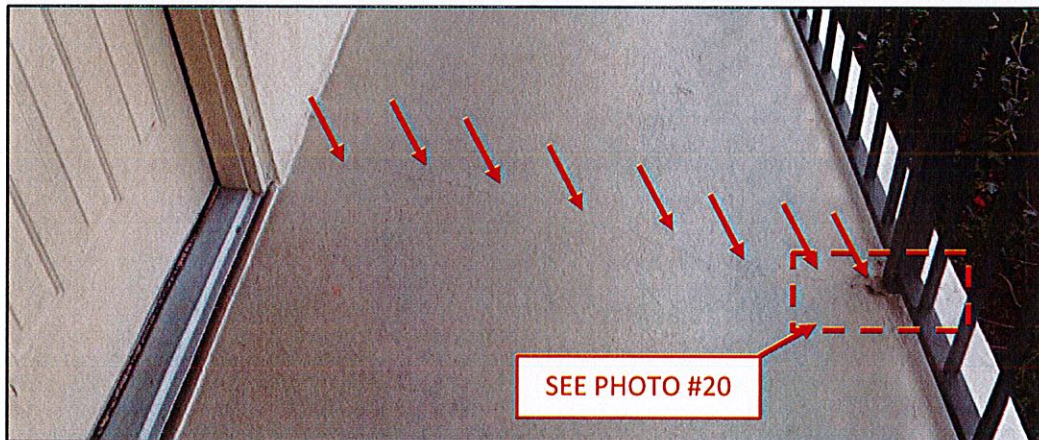
Photo #18. View of slab with visible cracks (Unit 202 front corridor shown).

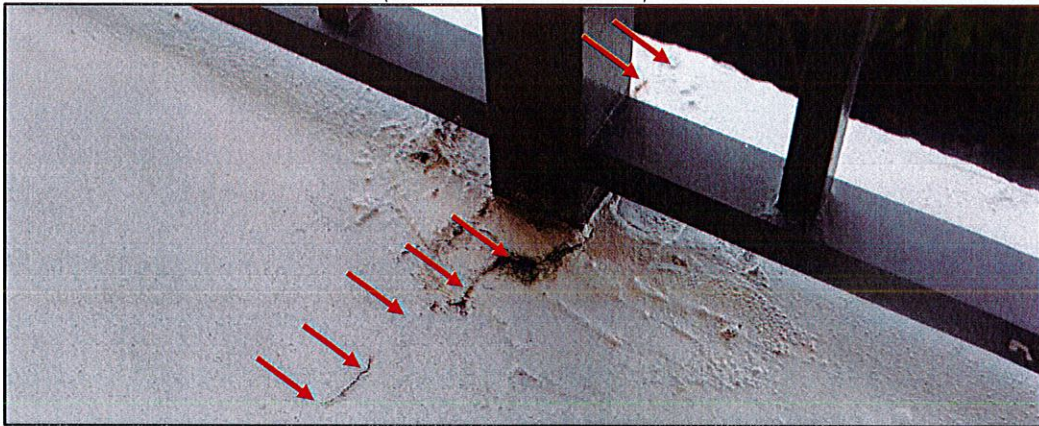
Photo #19. Close up view of slab crack (Unit 202 front corridor shown).
