January 31, 2023

Board of Directors  
The Marina at the Bluffs Condominium Association, Inc.  
1550 Marina Isle Way  
Jupiter, FL 33477

**Re: Milestone Inspection Report – Phase One.  
Building 8.  
801 Seafarer Cir, Jupiter, FL 33477**

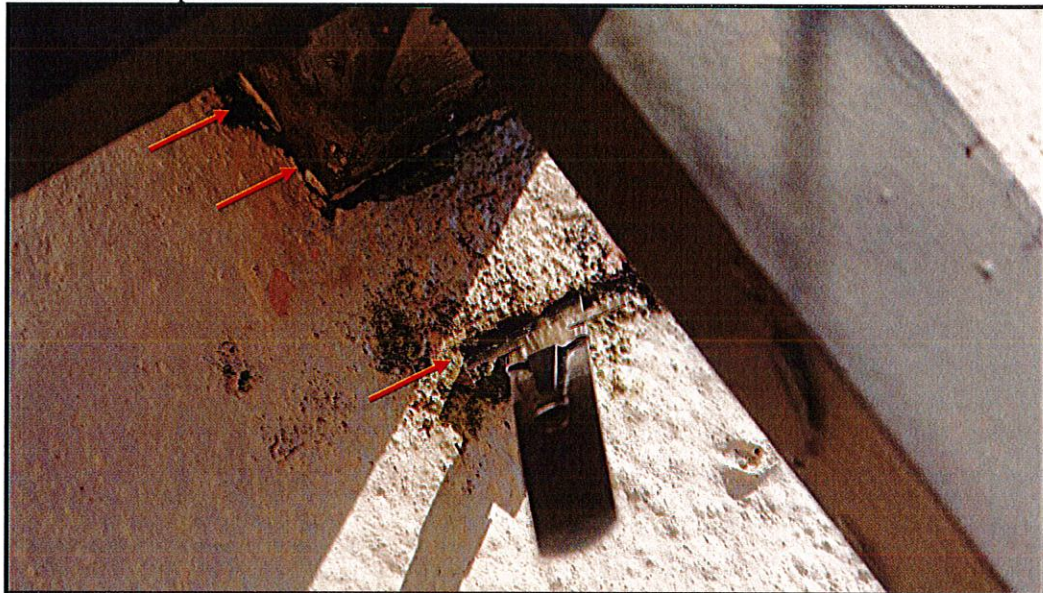
- Balcony guardrail vertical posts with visible separation and/or gaps between the concrete wall of the concrete pocket and the post. Also, moisture was observed ponding in low spots around the post base. This condition indicates moisture has penetrated the base of the post and could cause damage to the concrete and corrosion of the reinforcement in the slab. Further evidence of moisture within the railing post base can be observed at locations with vegetation and/or organic growth (see **Photo #1**). Also, at several locations, the degree of deterioration of the post base grout allows unwanted lateral movement of the guardrail system top member or top rail.

**Photo #1.** View of post base deteriorated grout and gaps around post with organic growth (unit 406 corridor – corner post).

- At locations where concrete/grout cracks, delamination, and/or spalling is identified, remove all grout to expose the embedded portion of railing post and remove adjoining cracked, delaminated and/or spalled concrete.
- Remove all grout, corrosion, scale, slurry, and other bond-inhibiting material from exposed railing post by thorough wire-brushing or high-pressure water blasting.
- Install weep hole at post base above finishes.
- Replace removed concrete non-shrink non-metallic grout around the post.
- Prime railing posts to a minimum of 1-inch above the finish concrete surface to provide adequate grout-to-aluminum isolation.
- Seal around post base with sealant.
- Plaster finish and paint the repair area to match the surroundings.

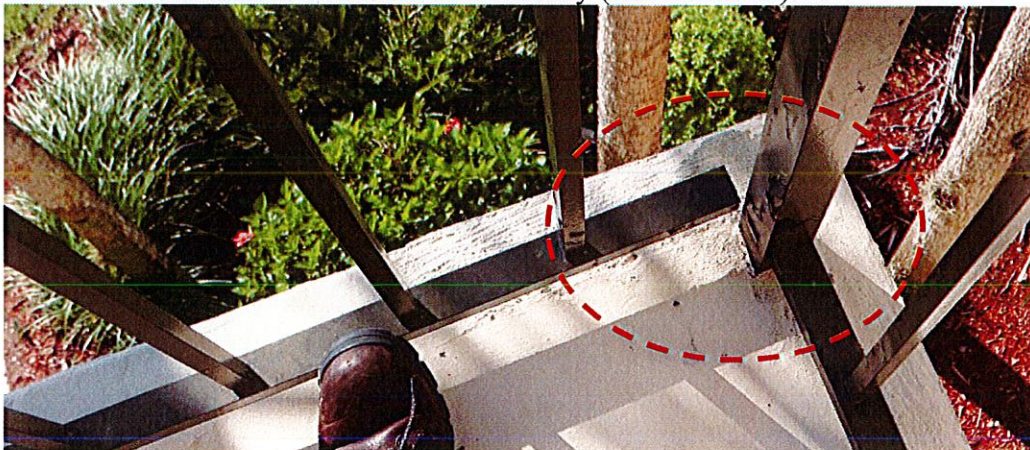
- Balcony guardrail horizontal low member at the return of the balcony (next to corner) at unit 301 was found broken at the base connection to the vertical post. This condition shall be corrected immediately (see **Photo #2**).

**Photo #2.** View of guardrail lower member detached from vertical post base (corner of unit 301 corridor).

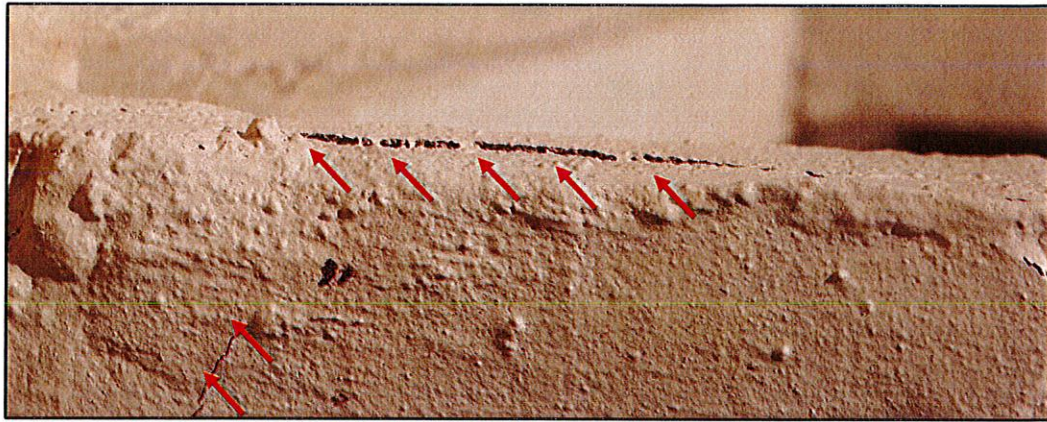
- Balcony floors and exterior edges with imminent concrete spalls. This condition can also be caused by insufficient rebar concrete coverage and by superficial cracks that allow moisture intrusion. Corrosion present at reinforcing steel produces expansion of the diameter of the bar which leads to displacement of surface materials, in this case, concrete (See **Photos #3 & #4**). Due to the uncertainty of this condition, it is not possible to predict if or when the finishes will fall. We recommend removing the deficient portions of the finishes or concrete elements from the slab edges or ceilings to prevent pieces of debris from falling down and hurting residents.

Photo #3. View of imminent spalling of edge finishes observed at exterior slab edge (unit 506).

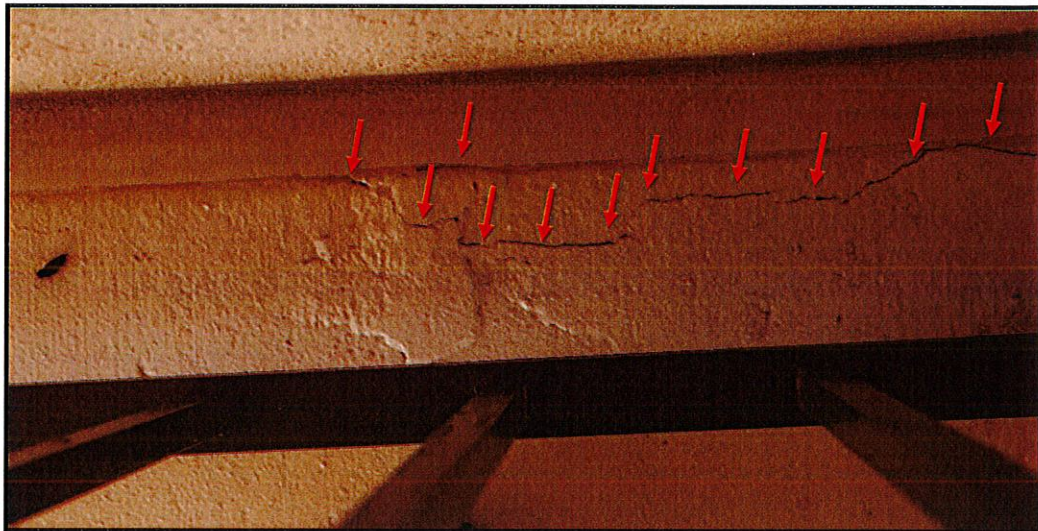
Photo #4. View of imminent spalling of concrete edge observed at exterior floor slab edge (between unit 403 and 404 corridor in front of elevator).

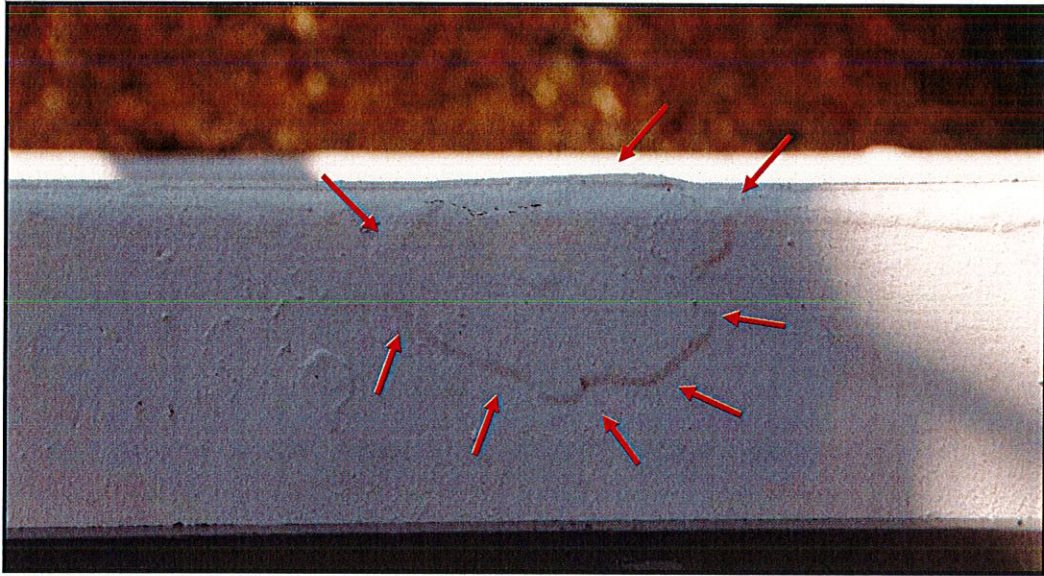
- Balcony ceiling and exterior edges with exposed and corroded reinforcement bars. This condition can be caused by insufficient rebar concrete coverage and by superficial cracks that allow moisture intrusion. Corrosion present at reinforcing steel produces expansion of the diameter of the bar (exfoliation) which leads to displacement (jacking) of surface finishes, such as stucco. This condition can be observed prior to stucco/concrete finishes failure, in the form of bulging of the exterior finishes (see **Photo #5**).

**Photo #5.** View of deteriorated stucco and concrete finishes at exterior edge of slab, signs of concrete spalling due to corroded reinforcing, condition observed at exterior edge of corridor at unit 301.

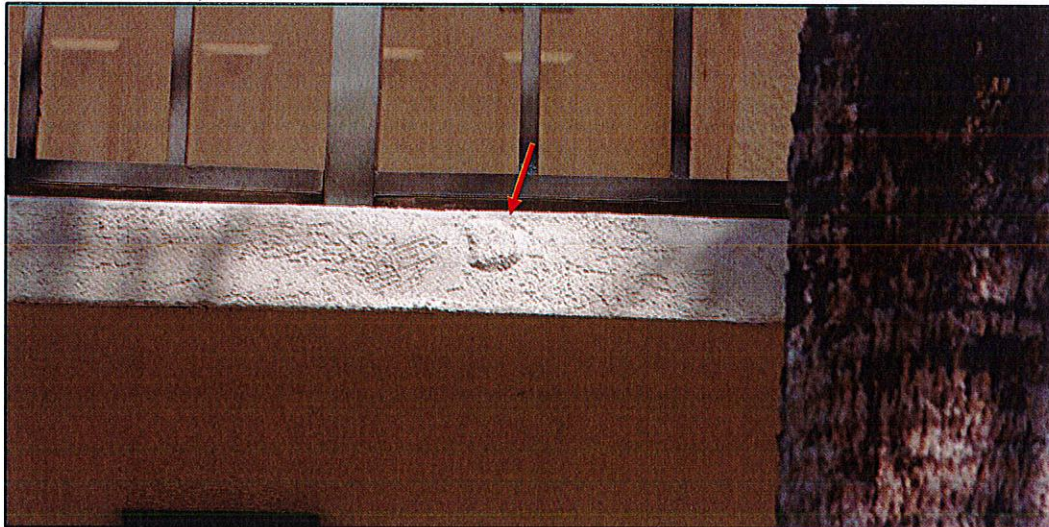
- In certain instances, this condition can be concealed by finishes that have not yet failed or have been covered by previous repairs. This condition requires additional invasive evaluations to clearly define the limits of the deficiency (see **Photo #6 & #7**).

**Photo #6.** View of cracks and deteriorated floor finishes, signs of concrete slab spalling due to corroded reinforcing, condition observed at floor (top of slab) of unit 302 front corridor near exterior wall.

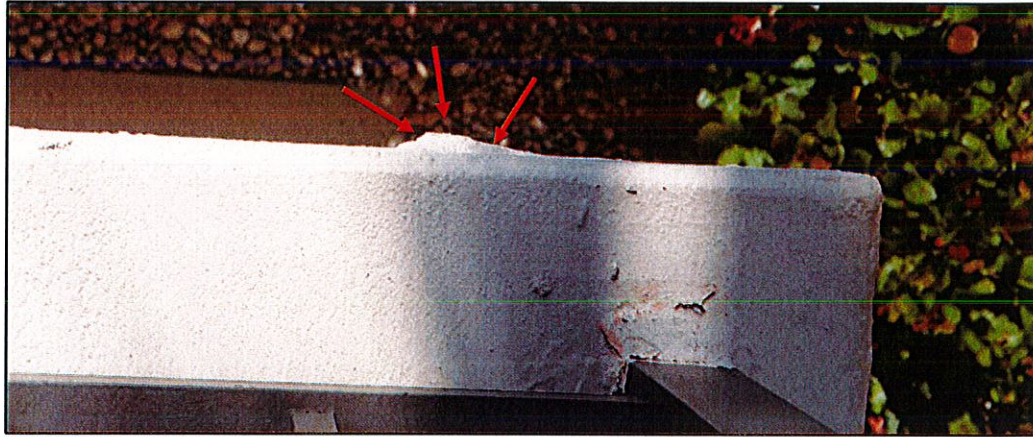
**Photo #7.** View of deteriorated stucco finishes, signs of concrete slab spalling due to corroded reinforcing, condition observed at outside edge of slab of unit 201 front corridor at corner.

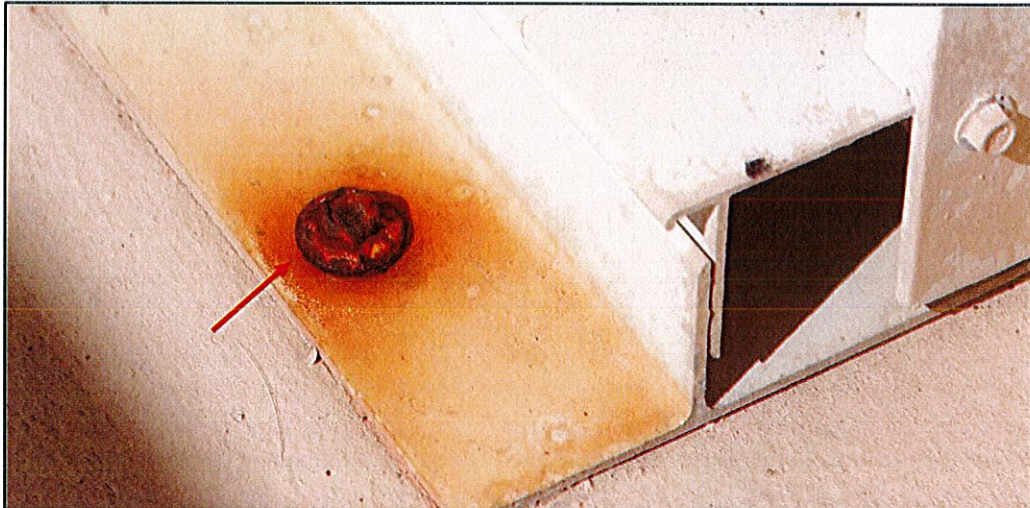
- Anchors for hurricane shutters observed with severe deterioration in the form of corrosion. This condition will compromise the structural integrity of the shutters under severe wind events. Expansion of the anchor due to severe corrosion will damage the concrete and can allow moisture to enter and damage reinforcing bars within the slab (see **Photo #8**). Corroded anchors shall be replaced with corrosion resistant anchors.

**Photo #8.** View of deteriorated metal anchors for the hurricane shutters. Observed at several units (unit 204 shown).

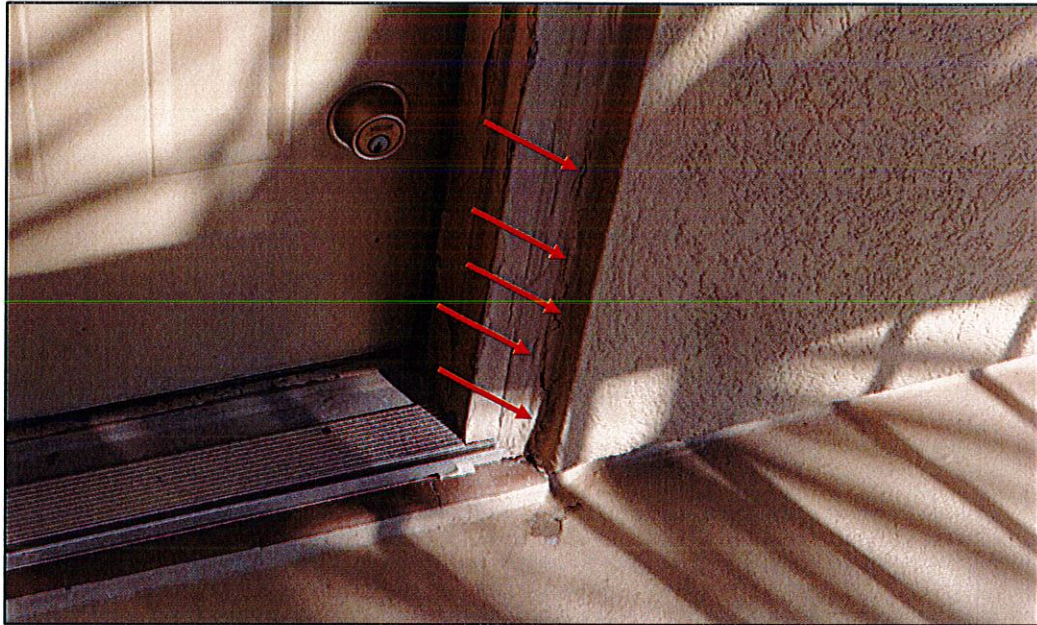
- Exterior sealants around door and windows and between building panels observed with signs of deterioration (cohesion failure). This condition can allow wind driven rain to enter the building envelope and cause damage to the concrete elements as well as damage to interior finishes, personal property and create environmental contamination such as mold and mildew. Sealant shall be removed and replaced preferably with a paintable and UV resistant silicone or hybrid sealant material (See **Photo #9**).

Photo #9. View of deteriorated sealant at entry door of unit 301.

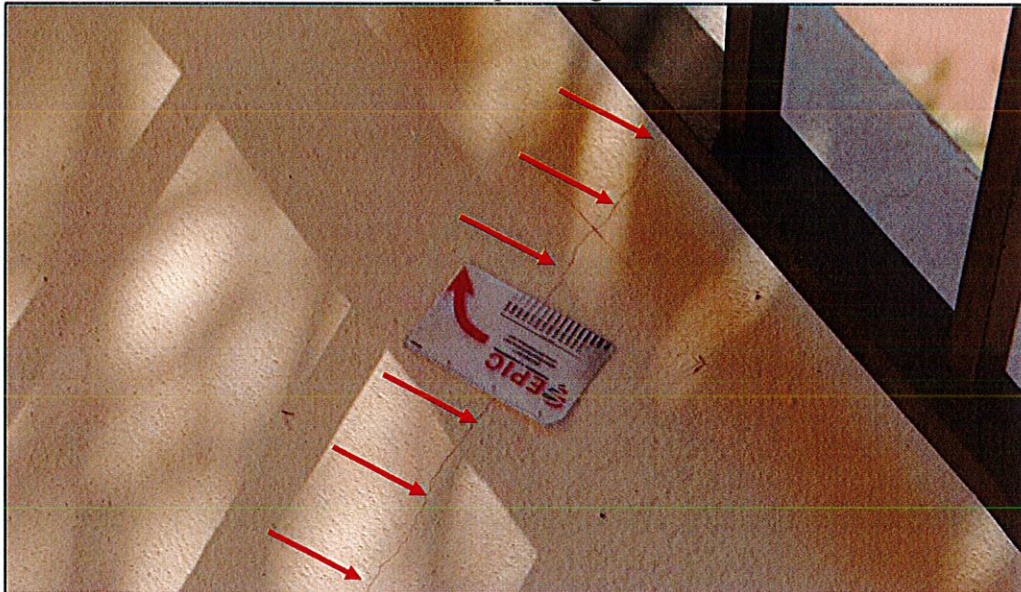
- Floor slab with unsealed penetrations and floor cracks. Unsealed penetrations allow rainwater to penetrate and usually leads to corrosion of member reinforcement and spalling of concrete (Long term). Unsealed penetrations shall be filled with epoxy materials. (See **Photo #10**). The majority of the cracks observed are hairline cracks and do not represent a structural concern, however if not repaired they can cause future damage to the structure. Cracks shall be routed, sealed and surfaces finished with waterproofing membrane.

Photo #10. View of exterior unsealed cracks at edge of slab (unit 401 front corridor).
