January 31, 2023

Board of Directors
The Marina at the Bluffs Condominium Association, Inc.
1550 Marina Isle Way
Jupiter, FL 33477

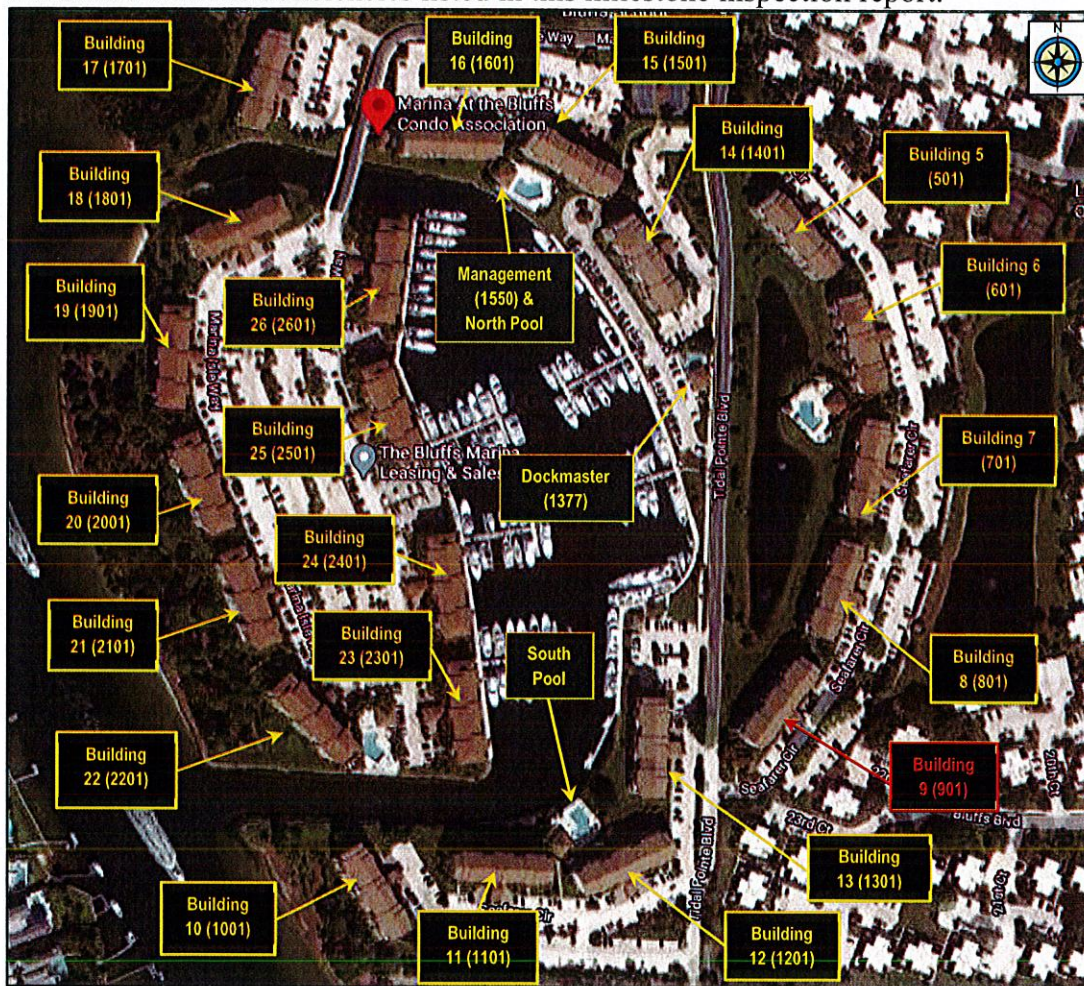
Exhibit 1: Aerial photograph of the property with building numbers and address numbers. (Source: Google Maps 2020)

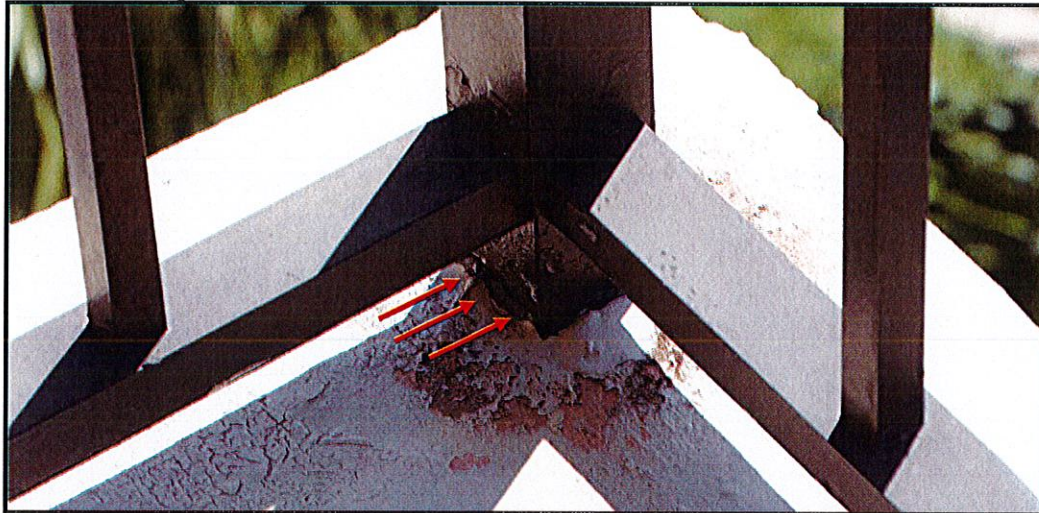
Photo #1. View of post base deteriorated grout with gaps around post and organic growth (unit 506 corridor).

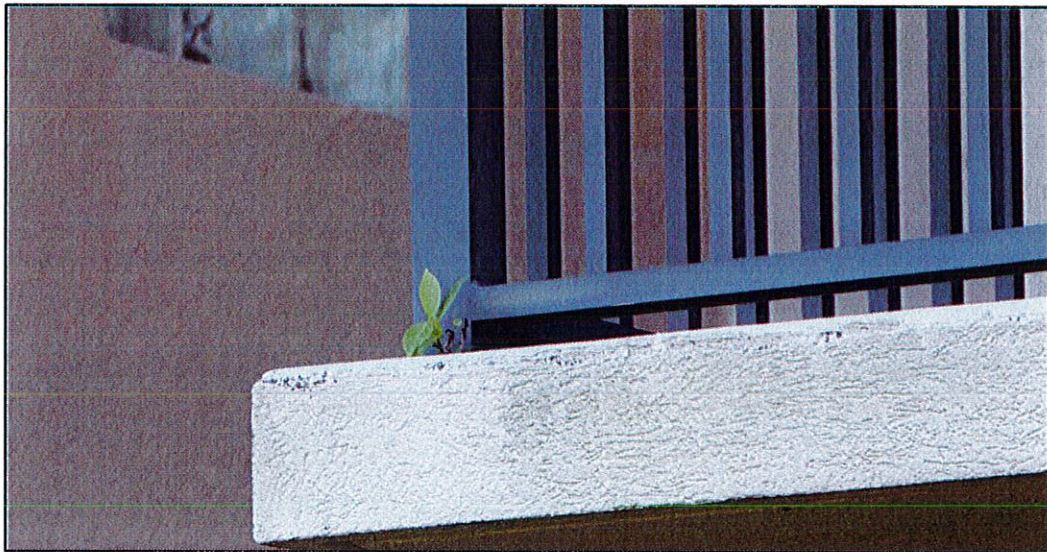
Photo #2. View of post base deteriorated grout with gaps around post and organic growth (unit 202 balcony).

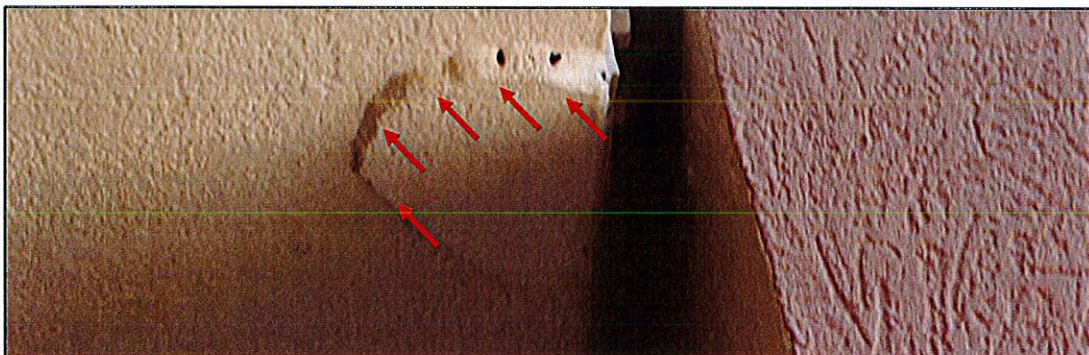
Photo #3. View of imminent spalling of ceiling finishes observed at exterior slab edge (unit 101 in front of stair).

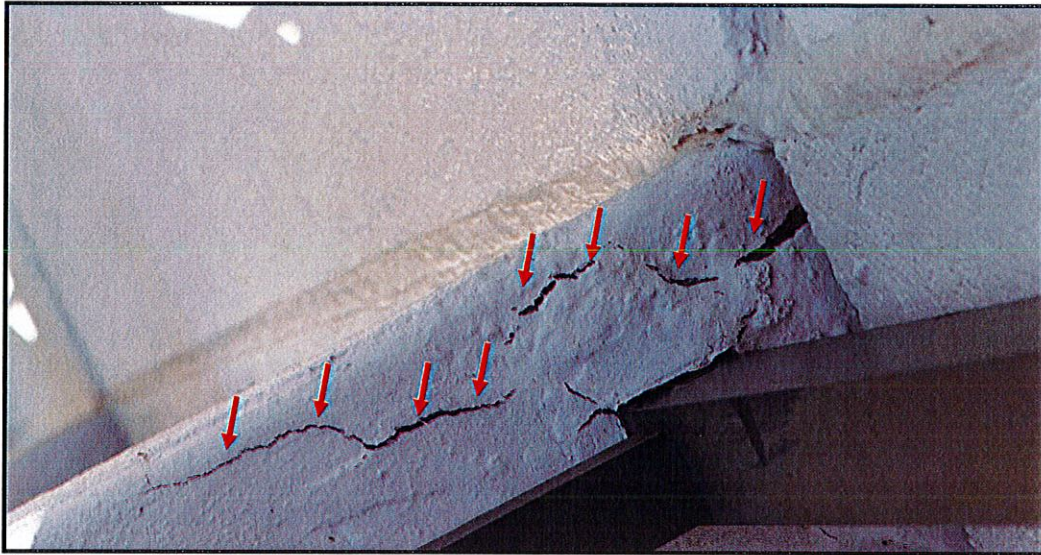
Photo #4. View of imminent spalling of south concrete edge observed at exterior floor slab edge (unit 401 corridor).

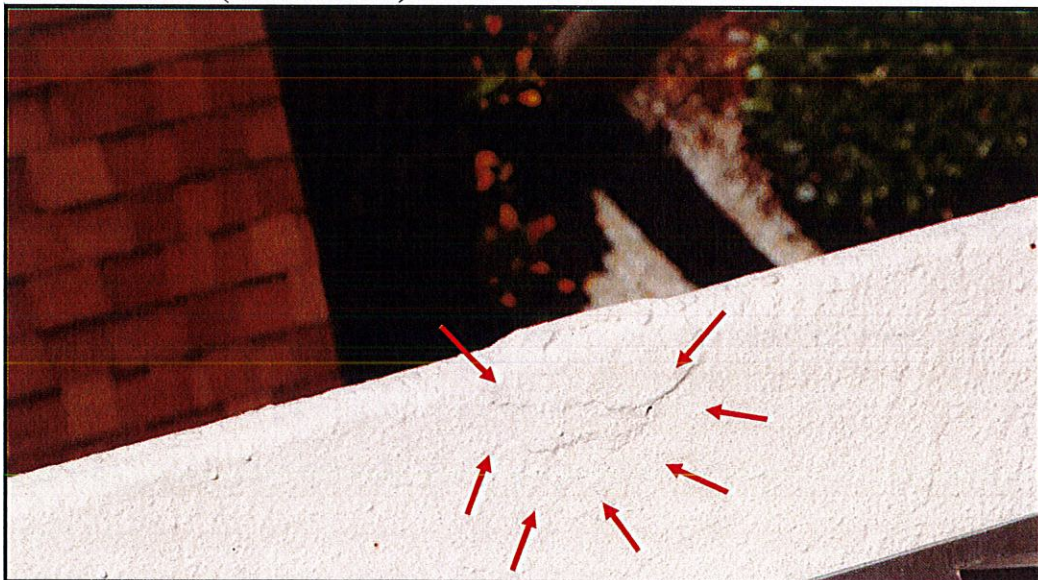
Photo #5. View of deteriorated stucco finishes at exterior edge of slab, signs of concrete spalling due to corroded reinforcing, condition observed at exterior edge of corridor at unit 503.

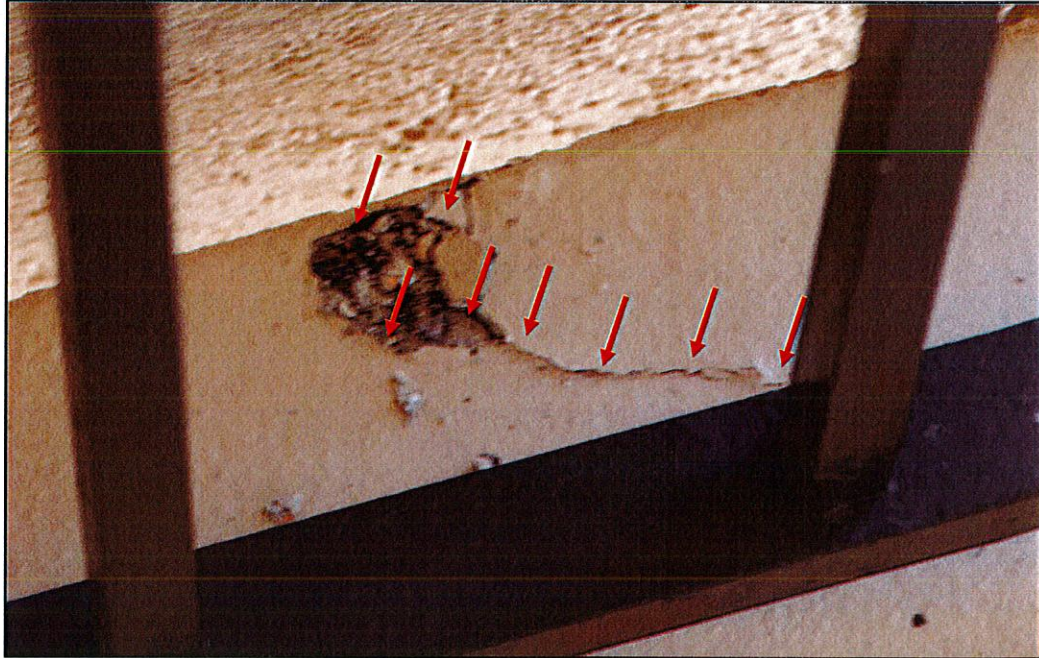
Photo #6. View of cracks and deteriorated floor finishes, signs of concrete slab spalling due to corroded reinforcing, condition observed at floor (top of slab) of unit 503 front corridor near exterior wall.

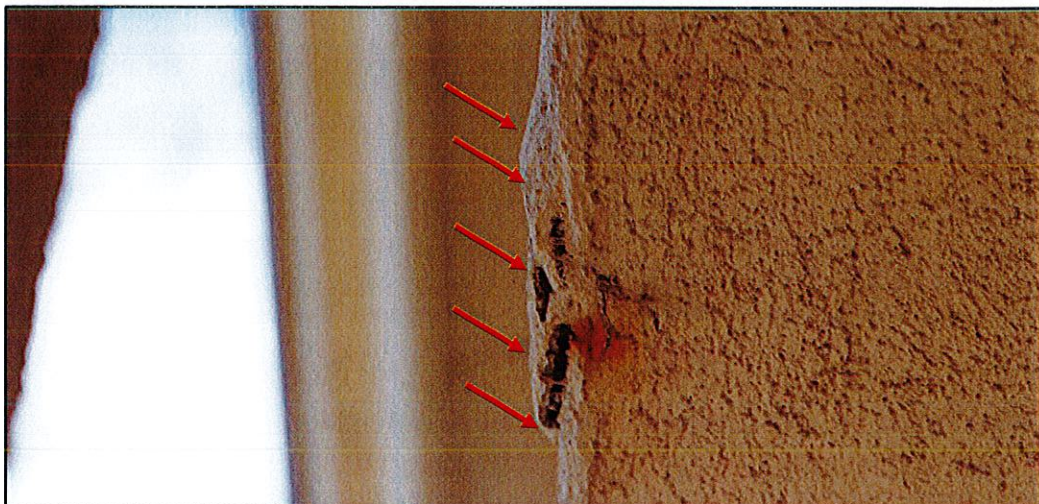
Photo #7. View of cracks and deteriorated floor finishes, signs of concrete slab spalling due to corroded reinforcing, condition observed at ceiling outside edge of slab of unit 405 front corridor near exterior wall.

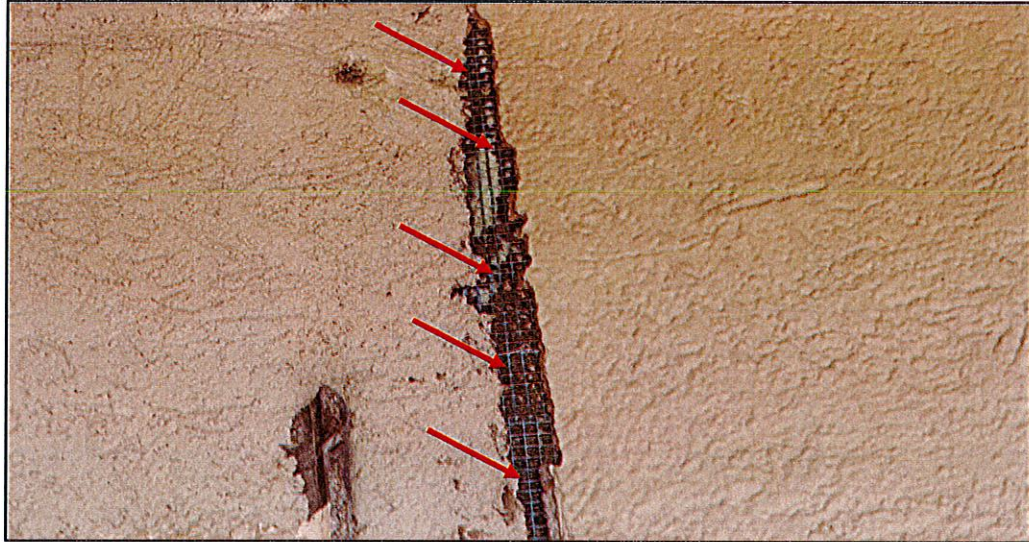
Photo #8. View of deteriorated sealant between wall panels at unit 506.

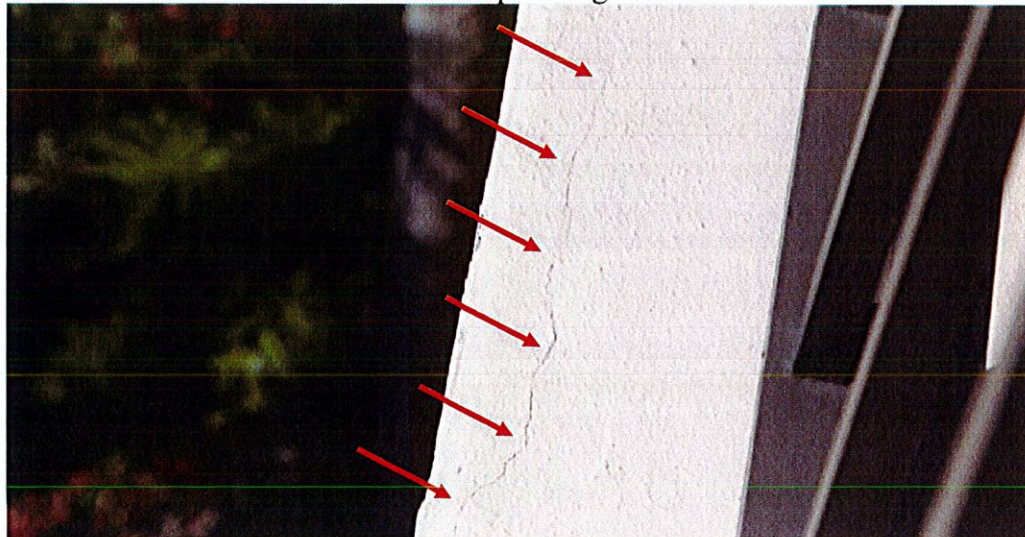
Photo #9. View of exterior unsealed cracks at edge of slab (unit 501 front corridor).
