January 31, 2023.

Board of Directors  
The Marina at the Bluffs Condominium Association, Inc.  
1550 Marina Isle Way  
Jupiter, FL 33477

**Re: Milestone Inspection Report – Phase One.  
Building 5.  
501 Seafarer Circle, Jupiter, FL 33477**

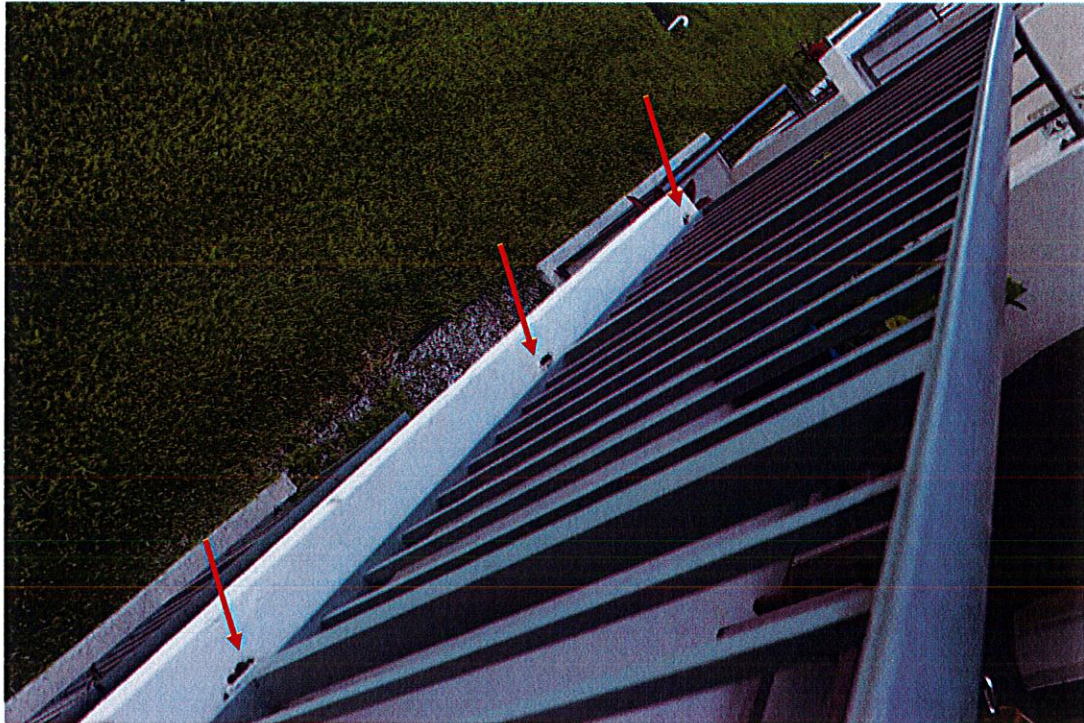
- Balcony guardrail vertical posts with visible separation and/or gaps between the concrete wall of the concrete pocket and the post (see **Photos #1 and #2**). In several locations, a metal ruler was able to be inserted to depths of up to 2 inches. Moisture was observed at the end of the ruler upon removal from the gap. Also, moisture was observed ponding in low spots around the post base. This condition indicates moisture has penetrated the base of the post and could cause damage to the concrete and corrosion of the reinforcement in the slab. Further evidence of moisture within the railing post base can be observed at locations with vegetation and/or organic growth. Also, at several locations, the degree of deterioration of the post base grout allows unwanted lateral movement of the guardrail system top member or toprail.

**Photo #1.** View of post base with missing grout (unit 201 balcony).

Since the existing guardrail system is not “current” code compliant, the guardrail system cannot be removed or un-installed from the current location. If the guardrail is removed, a new current code compliant system shall be installed in its place. For that reason, we recommend the following remedial actions:

- At locations where concrete/grout cracks, delamination, and/or spalling is identified, remove all grout to expose the embedded portion of railing post and remove adjoining cracked, delaminated and/or spalled concrete.
- Remove all grout, corrosion, scale, slurry, and other bond-inhibiting material from exposed railing post by thorough wire-brushing or high-pressure water blasting.
- Install weep hole at post base above finishes.
- Replace removed concrete non-shrink non-metallic grout around the post.
- Prime railing posts to a minimum of 1-inch above the finish concrete surface to provide adequate grout-to-aluminum isolation.
- Seal around post base with sealant.
- Plaster finish and paint the repair area to match the surroundings.

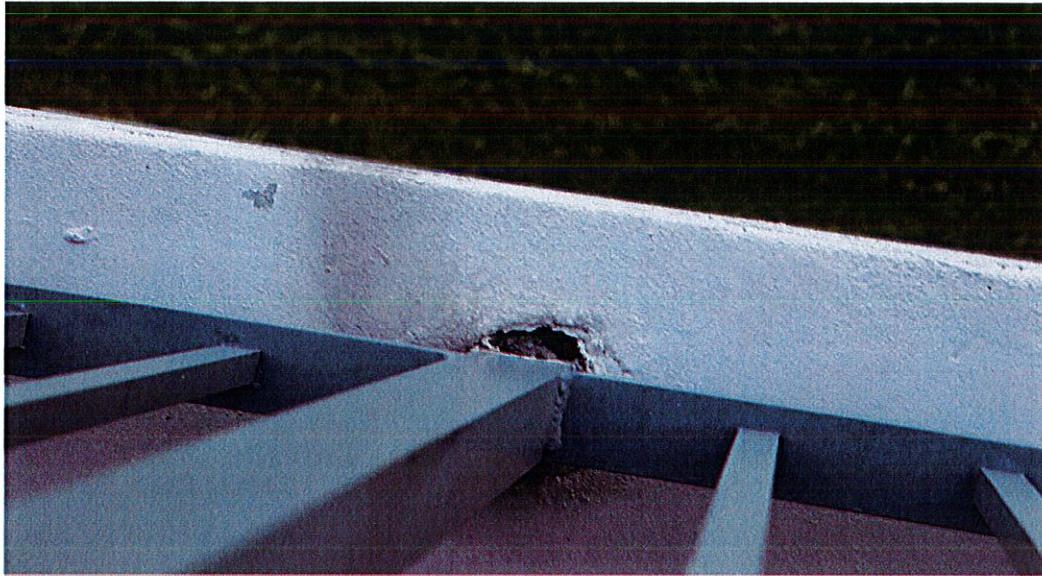
Photo #2. View of post base deteriorated (unit 201 balcony).

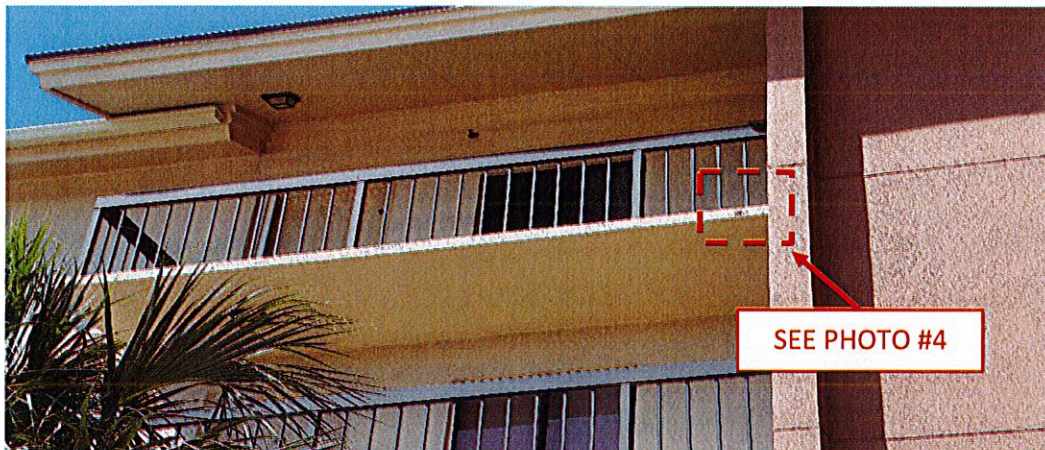
- Balcony floors and exterior edges with imminent concrete spalls. This condition can also be caused by insufficient rebar concrete coverage and by superficial cracks that allow moisture intrusion. Corrosion present at reinforcing steel produces expansion of the diameter of the bar which leads to displacement of surface materials, in this case, concrete (See **Photos #3 and #4**). Due to the uncertainty of this condition, it is not possible to predict if or when the finishes will fall. We recommend removing the deficient portions of the finishes or concrete elements from the slab edges or ceilings to prevent pieces of debris from falling down and hurting residents.

Photo #3. View of spalled concrete slab edge observed in front of unit 501.

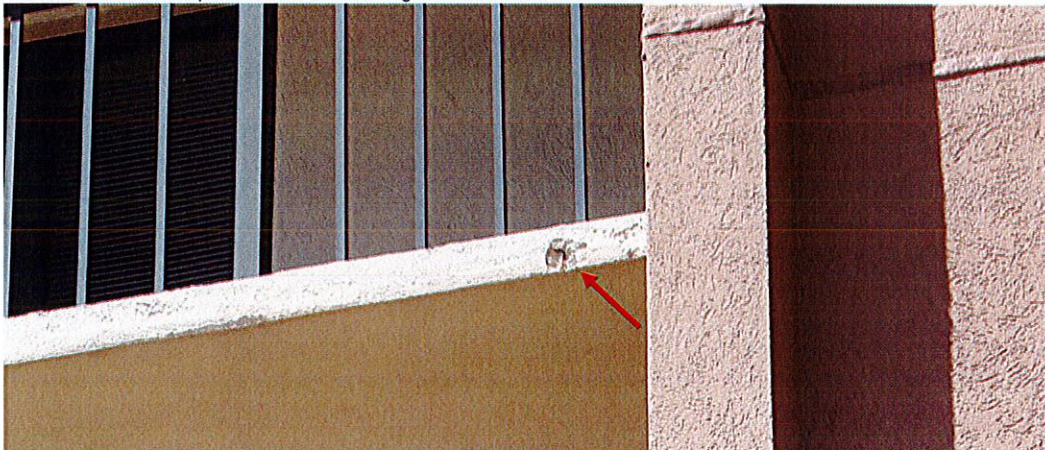
Photo #4. View of spalled concrete slab edge observed in front of unit 501.

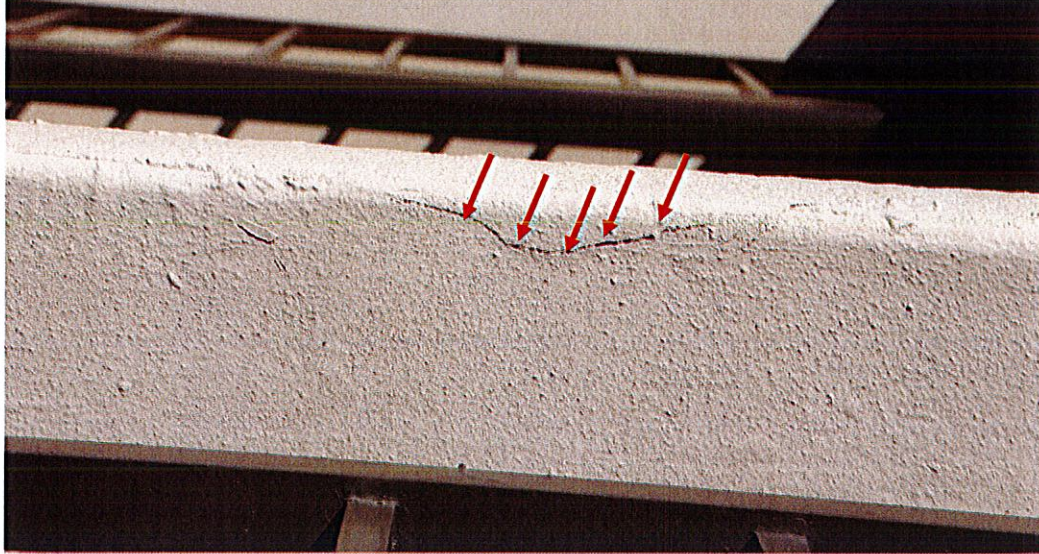
- Balcony ceiling and exterior edges with exposed and corroded reinforcement bars. This condition can be caused by insufficient rebar concrete coverage and by superficial cracks that allow moisture intrusion. Corrosion present at reinforcing steel produces expansion of the diameter of the bar (exfoliation) which leads to displacement (jacking) of surface finishes, such as stucco. This condition can be observed prior to stucco/concrete finishes failure, in the form of bulging of the

exterior finishes (see **Photo #5**) and after finishes have been removed or displaced by the expansion of the reinforcing bar due to corrosion (see **Photo #6**).

**Photo #5.** Signs of concrete slab spalling due to corroded reinforcing, condition observed at floor do front corridor of unit 502.

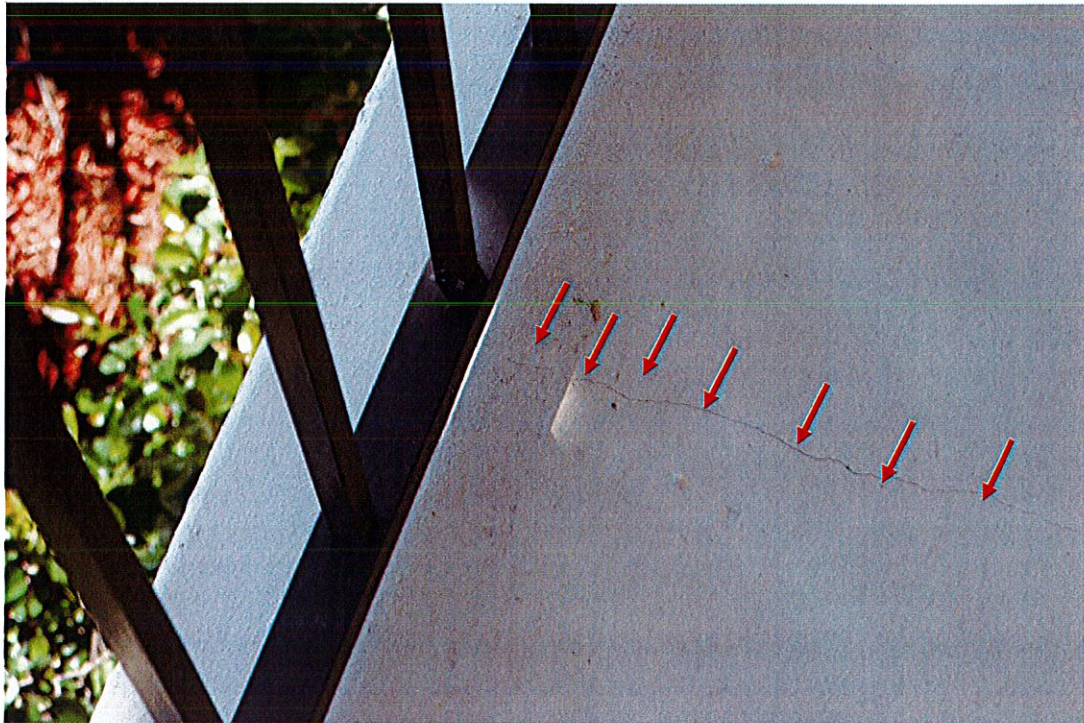
- View of floor slab with unsealed penetrations and floor cracks. Unsealed penetrations allow rainwater to penetrate and usually leads to corrosion of member reinforcement and spalling of concrete (Long term). Unsealed penetrations shall be filled with epoxy materials. The majority of the cracks observed are hairline cracks and do not represent a structural concern, however if not repaired they can cause future damage to the structure. Cracks shall be routed, sealed and surfaces finished with waterproofing membrane.

Photo #6. View slab cracks with visible corrosion stains and damages to stucco finishes (Unit 303 front corridor shown).
